## Hazard Mitigation Plan

THE EASTERN SHORE OF VIRGINIA

Eastern Shore Hazard Mitigation Planning Committee Accomack-Northampton Planning District Commission

## 2011 Hazard Mitigation Plan

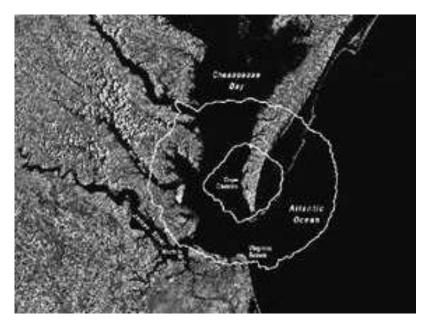
FIGURE 1.2 The inner and outer rims of the Chesapeake Bay Impact Crater (white outlines) underlie approximately the southern half of the Eastern Shore . *Image from USGS Professional Paper 1622*.

It has been determined that a bolide, or object from space, struck near the area of what is now Cape Charles nearly 35.5 million years ago towards the end of the Eocene epoch. During this time, sea levels were much higher than today. The coastline existed above the Fall Line and west of the City of Richmond and what is now eastern Virginia lay beneath a shallow sea approximately 100 feet in depth. The impact created a crater twice the size of Rhode Island and generated an enormous tsunami that engulfed the continent, possibly overtopping the Blue Ridge Mountains. The crater, now underlying all of Northampton County and portions of southern Accomack County, and the sediments that have buried it have continuously settled over time, creating increased subsidence of landforms in the region. It is speculated that the subsidence associated with the crater has influenced the geologic evolution of the southern Delmarva Peninsula and southern Chesapeake Bay region.

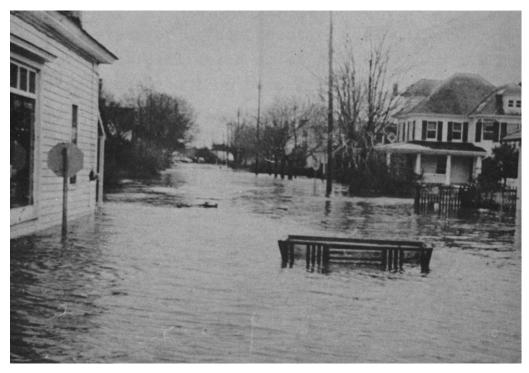
FIGURE 1.5 Flooding during the Ash Wednesday Storm of 1962. Photo printed in the Army Corp of Engineers Flood Plain Report for Wachapreague

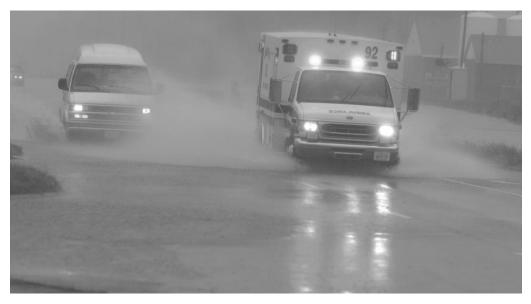
FIGURE 1.6 Storm water flooding on U.S. Route 13 during Tropical Depression Ernesto in 2006. *Photo by Jay Diem, Eastern Shore News*.

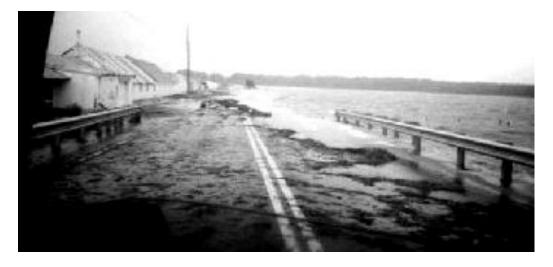
FIGURE 4.3 Causeway to Quinby during Hurricane Isabel in 2003. Photo by David Fluhart

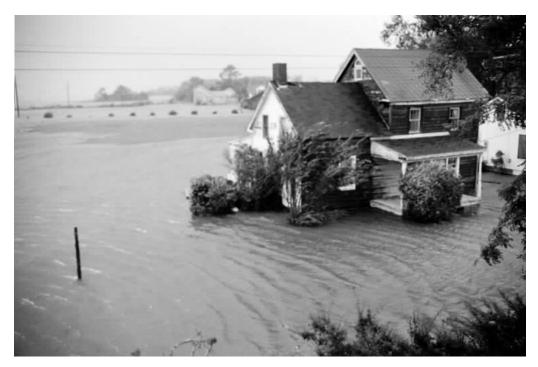
FIGURE 4.4 Flood waters inundating homes located in an A zone in Wachapreague during Hurricane Isabel. *Photo by Dan Bilicki*

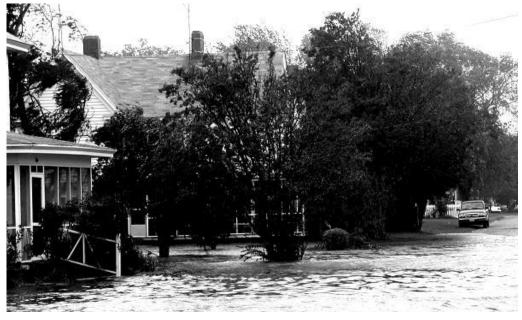
FIGURE 4.5 Homes in Wachapreague during Hurricane Isabel. These homes are located in an A zone with a Base Flood Elevation that includes a wave height component. *Photo by John Aigner*

Coastal A zones also represent increased vulnerability to both Accomack and Northampton County. The NFIP does not recognize the difference between A zones where the source of water is an inland river or an A zone where the source of water is from a bay or ocean. Therefore, the NFIP regulations do not require special construction for coastal A zones. However, structures in these zones are commonly exposed to weaker V zone conditions including waves, scour, and velocity flows. Open foundations are not required in these areas. However, waves and debris can still destroy structures there. If a structure is built with a closed foundation, that structure can expect to receive more damage if struck with storm surge water than a similar structure with an open foundation.

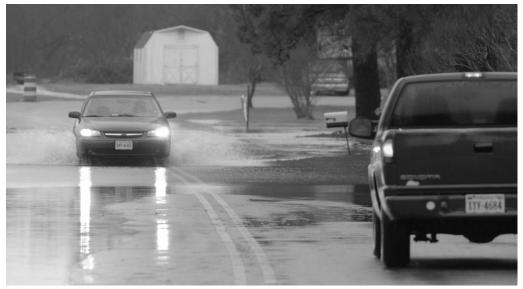
FIGURE 5.1 Common scene of flooded roadways following intense rainfall on the Eastern Shore. *Photo by Jay Diem, Eastern Shore News*.

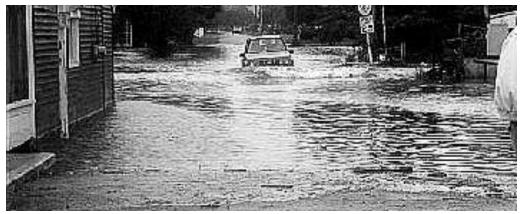
FIGURE 5.2 Car fording street flooded by surge from Hurricane Isabel in 2003. *Photo by David Fluhart*.

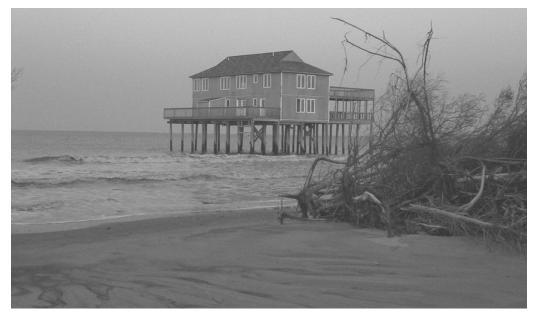
FIGURE 7.1 This photograph of southern Cedar Island in Accomack County illustrates the amount of shoreline change occurring on the seaside barrier islands on the Eastern Shore. There are a minimal number of structures located along the oceanfront. *Photo by Curt Smith.*

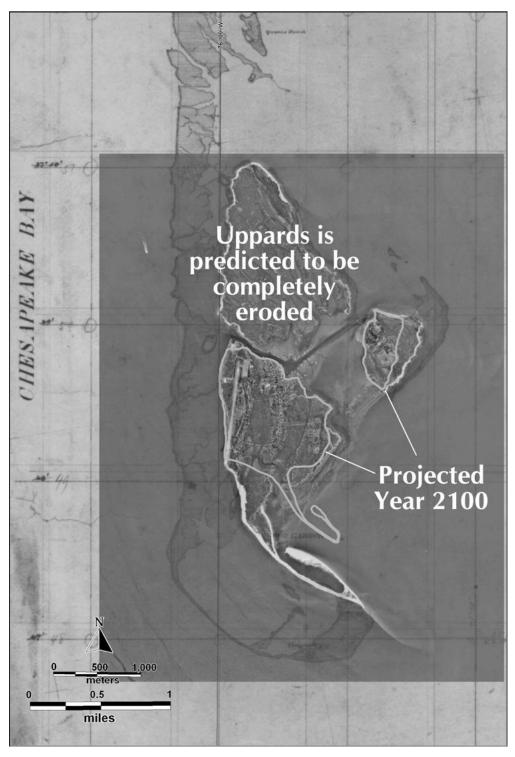
FIGURE 7.2 Illustration of historic shoreline change occurring since 1850 and project shoreline position for 2100 for Tangier Island. A map showing the 1850 location of Tangier is in the background and is overlain by an aerial photo showing the island's position in 2000. The projected shoreline in 2100 is illustrated by darker outline. *From Mills, 2003.*

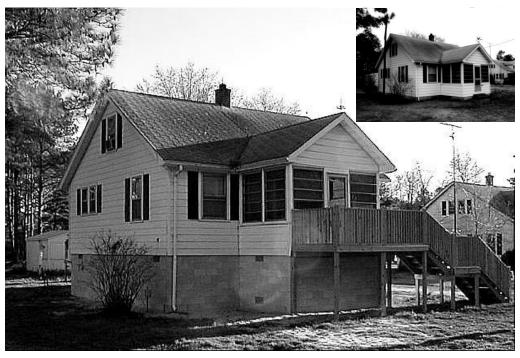
FIGURE 8.2 The County elevated this home in the Deep Creek area using Hazard Mitigation Grant Program money following Hurricane Floyd in 1999. *Photos by David Fluhart*

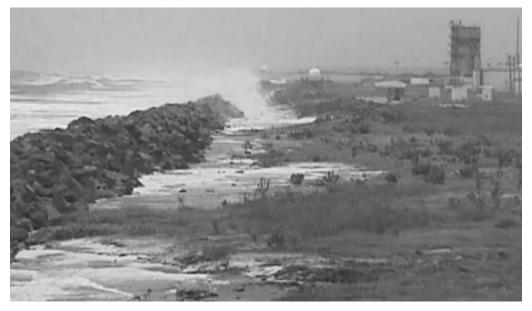
FIGURE 8.3 Waves overtopping the seawall on Wallops Island during Hurricane Dennis in September 1999. *Photo Courtesy of U.S. Army Corps of Engineers.*

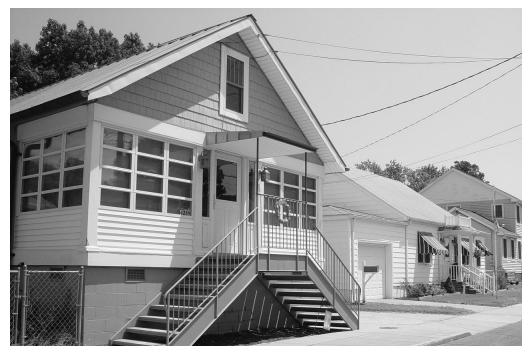
FIGURE 9.2 Chincoteague home elevation project.

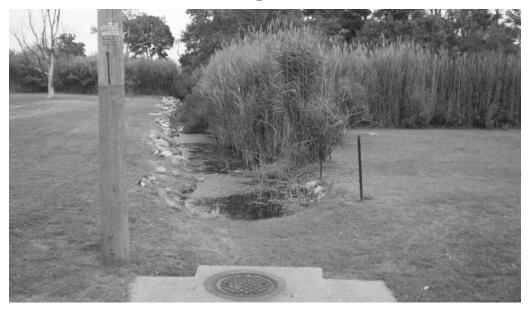
FIGURE 10.4 Drainage ditches in Saxis are commonly clogged by the invasive plant species, phragmites. *Photo by Curt Smith*

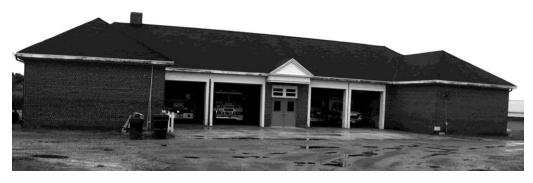
FIGURE 10.5 Saxis' firehouse and Town office located in a flood zone. *Photo by Elaine Meil*

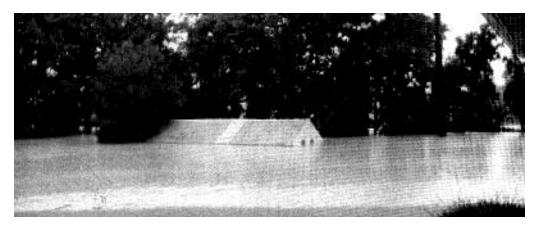
FIGURE 12.1 A structure in the Town of Bloxom on September 3, 2003. The trees in the distance line the railroad. *Photo by Franklin Kreisl*

In specific instances, storm water has accumulated and caused flooding. Bloxom received a flood of this nature on September 3, 2003, just prior to Hurricane Isabel. A heavy rain occurred and water flowed to the railroad tracks, which acted as a dam, back flooding several homes. In addition, farm fields in the area were covered in plastic that potentially acted like a parking lot does in a more urban environment. Although the storm is called the Great Bloxom Flood of 2003, several areas were flooded including Bloxom, Clam, Guilford, Hallwood and Nelsonia.

This particular incident was caused by several conditions. An afternoon rainstorm had already passed through the area. During the height of this storm, motorists on Route 13 had slowed to a crawl, as the rain was too intense to adequately see ahead of them. That evening at least two thunderstorms passed over Accomack County. In a very short period of time, 6 to 8 inches of rain fell. An 8-inch backyard rain gauge was full to overflowing. Ten inches of rain was found in a bucket left outside. Radar out of Salisbury indicated that the area received about 6 inches during the thunderstorm.

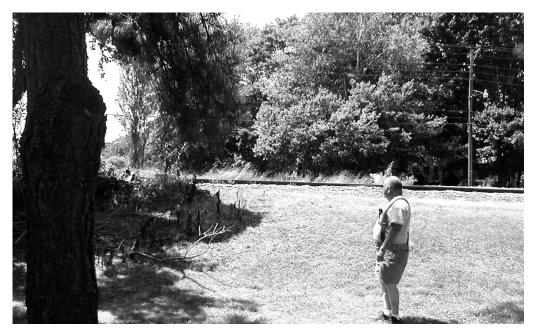
FIGURE 12.2 Area where the floodwater was dammed against the railroad tracks. The pine in this picture is the same as the lone pine in the previous photo of the flooding. *Photo by Elaine Meil*

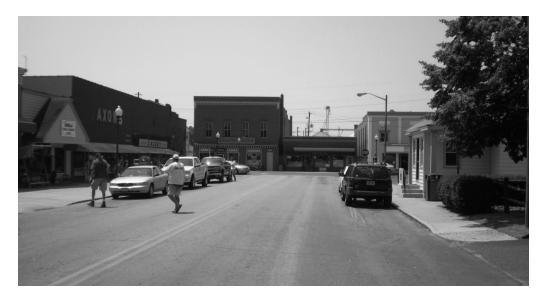
FIGURE 13.1 The Downtown Business District in Parksley is regularly flooded during larger rain events because the drainage pipes in this area are undersized. Rainwater commonly becomes backed-up as result and floods the streets and storefronts. *Photo by Curt Smith.*

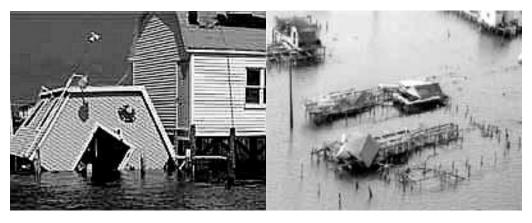
FIGURE 14.1 Crab houses on Tangier damaged during Hurricane Isabel. Left Photo by George Roarty, Right Photo by Chesapeake Fire Department

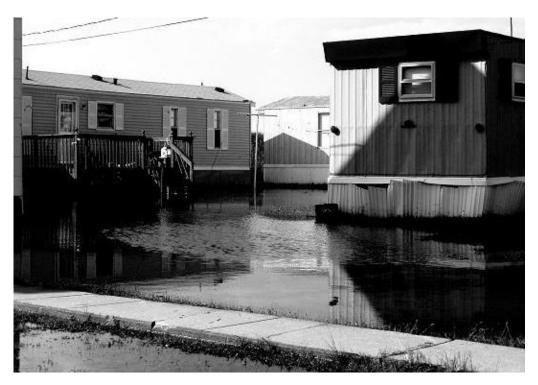
FIGURE 14.2 Flood water ponding around homes on Tangier after Hurricane Isabel in September 2003. *Photo by Deborah Mills*

The island is susceptible to poor drainage due to high water and has localized ponding after storms. Currently, there is no storm water management on Tangier (*Tangier Town Plan*, 2001). In particular, storm water carries pollutants into the wetlands and damages the nurseries of marine life that the Town's economy depends on.

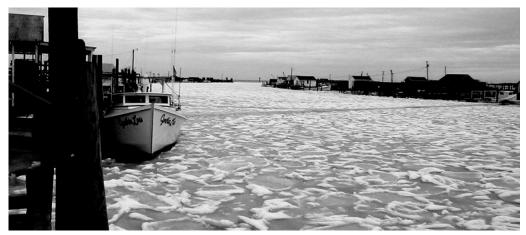
FIGURE 14.3 Tangier in February 2003, a coast guard cutter came later to break up the ice and deliver the mail. *Photo by John Aigner*

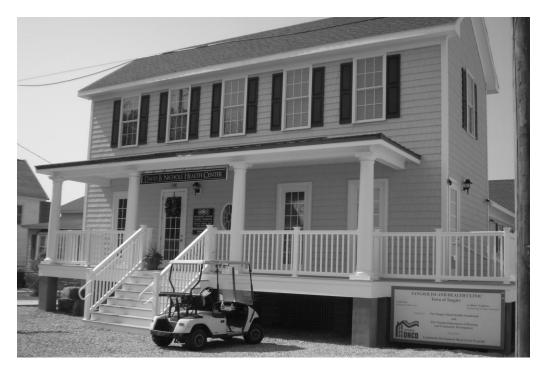
FIGURE 14.6 The Tangier Health Center was constructed in 2010 in a manner that minimizes impacts from flooding and high winds. *Photo by Curt Smith*

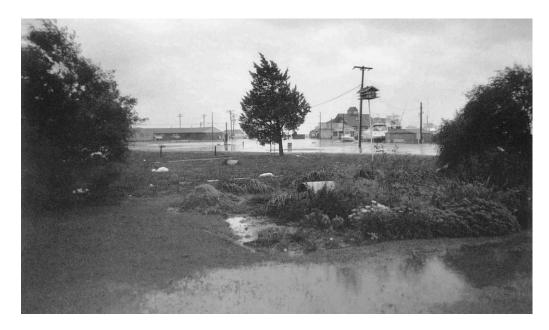
FIGURE 15.1 Surge impacting the location of the Seaside Park, marina, and Island House Restaurant during a storm event in October 2005. *Photo by Dan Bilicki*

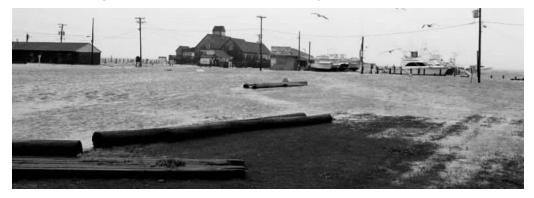
FIGURE 15.2 Photograph showing the surge from Hurricane Isabel in September 2003 impacting the same area depicted in Figure 15.1. *Photo by Dan Bilicki*

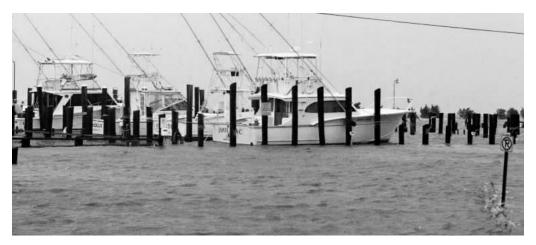
FIGURE 15.4 Photograph showing the Wachapreague Waterfront Commercial Area during Hurricane Isabel in September 2003. *Photo by Dan Bilicki*

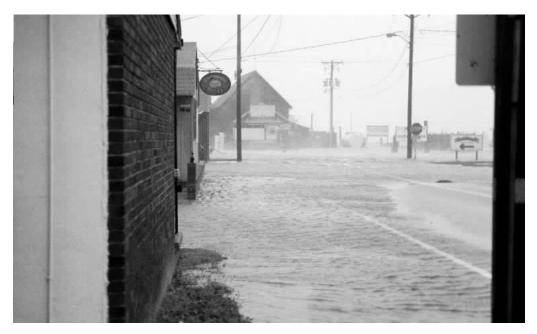
FIGURE 15.5 The Wachapreague Waterfront Commercial Area shown being impacted by Hurricane Isabel in 2003 has historically experienced destructive coastal flooding. *Photo by Dan Bilicki*

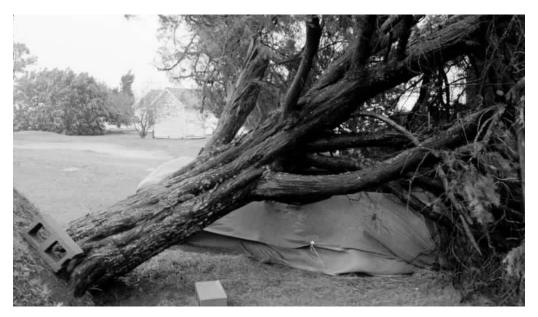
FIGURE 15.6 High winds from Hurricane Isabel in September 2003 downed trees in Wachapreague including this tree which damaged a car. *Photo by Dan Bilicki*

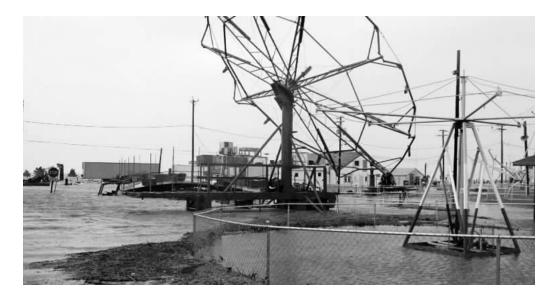
FIGURE 15.7 The carnival grounds in Wachapreague are at risk to coastal flooding and were inundated with flood waters from Hurricane Isabel in 2003. High winds and lightning also threaten these structures. *Photo by Dan Bilicki*

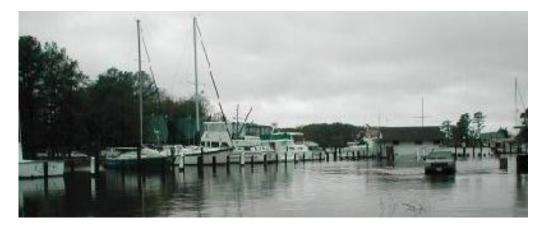
FIGURE 17.1 Photograph showing the Town Wharf flooded during the November Northeaster of 2009. The Harbormaster's House is visible behind the truck. *Photo by Possum Lane*

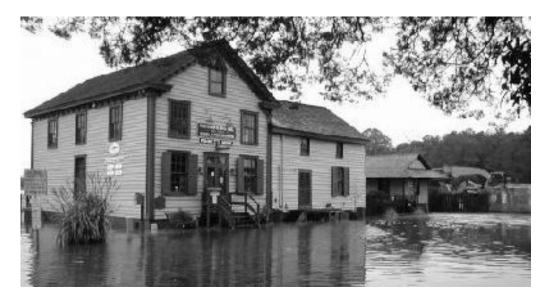
FIGURE 17.2 Photograph showing the historic Hopkins Store at the Onancock Wharf flooded during the November Northeaster of 2009. Commercial businesses are located in the two structures seen in this photo. *Photo by Possum Lane*

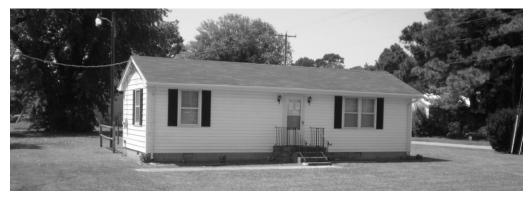
FIGURE 18.2 The Keller Town Office is at risk from storm water flooding and wind damage. *Photo by Curt Smith*

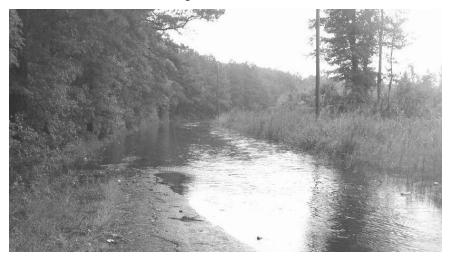
FIGURE 19.1 Common scene of flooding of low-lying roadways following storm events. *Photo courtesy of Northampton County.*

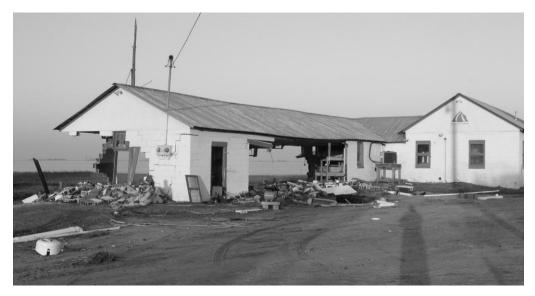
FIGURE 19.2 The Ocean Cove Seafood building in Magotha was destroyed during Hurricane Isabel in 2003. The 80 year old building had survived numerous storm events including the great hurricane of August 1933. At the time of its destruction, this seafood facility employed five people. *Photo courtesy of Northampton County*.

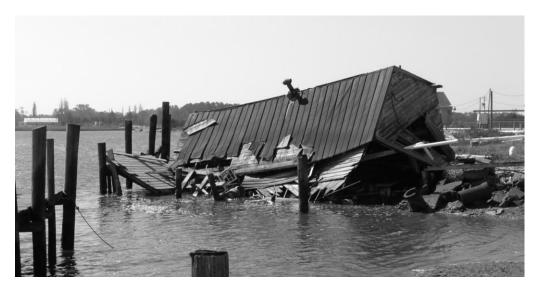
FIGURE 19.3 Older facilities are common along shorelines in the County and are more vulnerable to damage from coastal flooding. *Photo courtesy of Northampton County*.

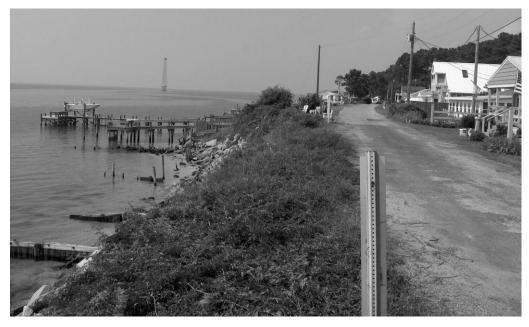
FIGURE 19.5 View of the eroded bluff and hardened shoreline protecting the smallcottage community of Silver Beach. *Photo by Peter Stith.*

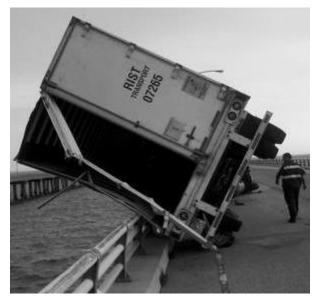
FIGURE 19.7 Sudden high winds created by a suspected microburst overturned two trucks on the Chesapeake Bay Bridge Tunnel in May 2011. One of the overturned trucks is shown. *Photo from Eastern Shore News.*

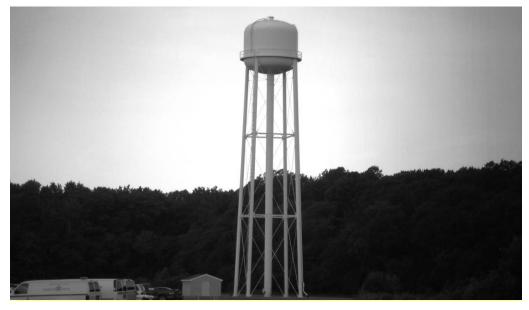
FIGURE 19.8 The Northampton County water tower in Eastville serves the County Courthouse Complex and is vulnerable to wind and ice damage *Photo by Curt Smith*

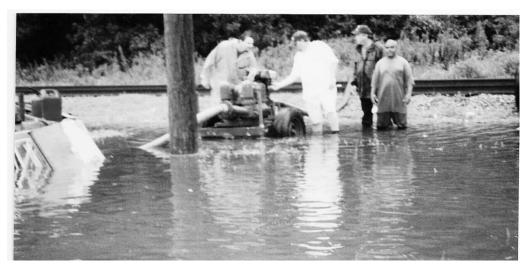
FIGURE 20.1 Storm waters backed up along the railroad tracks in Exmore. *Photo from* Town of Exmore

The Town wishes to work closely with the Virginia Department of Transportation to alleviate the storm water problems within Town.

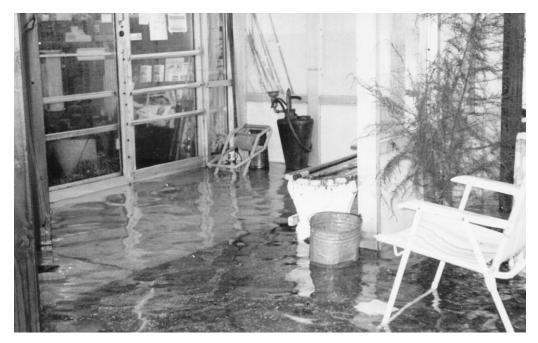
FIGURE 20.2 Storm water flooding in a business located in the downtown business district in Exmore. *Photo from Town of Exmore*

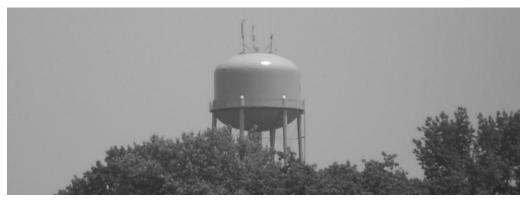
FIGURE 20.4 The Exmore Water Supply Tower supplies potable water to the Town's residents and businesses. *Photo by Curt Smith.*

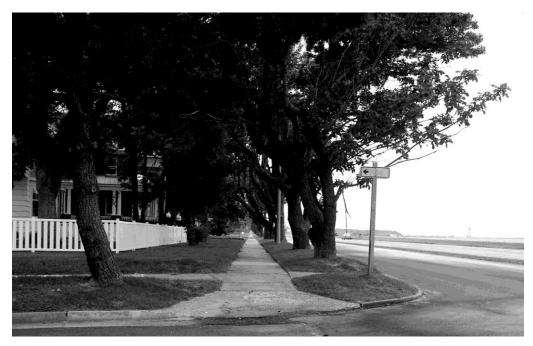
FIGURE 22.1 Bay Avenue is the western Boundary of the Cape Charles Historic Area. This is also part of the Sea Cottage Addition and will be one of the first to feel the brunt of any flooding. *Photo by Elaine Meil.*
