# TOWN OF CHINCOTEAGUE

## TOWN PROFILE

## Eastern Shore of Virginia Hazard Mitigation Plan

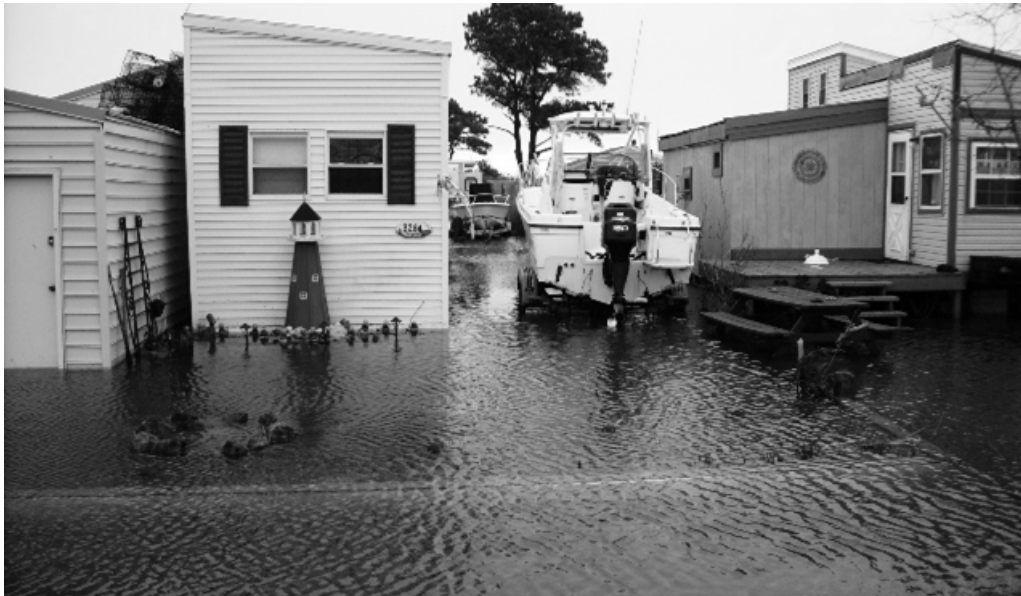
*Figure 6: Mobile Home Park on the Southern Tip of Chincoteague Island; Photo Courtesy of Capt'n Bob's Marina.*

ASCE 7-98 defines the Wind Borne Debris Hazard Area as within 1 mile of the coast where basic wind speed is equal to or greater than 110 mph (3 sec gust). Chincoteague is within the 110-120 mph range. The coast of Assateague Island and Wallops Island generally are further than 1 mile from Chincoteague. The southern tip of Chincoteague is the only place that falls near or within this zone. There are two mobile home parks in this area, one of which is featured in Figure 6. There are approximately 180 units in the park most threatened worth approximately \$6.8 million. Assuming, a 110 mph (3 sec gust) event, which is the 1%-annual-chance event in hurricane prone areas, Chincoteague could expect that many of these mobile homes would be a complete loss. It should be noted that the Floodplain Ordinance adopted by the Town in September 2006 requires elevation and anchoring for all new or substantially improved structures.
