Hazard Mitigation Plan

THE EASTERN SHORE OF VIRGINIA

Eastern Shore Hazard Mitigation Planning Committee
Accomack-Northampton Planning District Commission

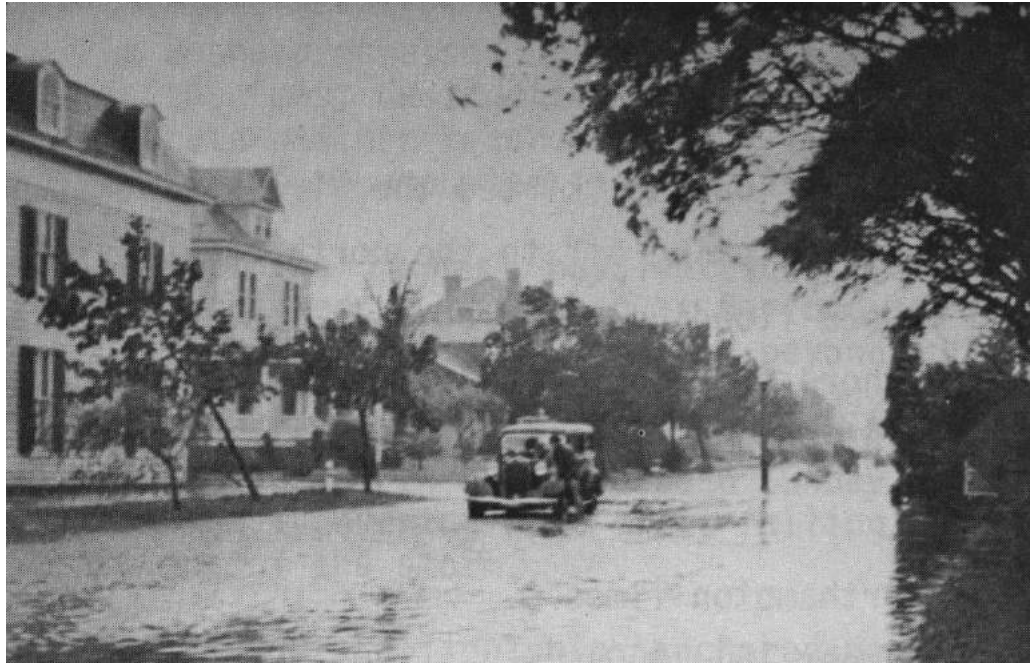
PICTURE 1.1 Flooding on Randolph Avenue, 3 ½ blocks from the Chesapeake Bay, in Cape Charles from one of the 1930s hurricanes. *Photo printed in the Army Corp of Engineers Flood Plain Report for Cape Charles*

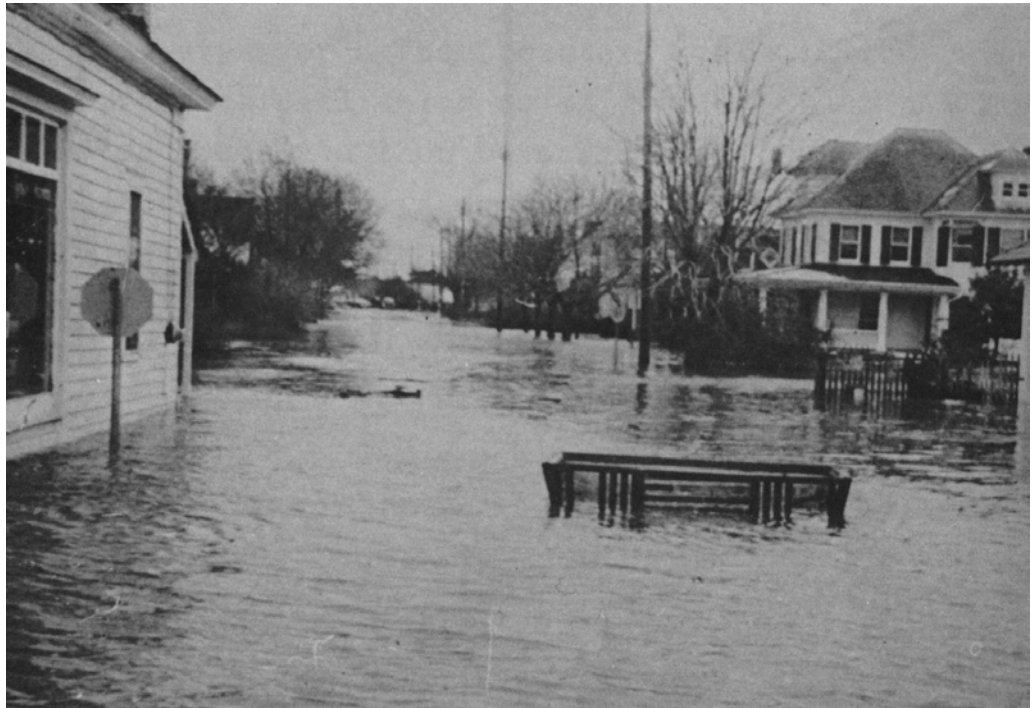
PICTURE 1.2 Flooding during the Ash Wednesday Storm of 1962. This same intersection during Hurricane Isabel is printed on page 35. *Photo printed in the Army Corp of Engineers Flood Plain Report for Wachapreague*

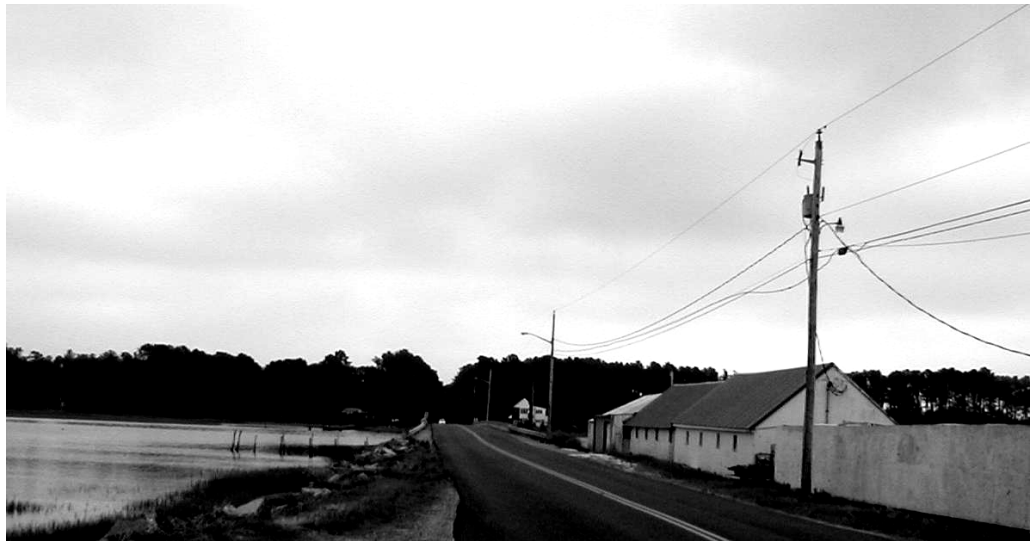
PICTURE 4.1 Causeway to Quinby during spring tide. *Photo by Elaine Meil*

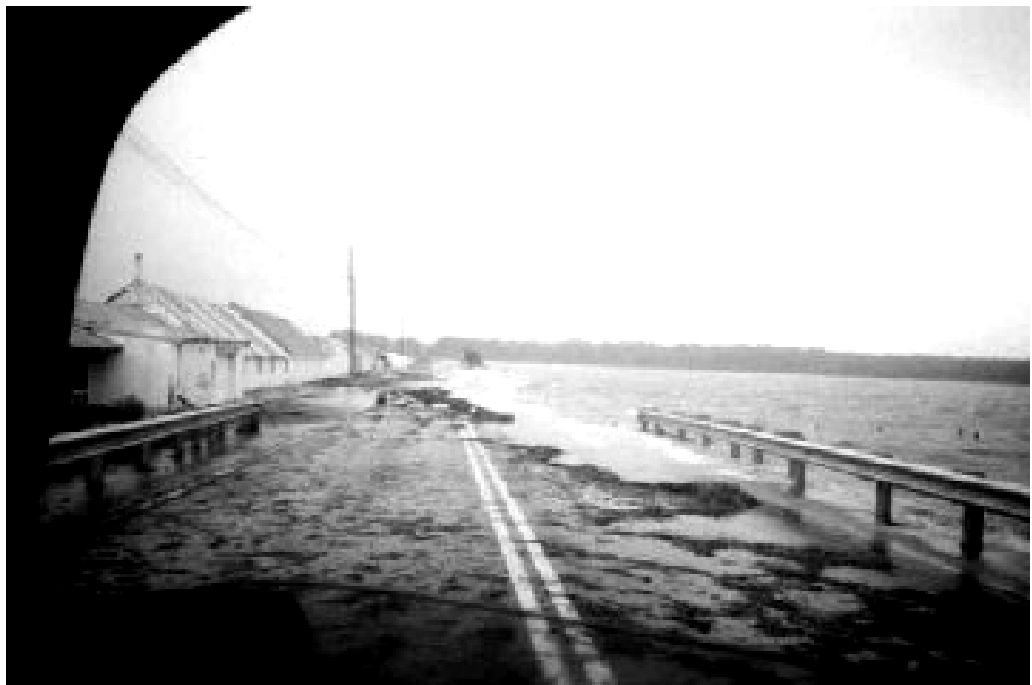
PICTURE 4.2 Causeway to Quinby during Hurricane Isabel. *Photo by David Fluhart*

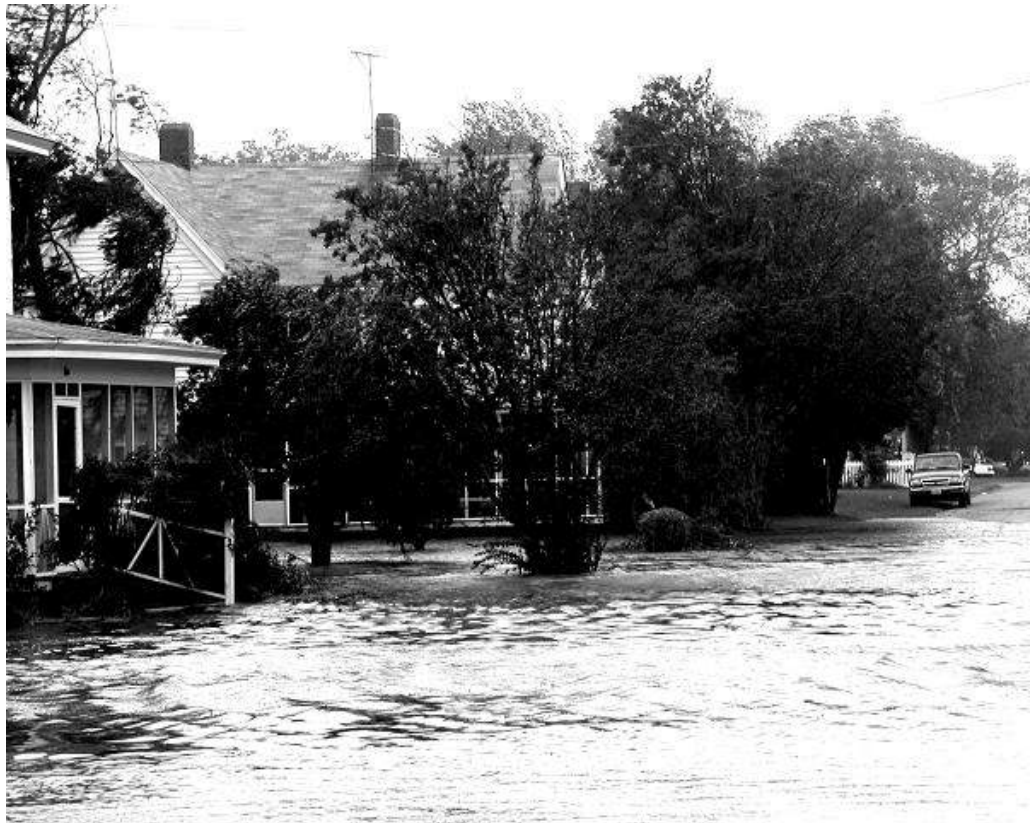
Coastal A zones also represent increased vulnerability to both Accomack and Northampton County. The NFIP does not recognize the difference between A zones where the source of water is an inland river or an A zone where the source of water is from a bay or ocean. Therefore, the NFIP regulations do not require special construction for coastal A zones. However, structures in these zones are commonly exposed to weaker V zone conditions including waves, scour and velocity flows. Open foundations are not required in these areas. However, waves and debris can still destroy structures there. If a structure is built with a closed foundation that structure can expect to receive more damage if struck with storm surge water than a similar structure with an open foundation.

PICTURE 4.3 Homes in Wachapreague during Hurricane Isabel. These homes are located in an A zone with a Base Flood Elevation that includes a wave height component.
Photo by John Aigner

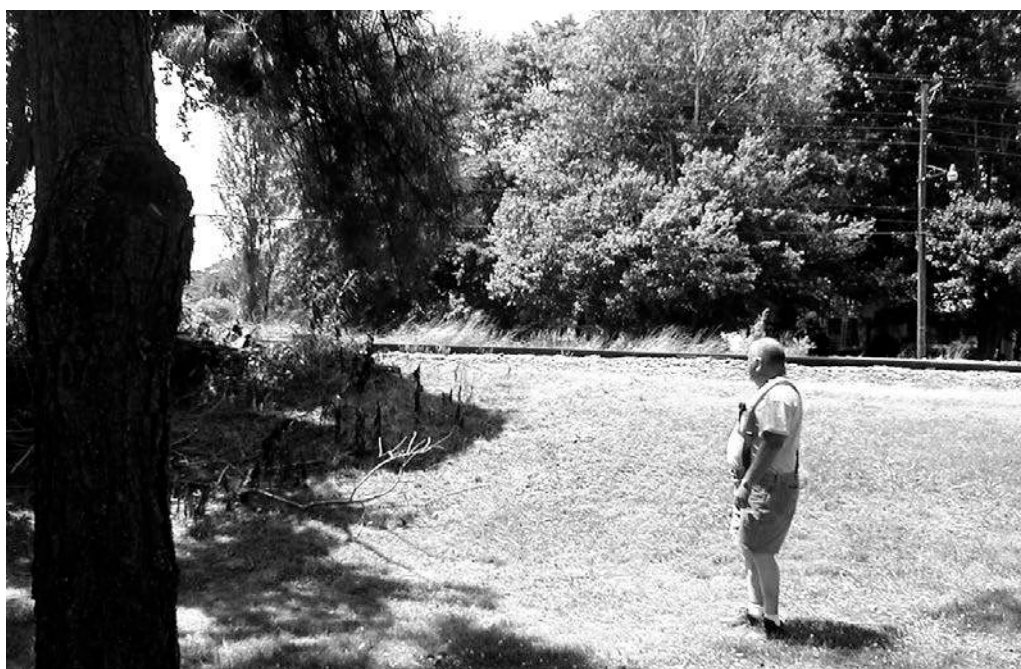
PICTURE 5.2 Area where the floodwater was dammed against the railroad tracks. The pine in this picture is the same as the lone pine in the previous photo of the flooding. *Photo by Elaine Meil*

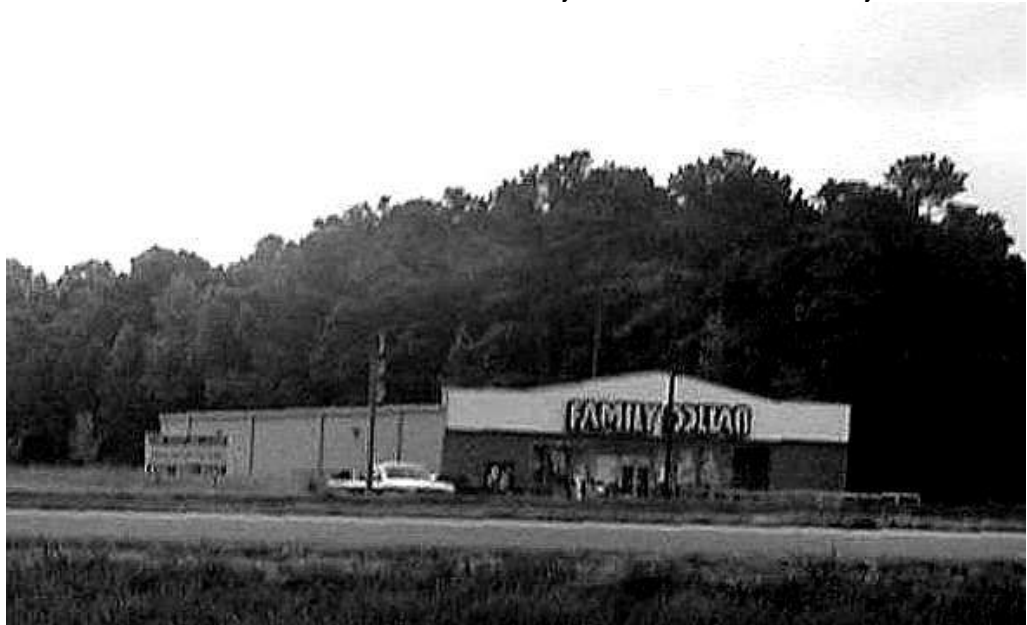
PICTURE 8.1 This building and its parking lot in the Town of Onley frequently is flooded by storm water. As can be seen from the truck in the picture this building was built in a substantial depression. Just visible in the photo is the platform for customers to access the store after a rain. The lot next door, also located in the depression, is for sale. *Photo by Elaine Meil*

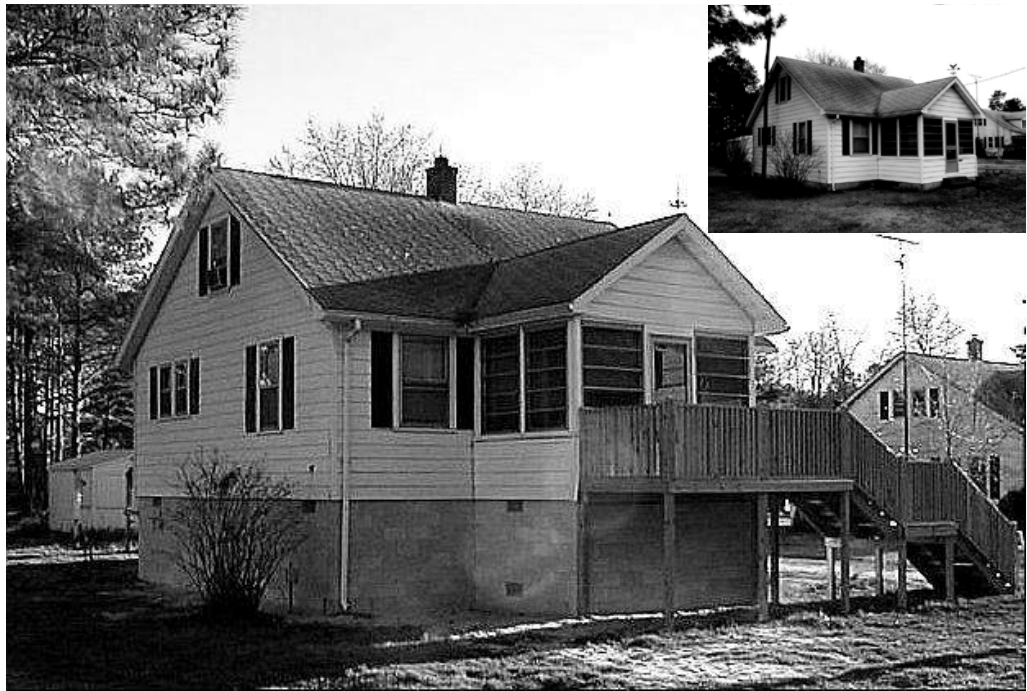
PICTURE 8.2 The county elevated this home using Hazard Mitigation Grant Program money. *Photos by David Fluhart*

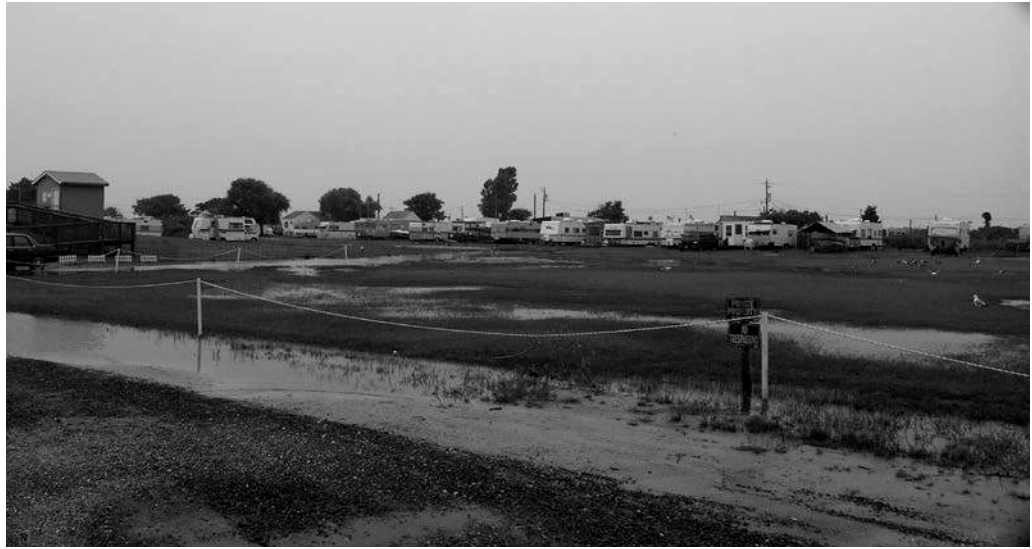
High Wind Events. ASCE 7-98 defines the Wind Borne Debris Hazard Area as within 1 mile of the coast where basic wind speed is equal to or greater than 110 mph (3 sec gust). Chincoteague is within the 110-120 mph range. The coast of Assateague Island and Wallops Island generally are further than 1 mile from Chincoteague. The southern tip of Chincoteague is the only place that falls near or within this zone. There are two mobile home parks in this area. There are approximately 180 units in the park most threatened worth approximately \$6.8 million. Assuming, a 110 mph (3 sec gust) event, which is the 100-year event in hurricane prone areas, Chincoteague could expect that most of these mobile homes would be a complete loss.

PICTURE 9.2 Mobile Home Park on the southern tip of Chincoteague Island. *Photo by Elaine Meil*

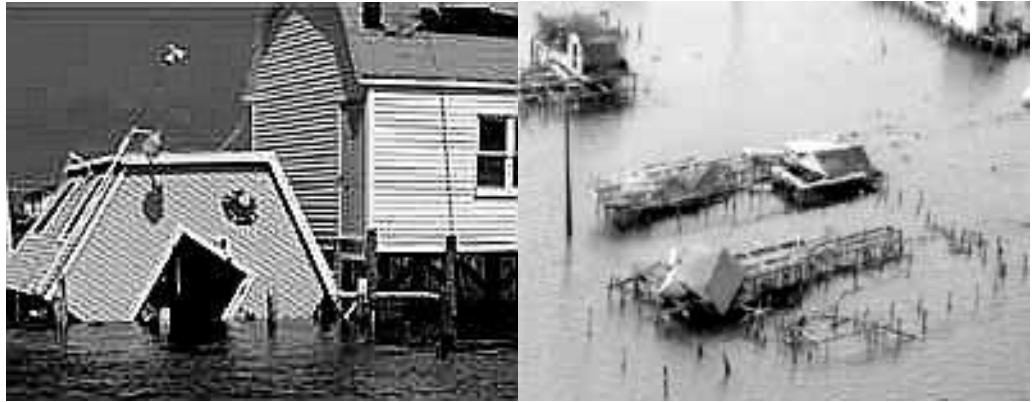
PICTURE 11.1 Crab houses on Tangier damaged during Hurricane Isabel. *Left Photo by George Roarty, Right Photo by Chesapeake Fire Department*

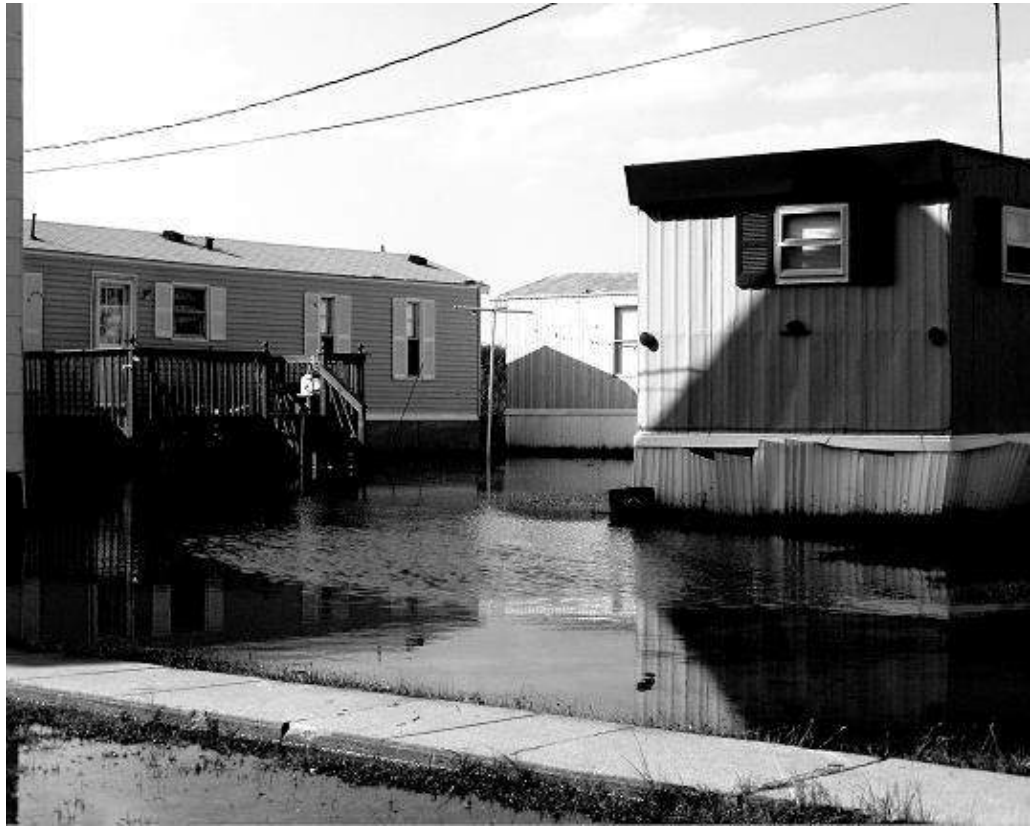
The island is susceptible to poor drainage due to high water and has localized ponding after storms. Currently, there is no stormwater management on Tangier (Tangier Town Plan, 2001). In particular, stormwater carries pollutants into the wetlands and damages the nurseries of marine life that the town's economy depends on.

PICTURE 11.2 Flood water ponding around homes on Tangier after Hurricane Isabel.
Photo by Deborah Mills

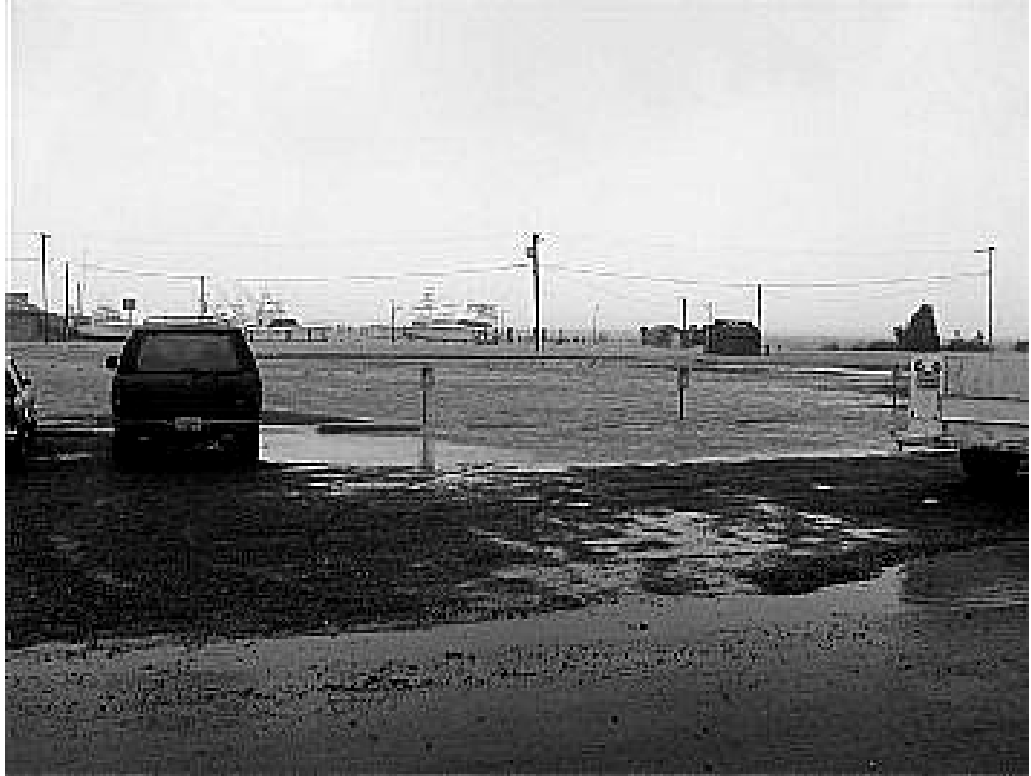
PICTURE 12.1 Surge during Hurricane Isabel taken from the Wachapreague Fire Department. *Photo by David Fluhart*

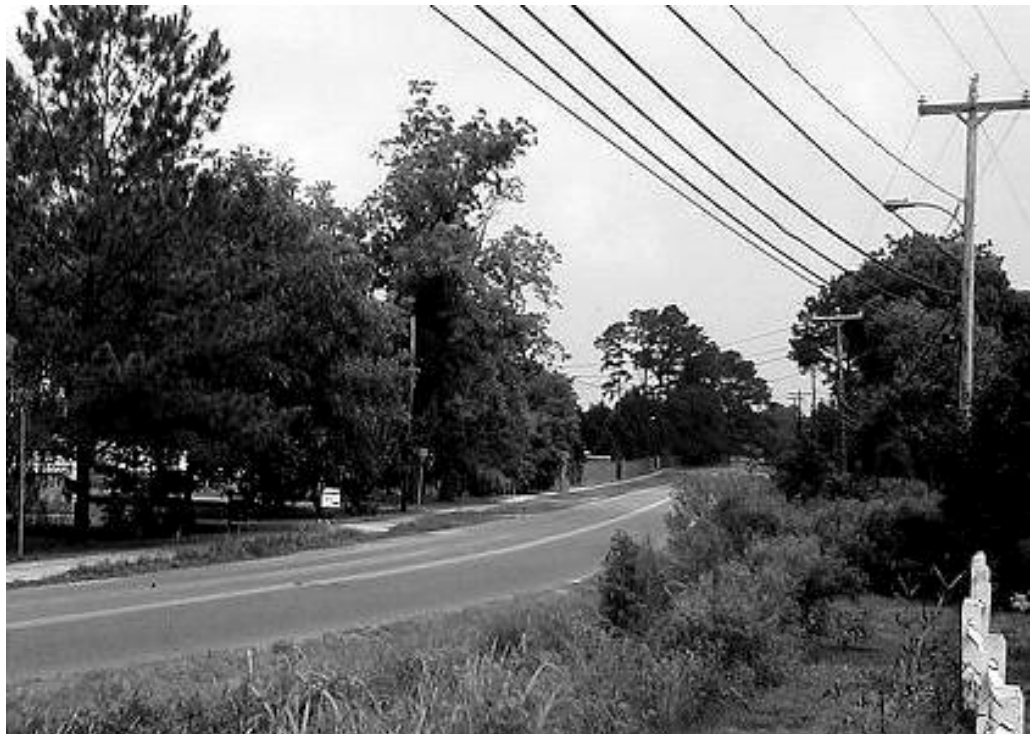
PICTURE 13.1 The fence in the distance is the Onancock Wastewater Treatment Plant. The home to the side of the picture has recently been elevated to the Base Flood Elevation.
Photo by Elaine Meil
