Eastern Shore

Safety Study

April 2016

Virginia Department of Transportation (VDOT)

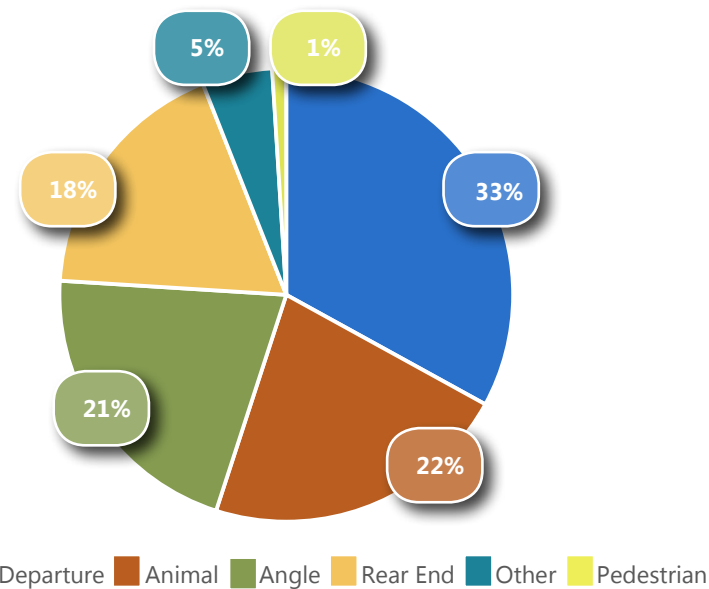
Figure ES.1. Crash Types.

The study utilized five years of crash data (2010 – 2014) to assess the current safety of the U.S. Route 13 and Route 175 corridors in accordance with the Corridor Safety Assessment (CSA) Process Guideline prepared for Corridors of Statewide Significance (CoSS). The data set included 1,574 crash records categorized as roadway departure, crash with an animal, angle, rear end, pedestrian, or other. The distribution by crash type is shown in Figure ES.1.

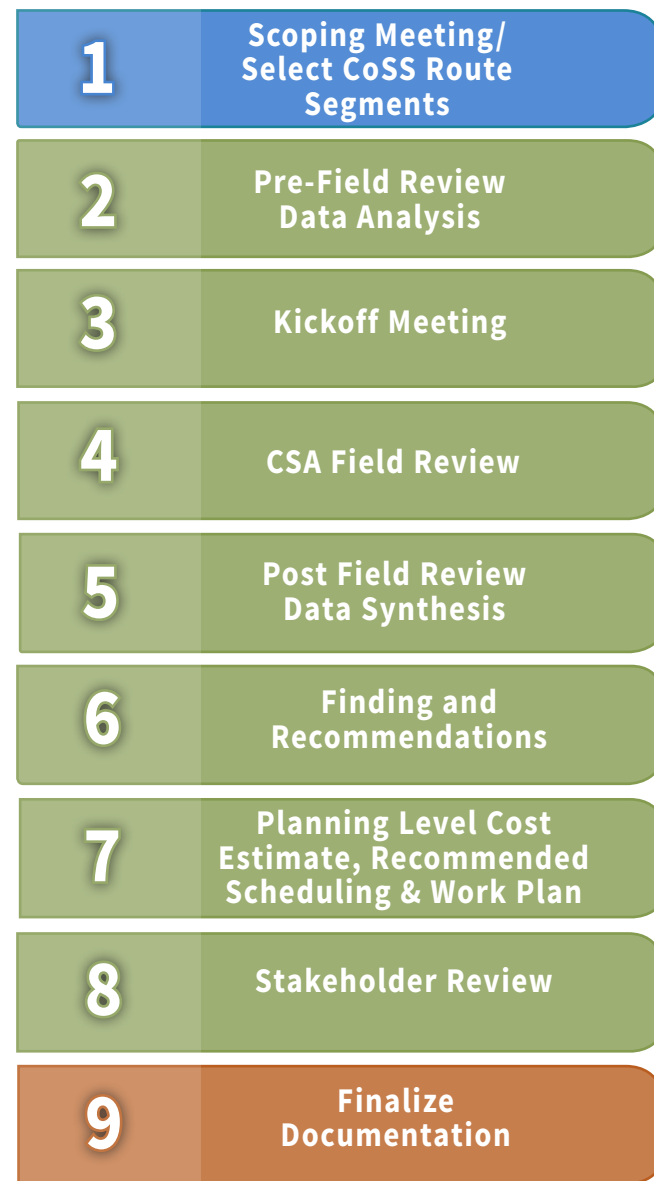
Figure 2.1. Study Process.

The study follows VDOT’s Corridor Safety Assessment (CSA) Process Guideline prepared for Corridors of Statewide Significance (CoSS). The CSA process is a systemic approach to proactively reduce potential crashes using a series of templates with tiered application for various geometric conditions. With the 2002 Study on file and used as a guiding document for more than a decade, the methodology for this study layered the nine step CSA process, see Figure 2.1, with a historic comparison to the 2002 Study, an assessment of crossover and intersection closure and treatments, and speed limit review. The comparative analysis has value in confirming the status of the corridor; however, the final recommendations are a product of the systemic analysis, crossover and intersection assessment, and the site specific location evaluation.

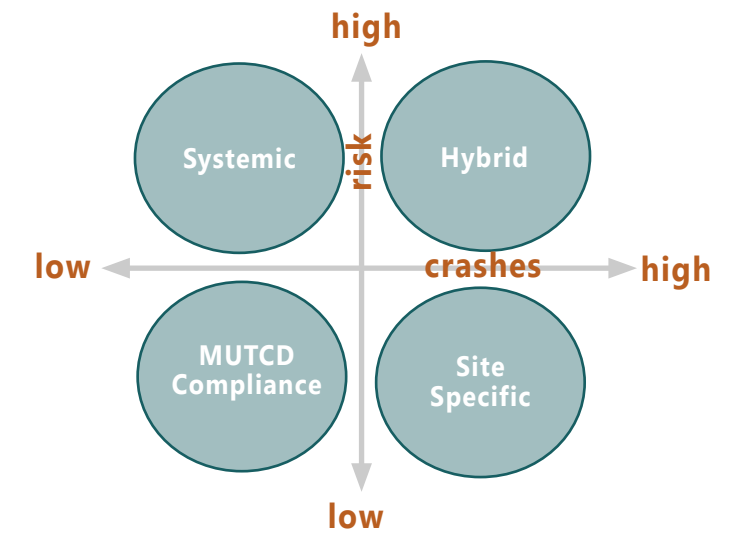
Figure 2.2. Systemic Analysis Process.

GIS mapping tools and crash data analysis for a five-year period along with VDOT’s Target Safety Need (TSN) were used to identify specific areas of concern or locations that have a potential for safety improvement. The more in-depth review was conducted at the 25 site specific locations which is described in detail in Chapter 6.

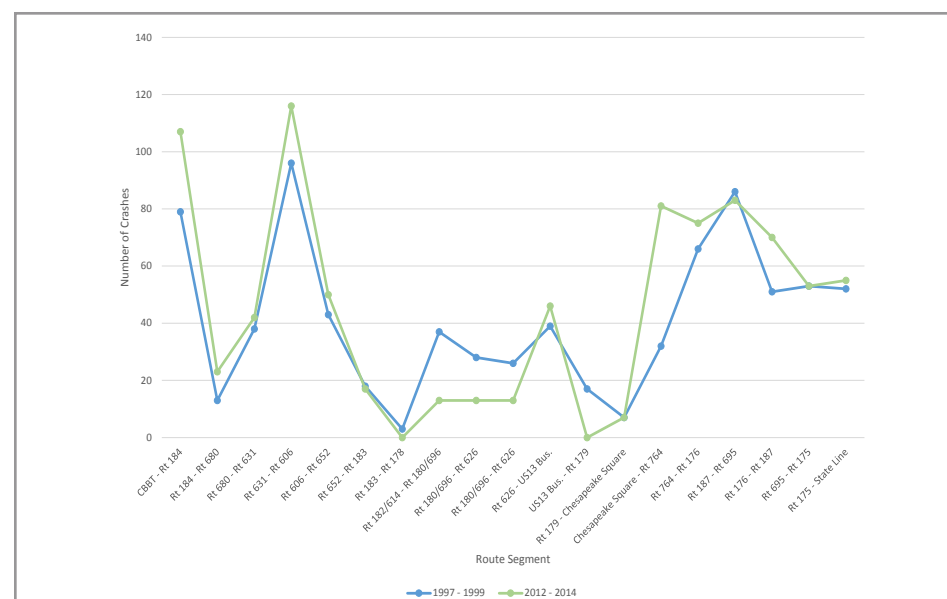
Figure 3.1. Number of Crashes.

There were a total of 80 more crashes along the study corridor. A 10% increase in crashes was shown from 1997-1999 to 2012-2014, see Figure 3.1. It can be noted that there was an increase of crashes in the north end; see Site Specific Locations 10-12. In the evaluation, the total number of crashes does not reflect the safety of the corridor relative to the volume of traffic served. While there are more crashes than before, which moves away from a desired count of zero, the corridor served more vehicles on an average daily basis in 2012 compared to the 2002 Study volume. The safety of the corridor is more accurately reflected when the increase in traffic volume is used in the measurement of the crash rate, expressed as crashes per 100 million vehicles miles traveled.

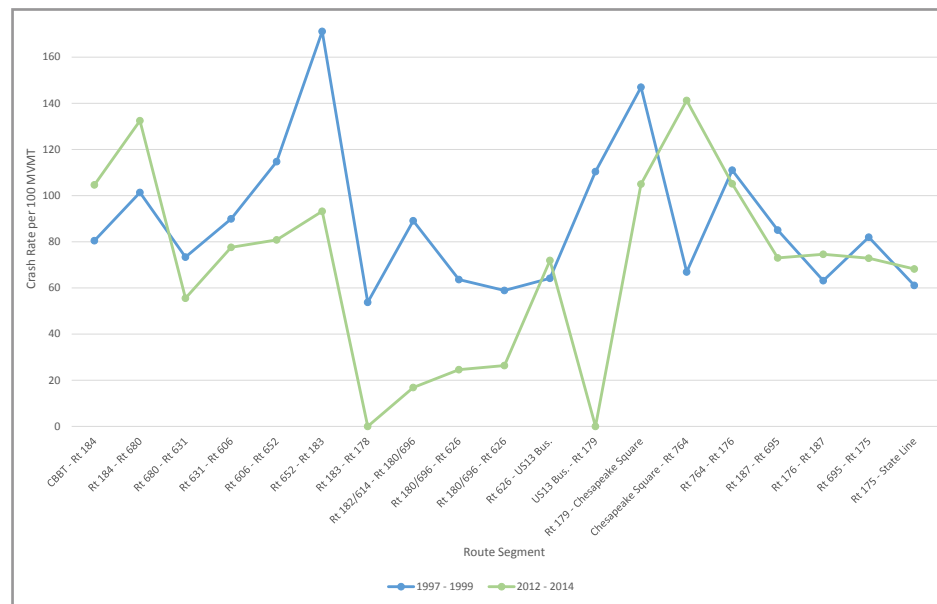
Figure 3.2. Crash Rates.

The crash rate of a specific location or along a segment is more telling of the safety of the conditions. For example, 20 crashes at a location that serves 10,000 vehicles per day is less safe than 20 crashes at a location that serves 20,000 vehicles per day. In review of the crash rates along the study corridors (see Figure 3.2), crash rates fell in 13 of the 19 segments, a reduction in 68% of the segments.

A crash data comparison between the three-year period from the 2002 Study (1997-1999) and the most recent three-year period (2012-2014) was prepared. The results show that there were 80 more crashes, a 10% increase, in the more recent period. Although there are more crashes, U.S. Route 13 and Route 175 serve more traffic on a daily basis. As a result, the crash rate calculations indicate that 13 of the 19 segments show a reduction in their crash rates.

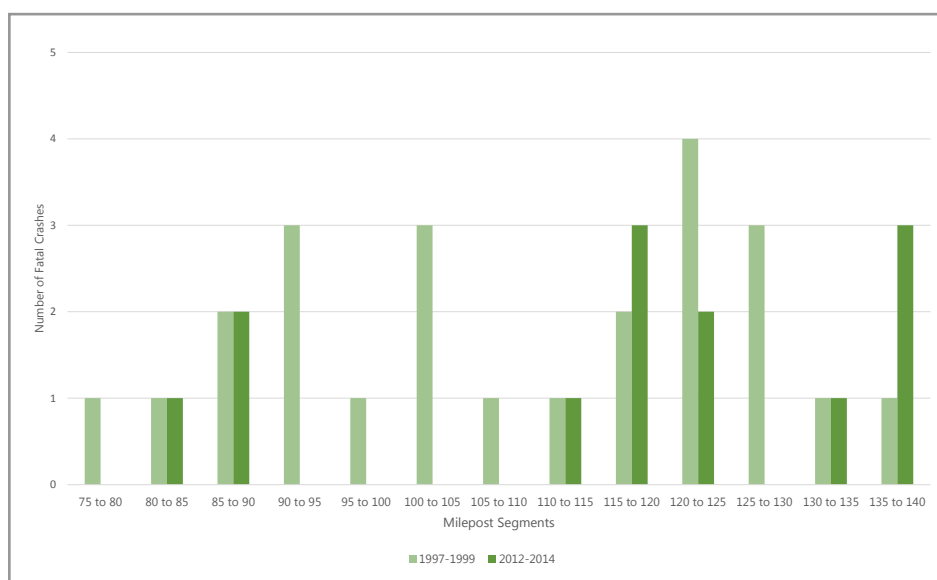
Figure 3.3. Fatal Crashes by Segment.

Fatal crashes are often random events; however, the locations where the events occur were investigated for environmental contributory factors. A comparison of 1997-1999 to 2012-2014 fatal crash data through the study area indicate that there has been a 54% reduction in fatal crashes. The location of the crashes are still concentrated between mileposts 115 and 125, and 135 and 140, see Figure 3.3. The site specific and systemic analyses included a detailed review of these areas and the recommendations incorporated from the findings are expected to enhance safety of these segments.

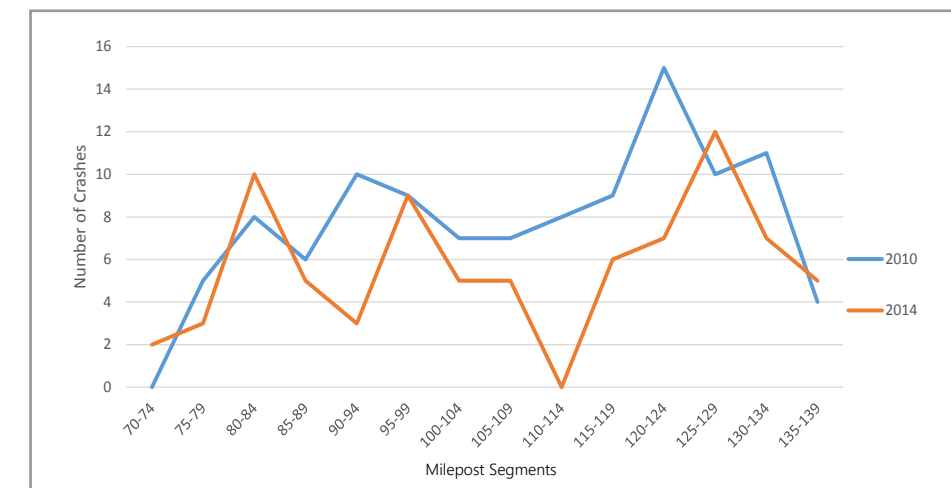
Figure 3.4. Roadway Departure Crash Comparison.

The rumble strips were installed just before 2014; therefore, the effectiveness of rumble strips in reducing roadway departure crashes on U.S. Route 13 was captured in data from 2010 versus 2014, see Figure 3.4. Rumble strips are the grooved edges of the travel lane which alert a driver through vibrational noise that the vehicle is drifting outside the travelway. VDOT installed rumble strips on both the left and right edges along U.S. Route 13 where it was feasible. This treatment is reported to have a crash modification factor of 0.82. It is reasonable to predict a reduction of roadway departure crashes over a three-year period by 18%. The analysis of the 2010 versus 2014 data showed an overall 27% reduction in roadway departure crashes, with reductions in nine of the 14 segments studied.

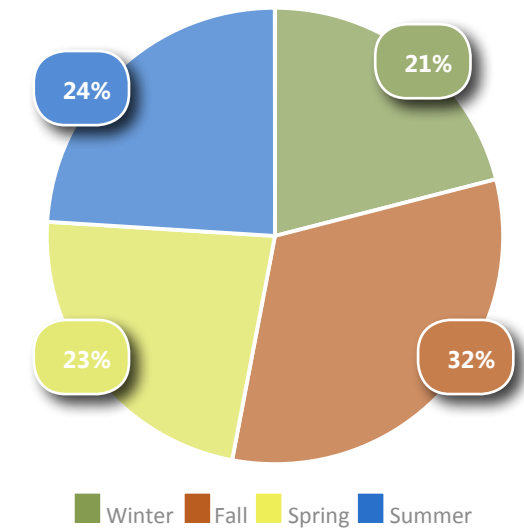
Figure 3.7. Crashes by Season.

The schedule to perform speed data collection was established based on the seasonal variation on when the most crashes related to speed occurred. As shown in Figure 3.7, 32% of speed related crashes occurred in the fall; therefore, the speed data was collected in September 2015, once school was back in session.

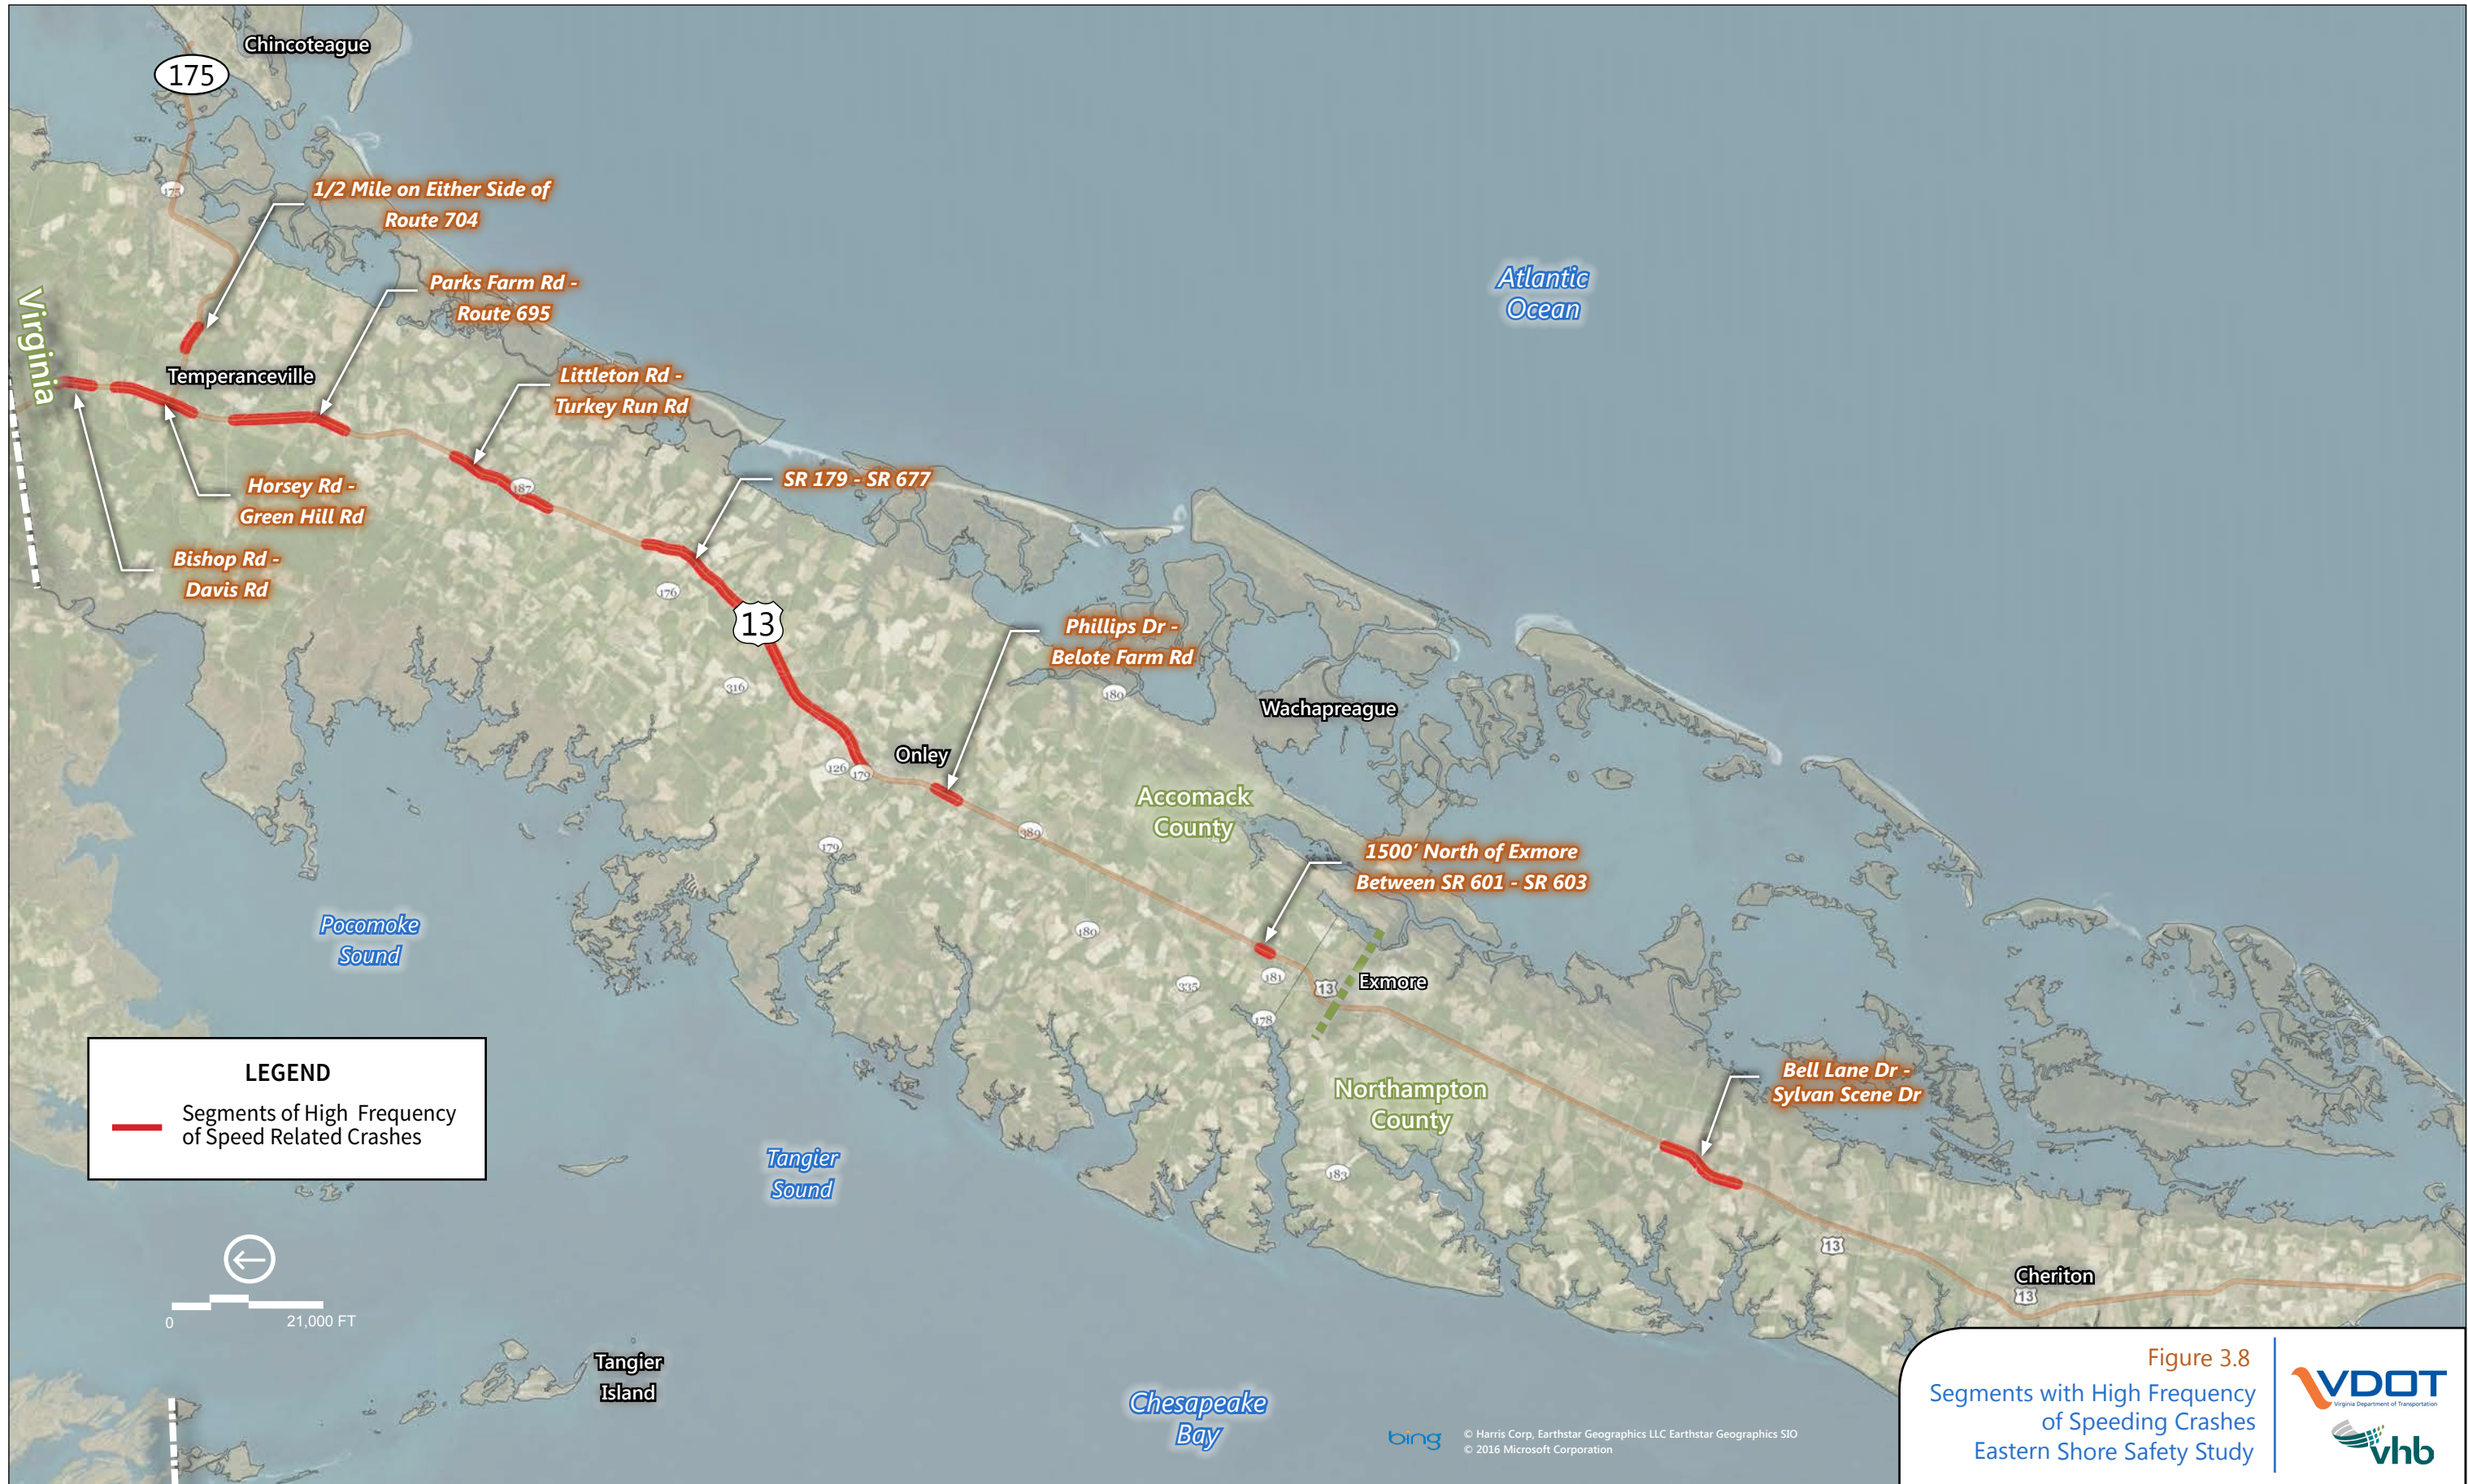
Figure 3.8
Segments with High Frequency of Speeding Crashes
Eastern Shore Safety Study

The first phase of the evaluation began with the crash history. The crash data from 2010 to 2014 identified 45 crashes of which the primary factor was speed. Forty-five crashes over a study area as large as this study was considered too small of a sample; therefore, expanding the sample to include other actions that may be speed-related such as improper passing, following too closely, and failure to maintain control, resulted in a total of 737 crashes. The larger sample size was used to identify the locations for speed data collection and analysis. The segments shown on the following page in Figure 3.8 represent the areas of the highest crashes directly attributable or may be related to speed.

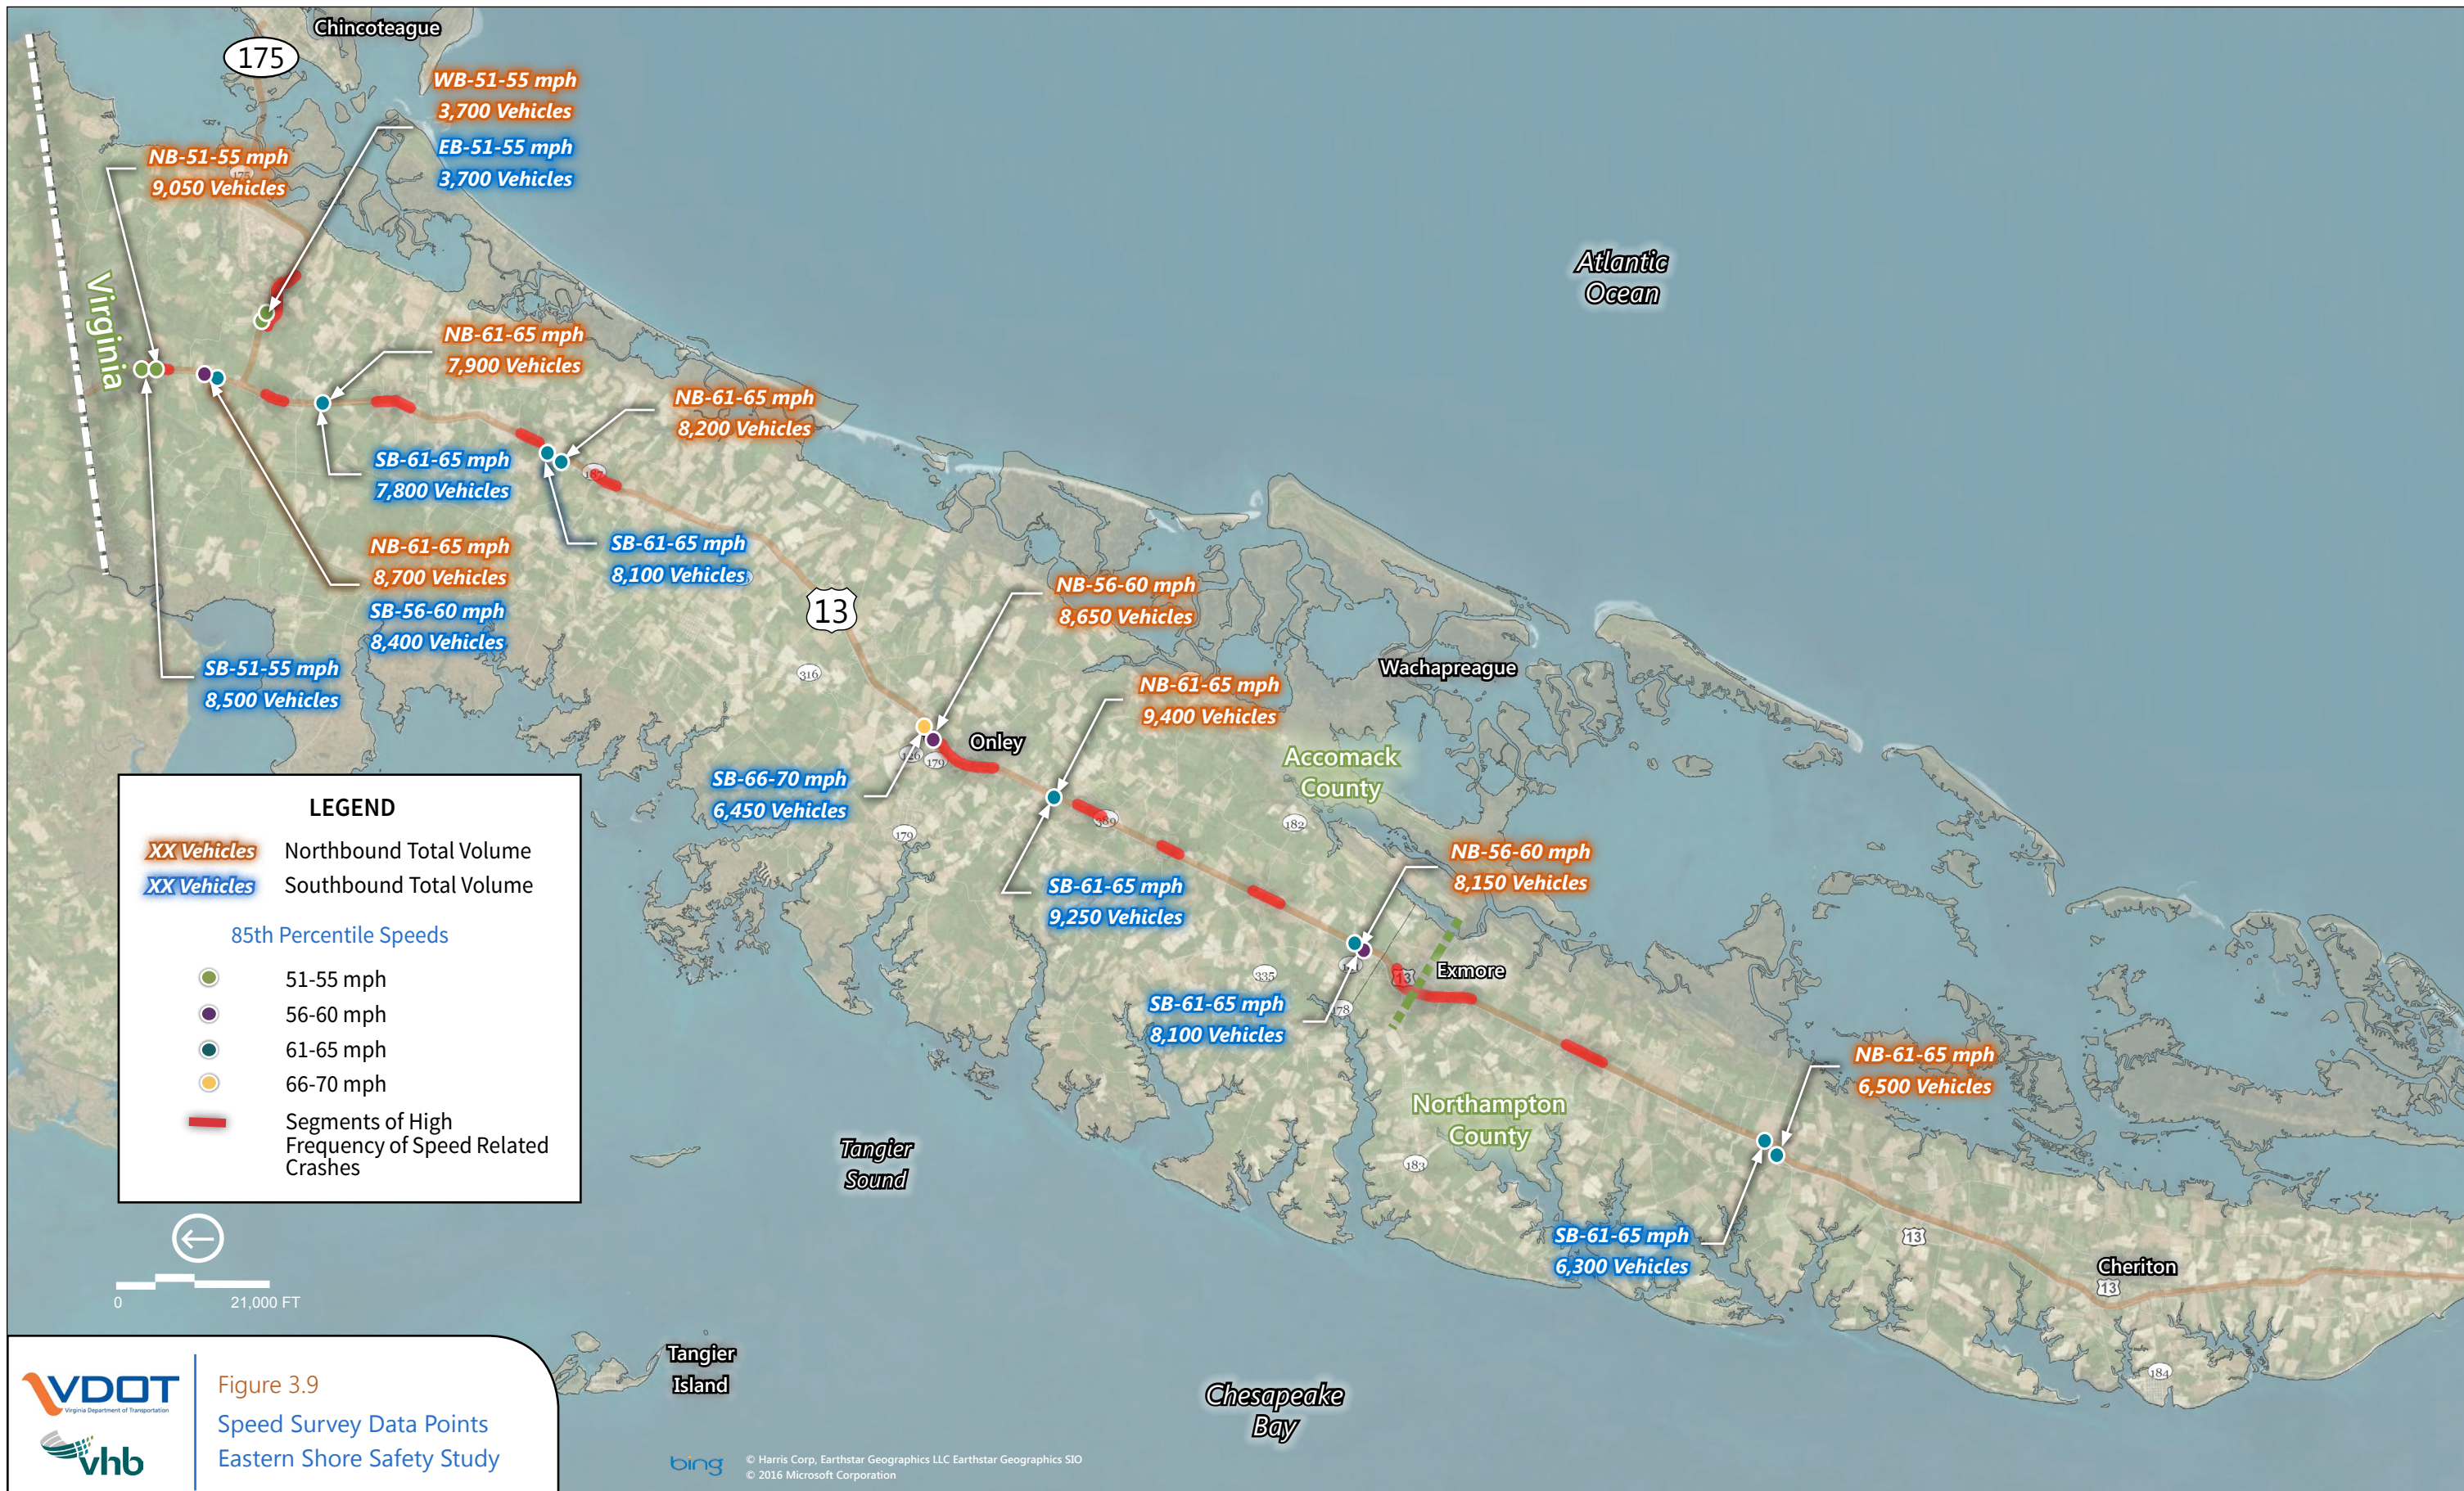
VDOT Virginia Department of Transportation
 vhb
 Figure 3.9
 Speed Survey Data Points
 Eastern Shore Safety Study

On the U.S. Route 13 segments outside town limits, as shown in Figure 3.9, the 85th percentile speed exceeds 60 mph in 70 percent of the segments. The 85th percentile speed on Route 175 was between 51 and 55 mph. Inside the town limits, as presented in Figure 3.10 and Table 3.1, the 85th percentile speed was measured to be 50 mph or higher. These results are indicators that drivers are comfortable traveling at speeds higher than posted.

Based on the analyses, the posted speed limits on U.S. Route 13 are appropriate. The analysis further indicates that a 50 mph posted speed limit is appropriate for Route 175, therefore, it is recommended for the posted speed limit to be reduced from 55 mph to 50 mph.

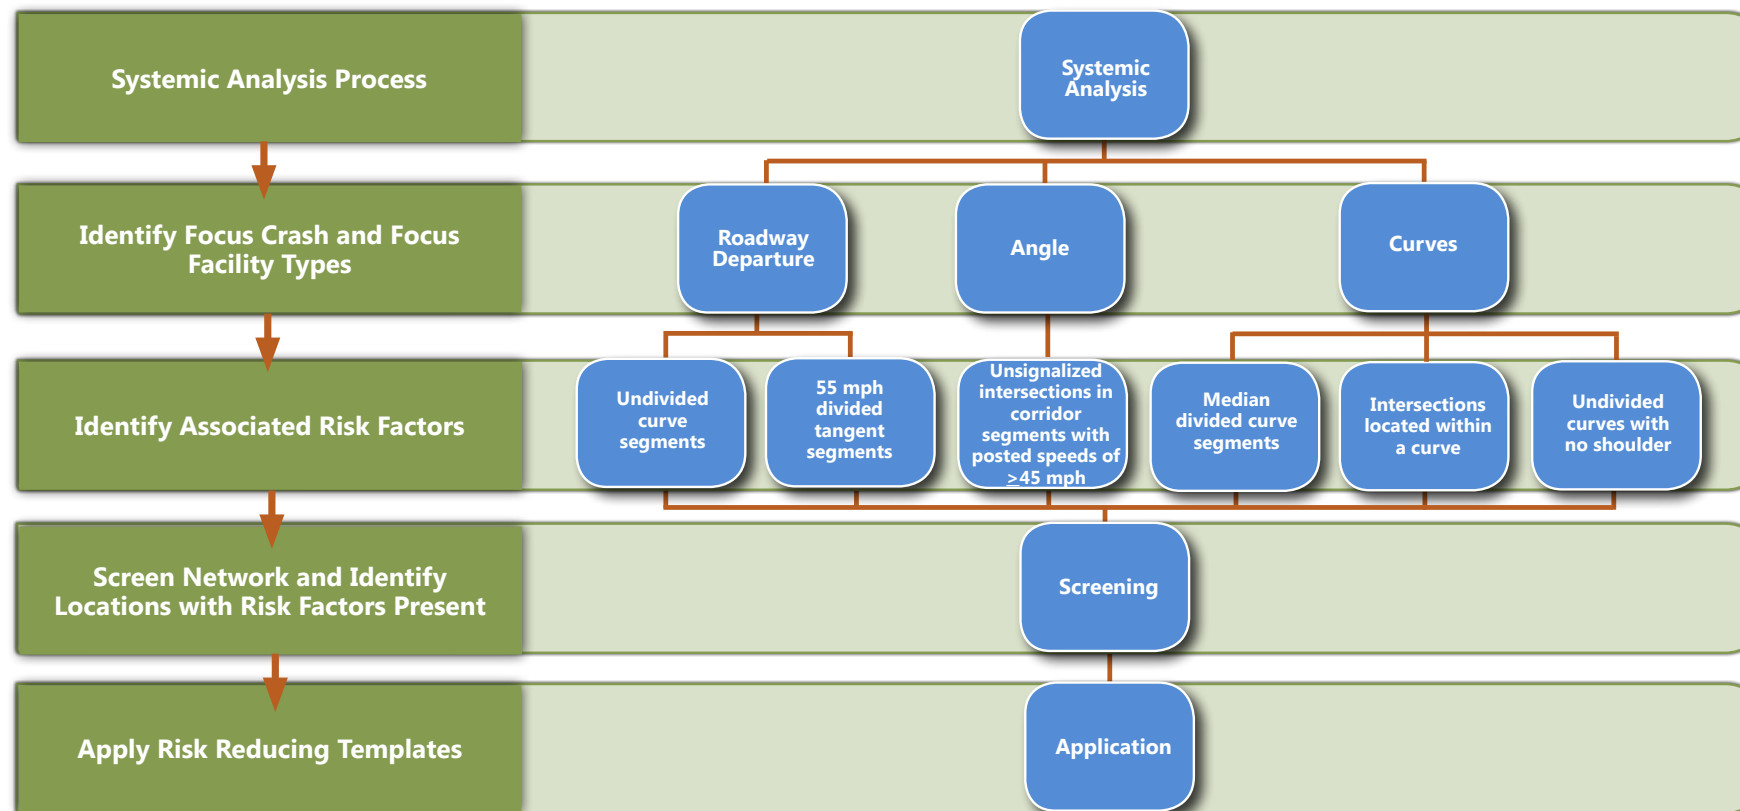
Figure 4.1. Systemic Process.

The project team used the methodology created for the VDOT CSA for CoSS whereby a set of risk reducing templates are provided for intersections and for corridors throughout the study area. A full series of templates are provided in Appendix A. The countermeasures in the templates are grouped into tiers and are applied to the intersections and corridors based upon the presence of systemic risk factors, crash risk, and their Potential for Safety Improvement (PSI). Each of these three factors and how they impact tier selection are described in this chapter. The AASHTO Highway Safety Manual and FHWA systemic methodology guided the analysis and identification of systemic risk factors present throughout the study area.^{1,2}

The PSI locations used in this analysis relate to the risk factors shown in Figure 4.1 and were created by VDOT using the top 100 PSI locations for the Hampton Roads District between 2011 and 2013.

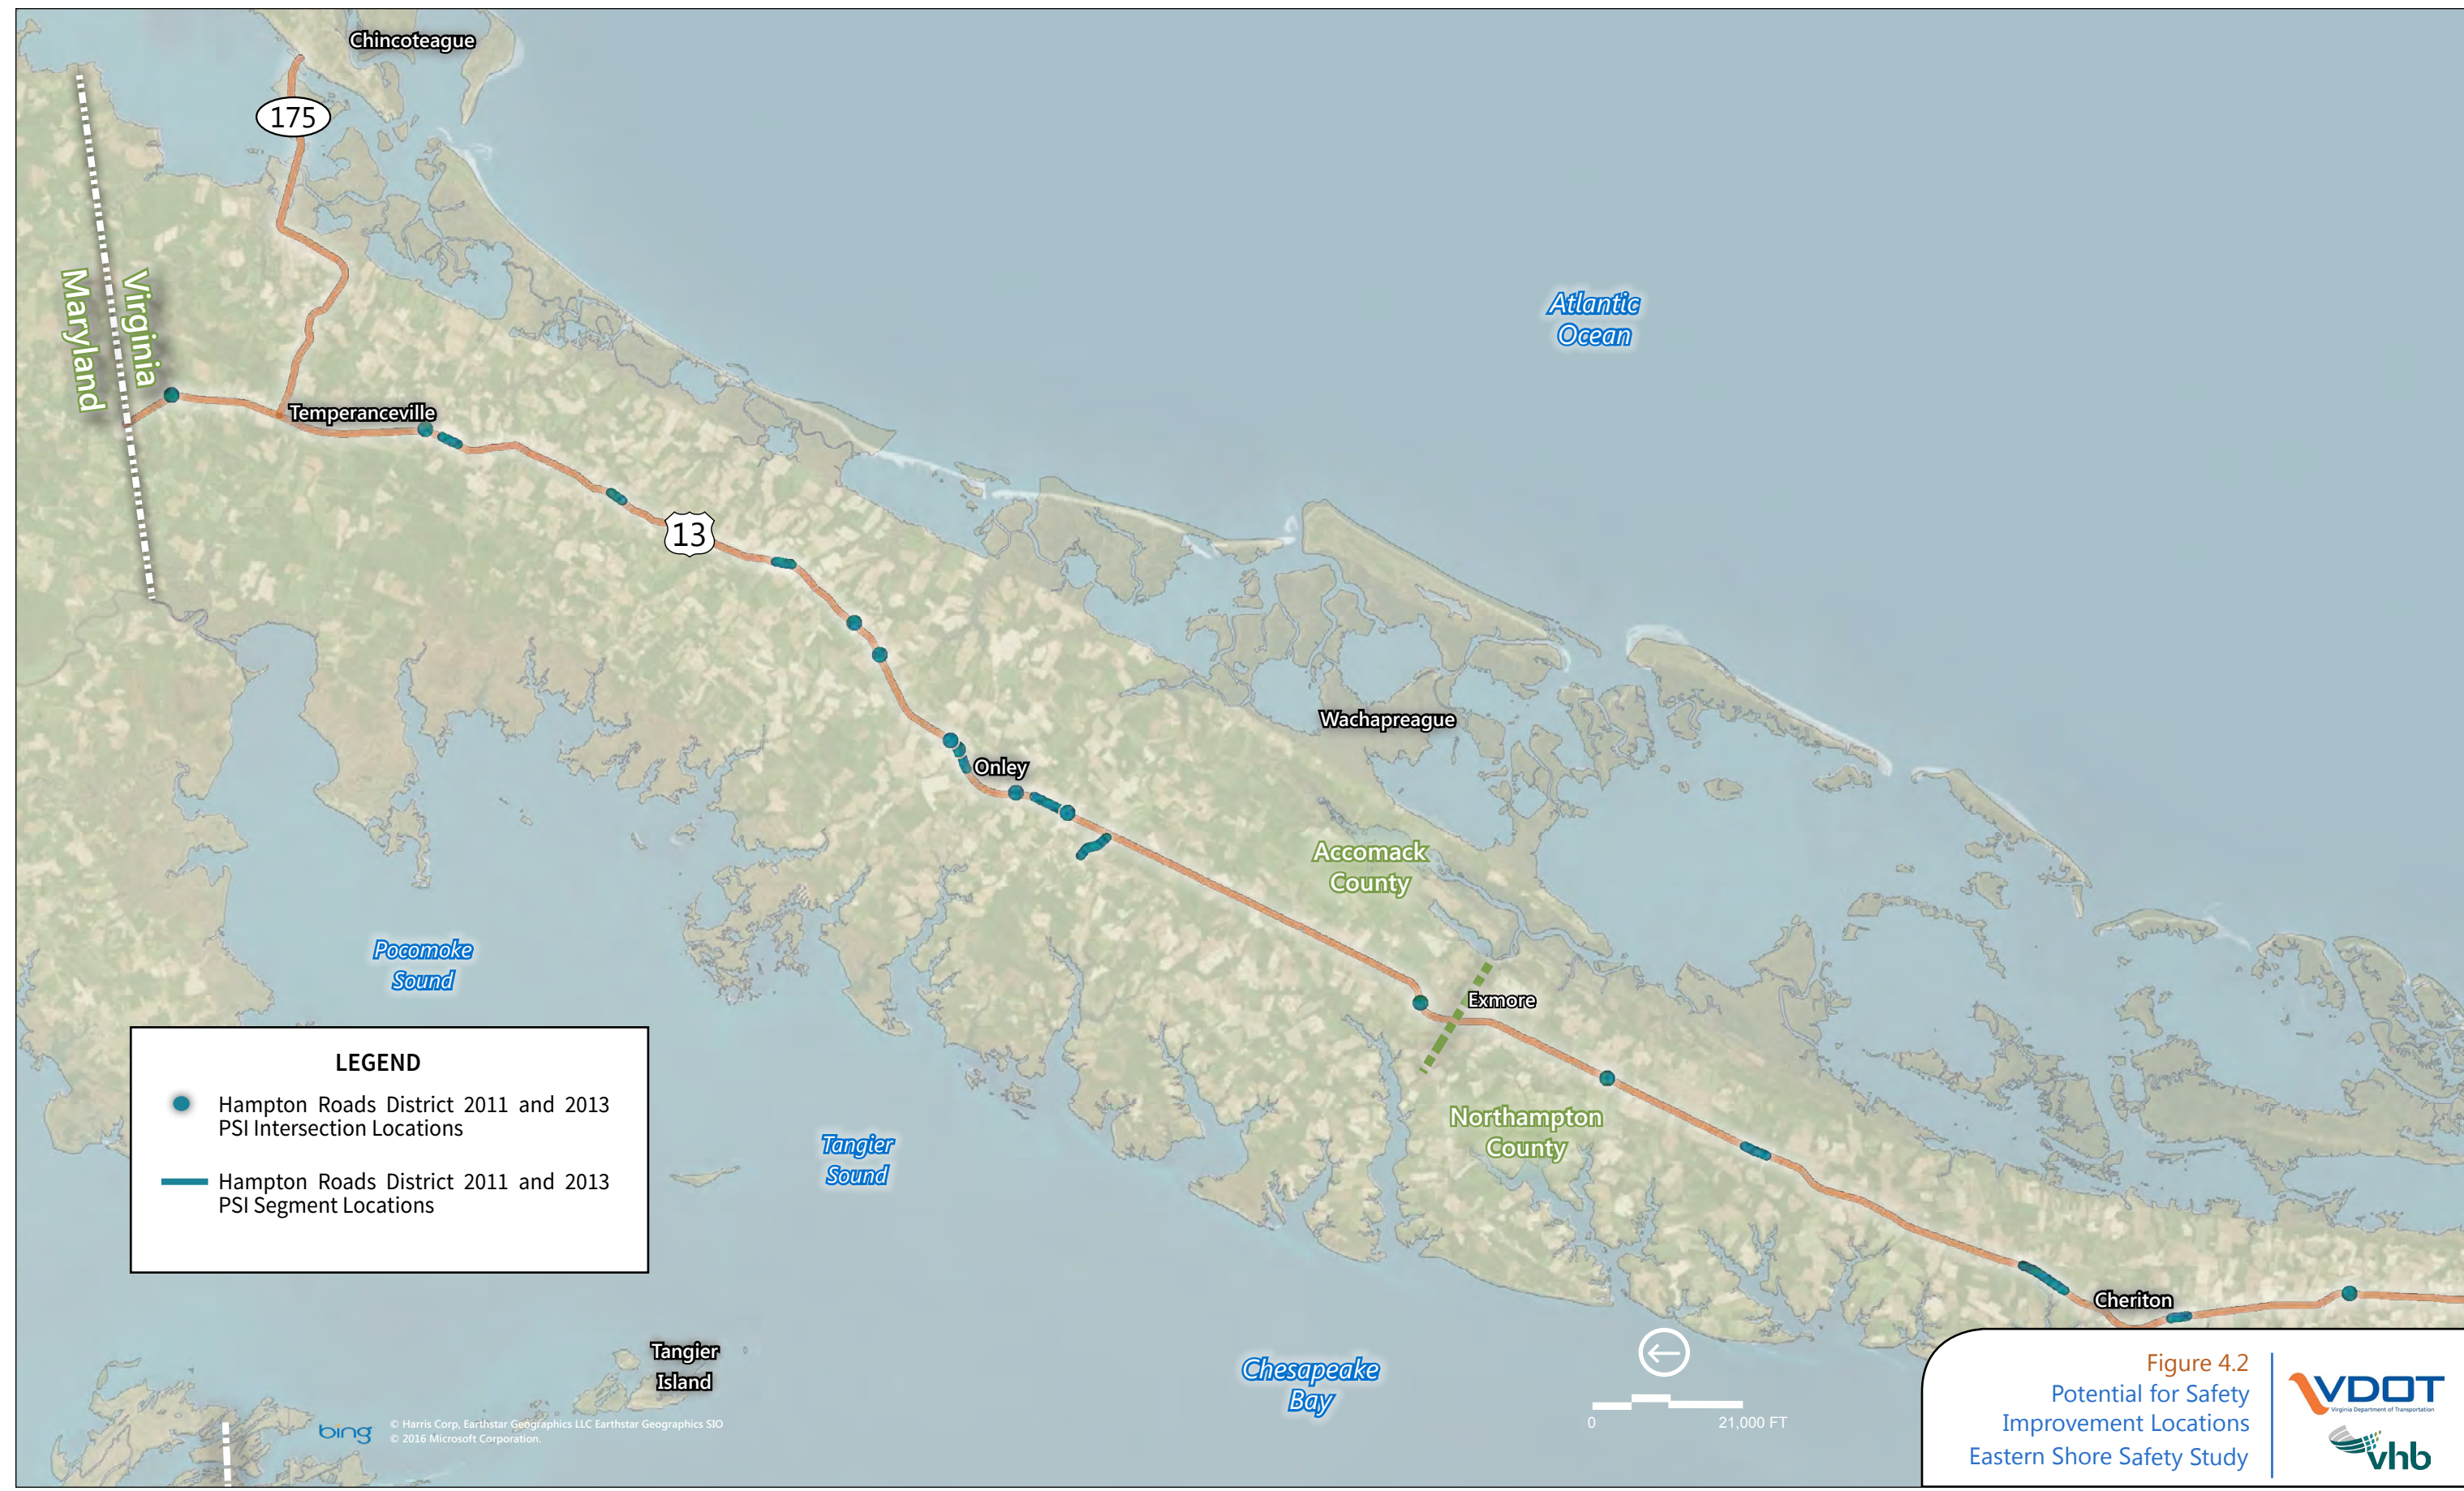
Figure 4.2
Potential for Safety Improvement Locations
Eastern Shore Safety Study

Table 4.20 and Table 4.21 contain the summary of the template tier application for intersections and corridor segments. Figures 4.2 – 4.15 depict the intersection and corridor template and tiers by location. It is important to note that some of the corridor templates overlap each other resulting in the total length of template application being greater than the length of corridor found in the study area. A complete listing of template and tier application locations are provided in Appendix A.

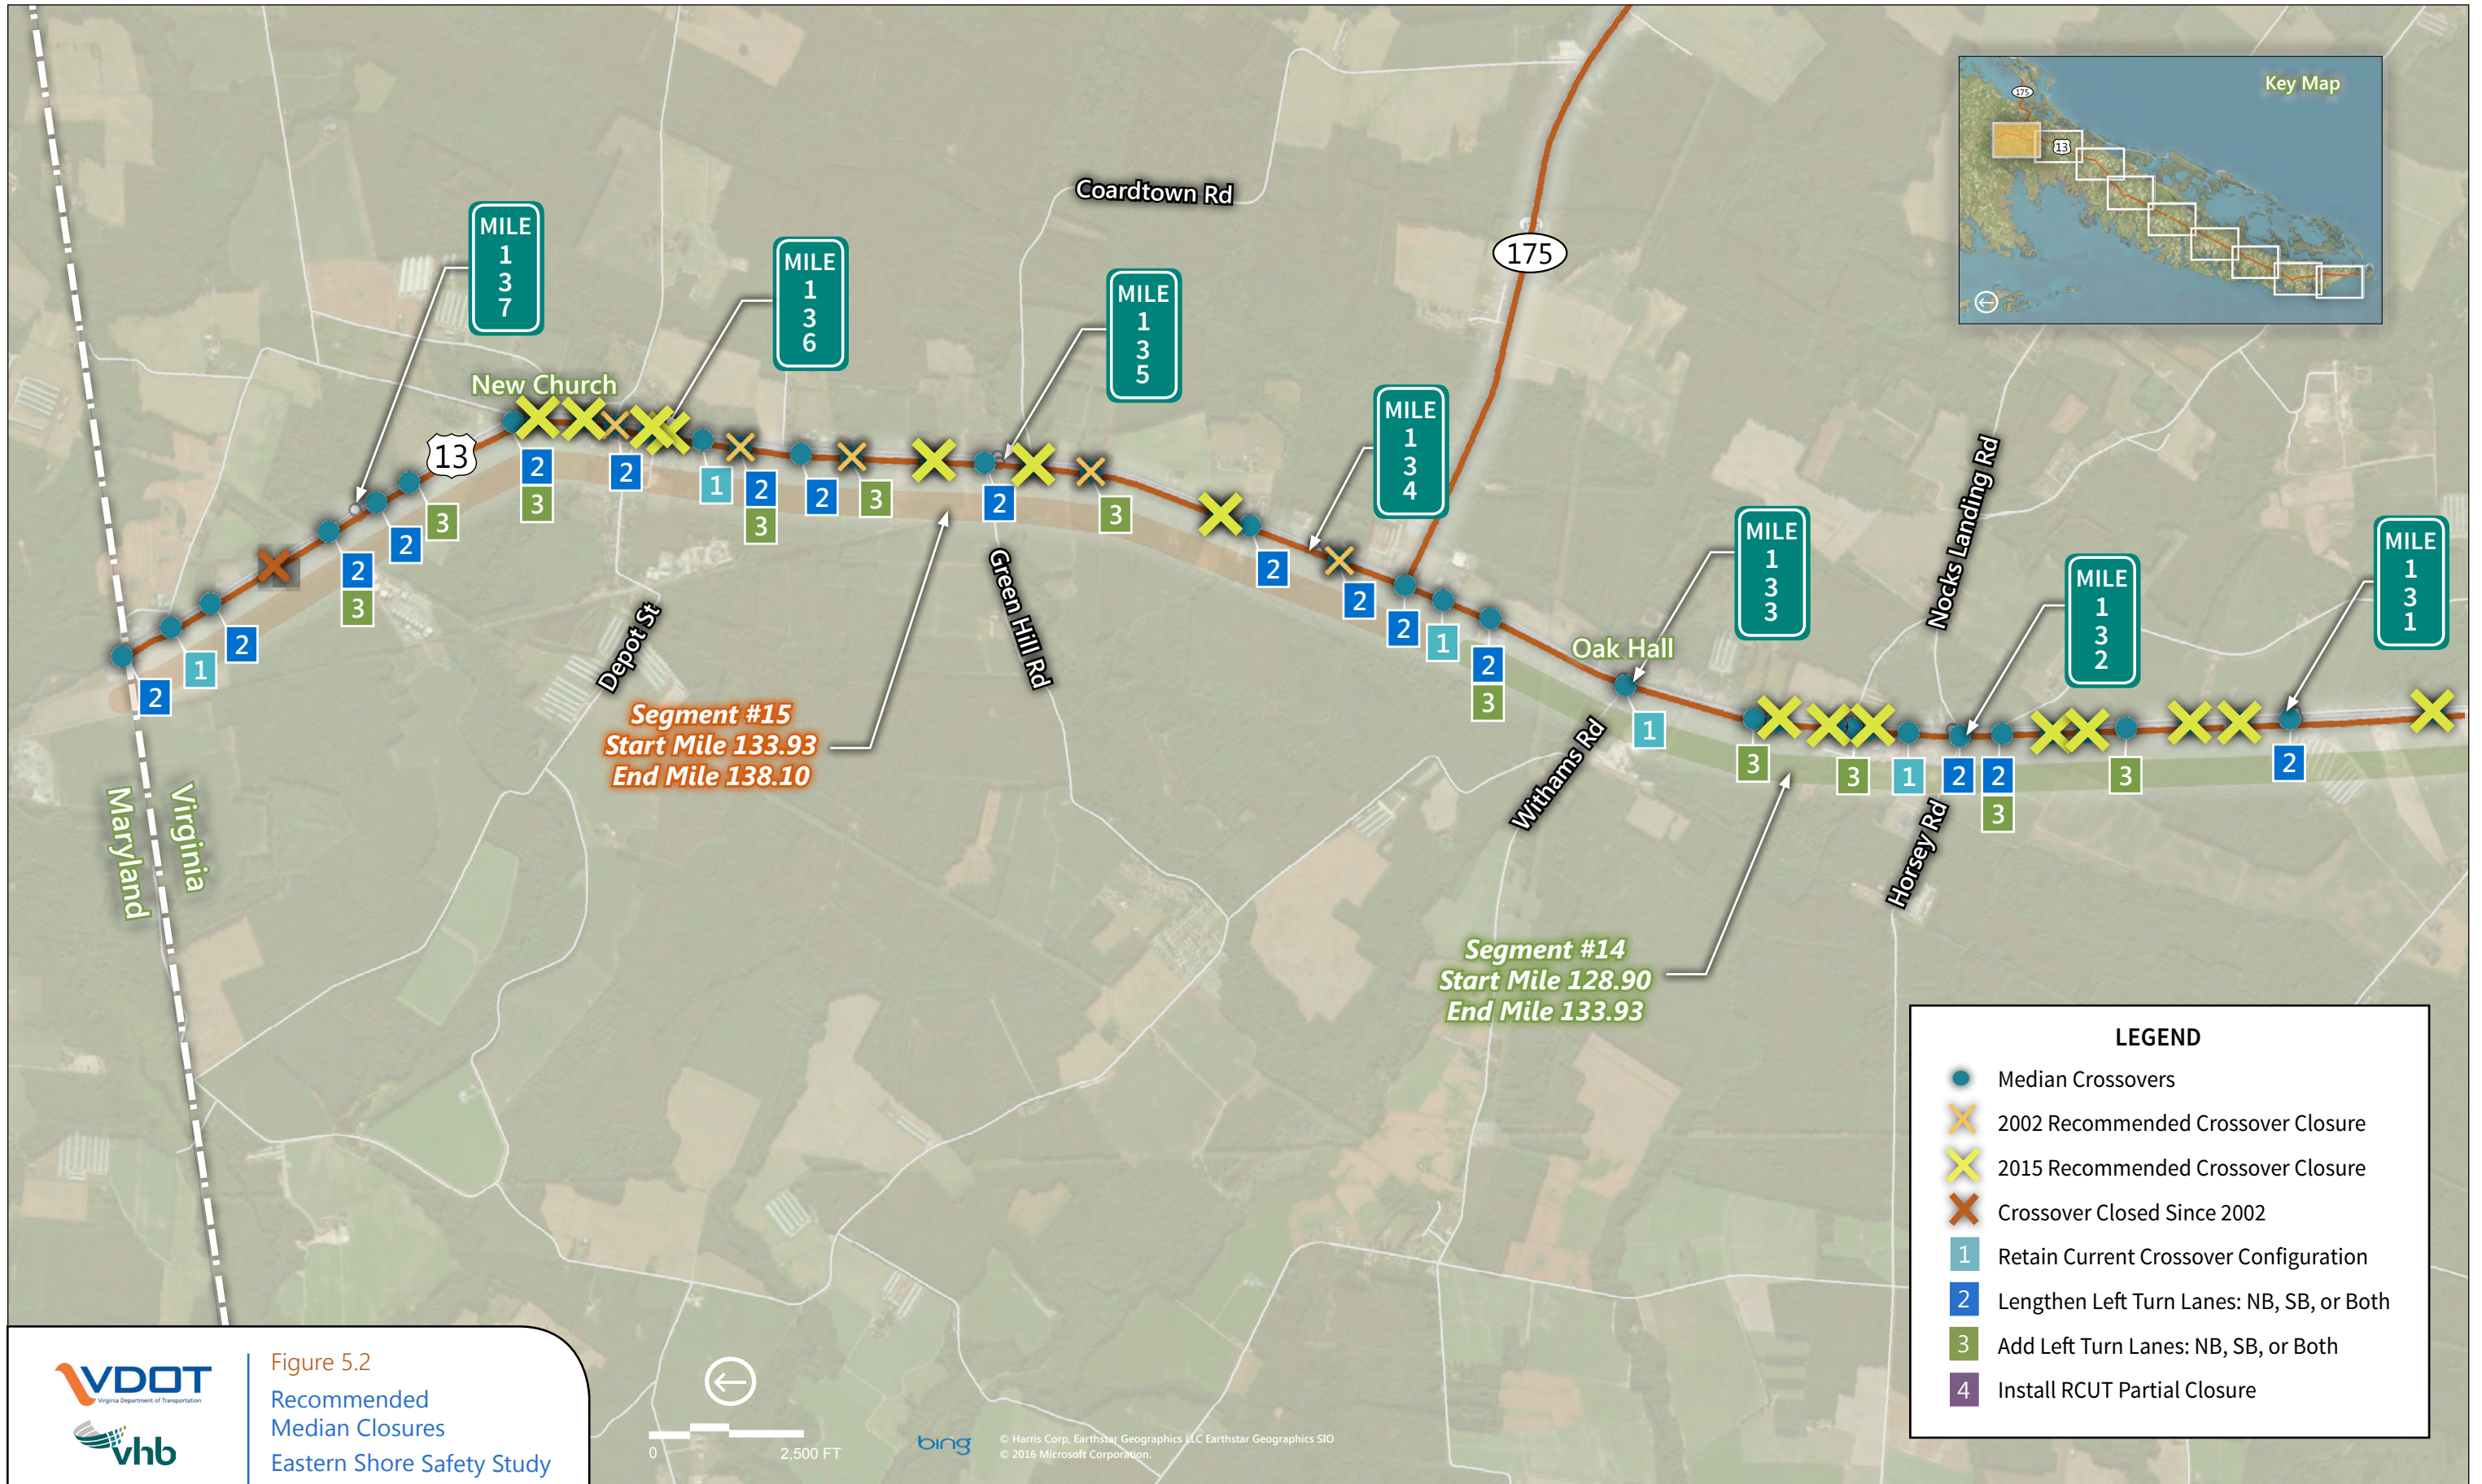
Figure 5.2
Recommended
Median Closures
Eastern Shore Safety Study

Figures 5.2 to 5.10 present the location of all crossovers and intersections, the crossovers recommended for closure in the 2002 Study, the crossovers closed since 2002, recommendations from VDOT during a 2014 evaluation, and the recommended closure or treatment based on this current study. Of the 85 remaining crossovers identified to be closed in the previous study, only 45 are still recommended to be closed. There are also 15 partial closures or RCUT median openings recommended. The detailed tabulated results of the evaluation can be found in Appendix D.
