Eastern Shore

Safety Study

April 2016

Virginia Department of Transportation (VDOT)

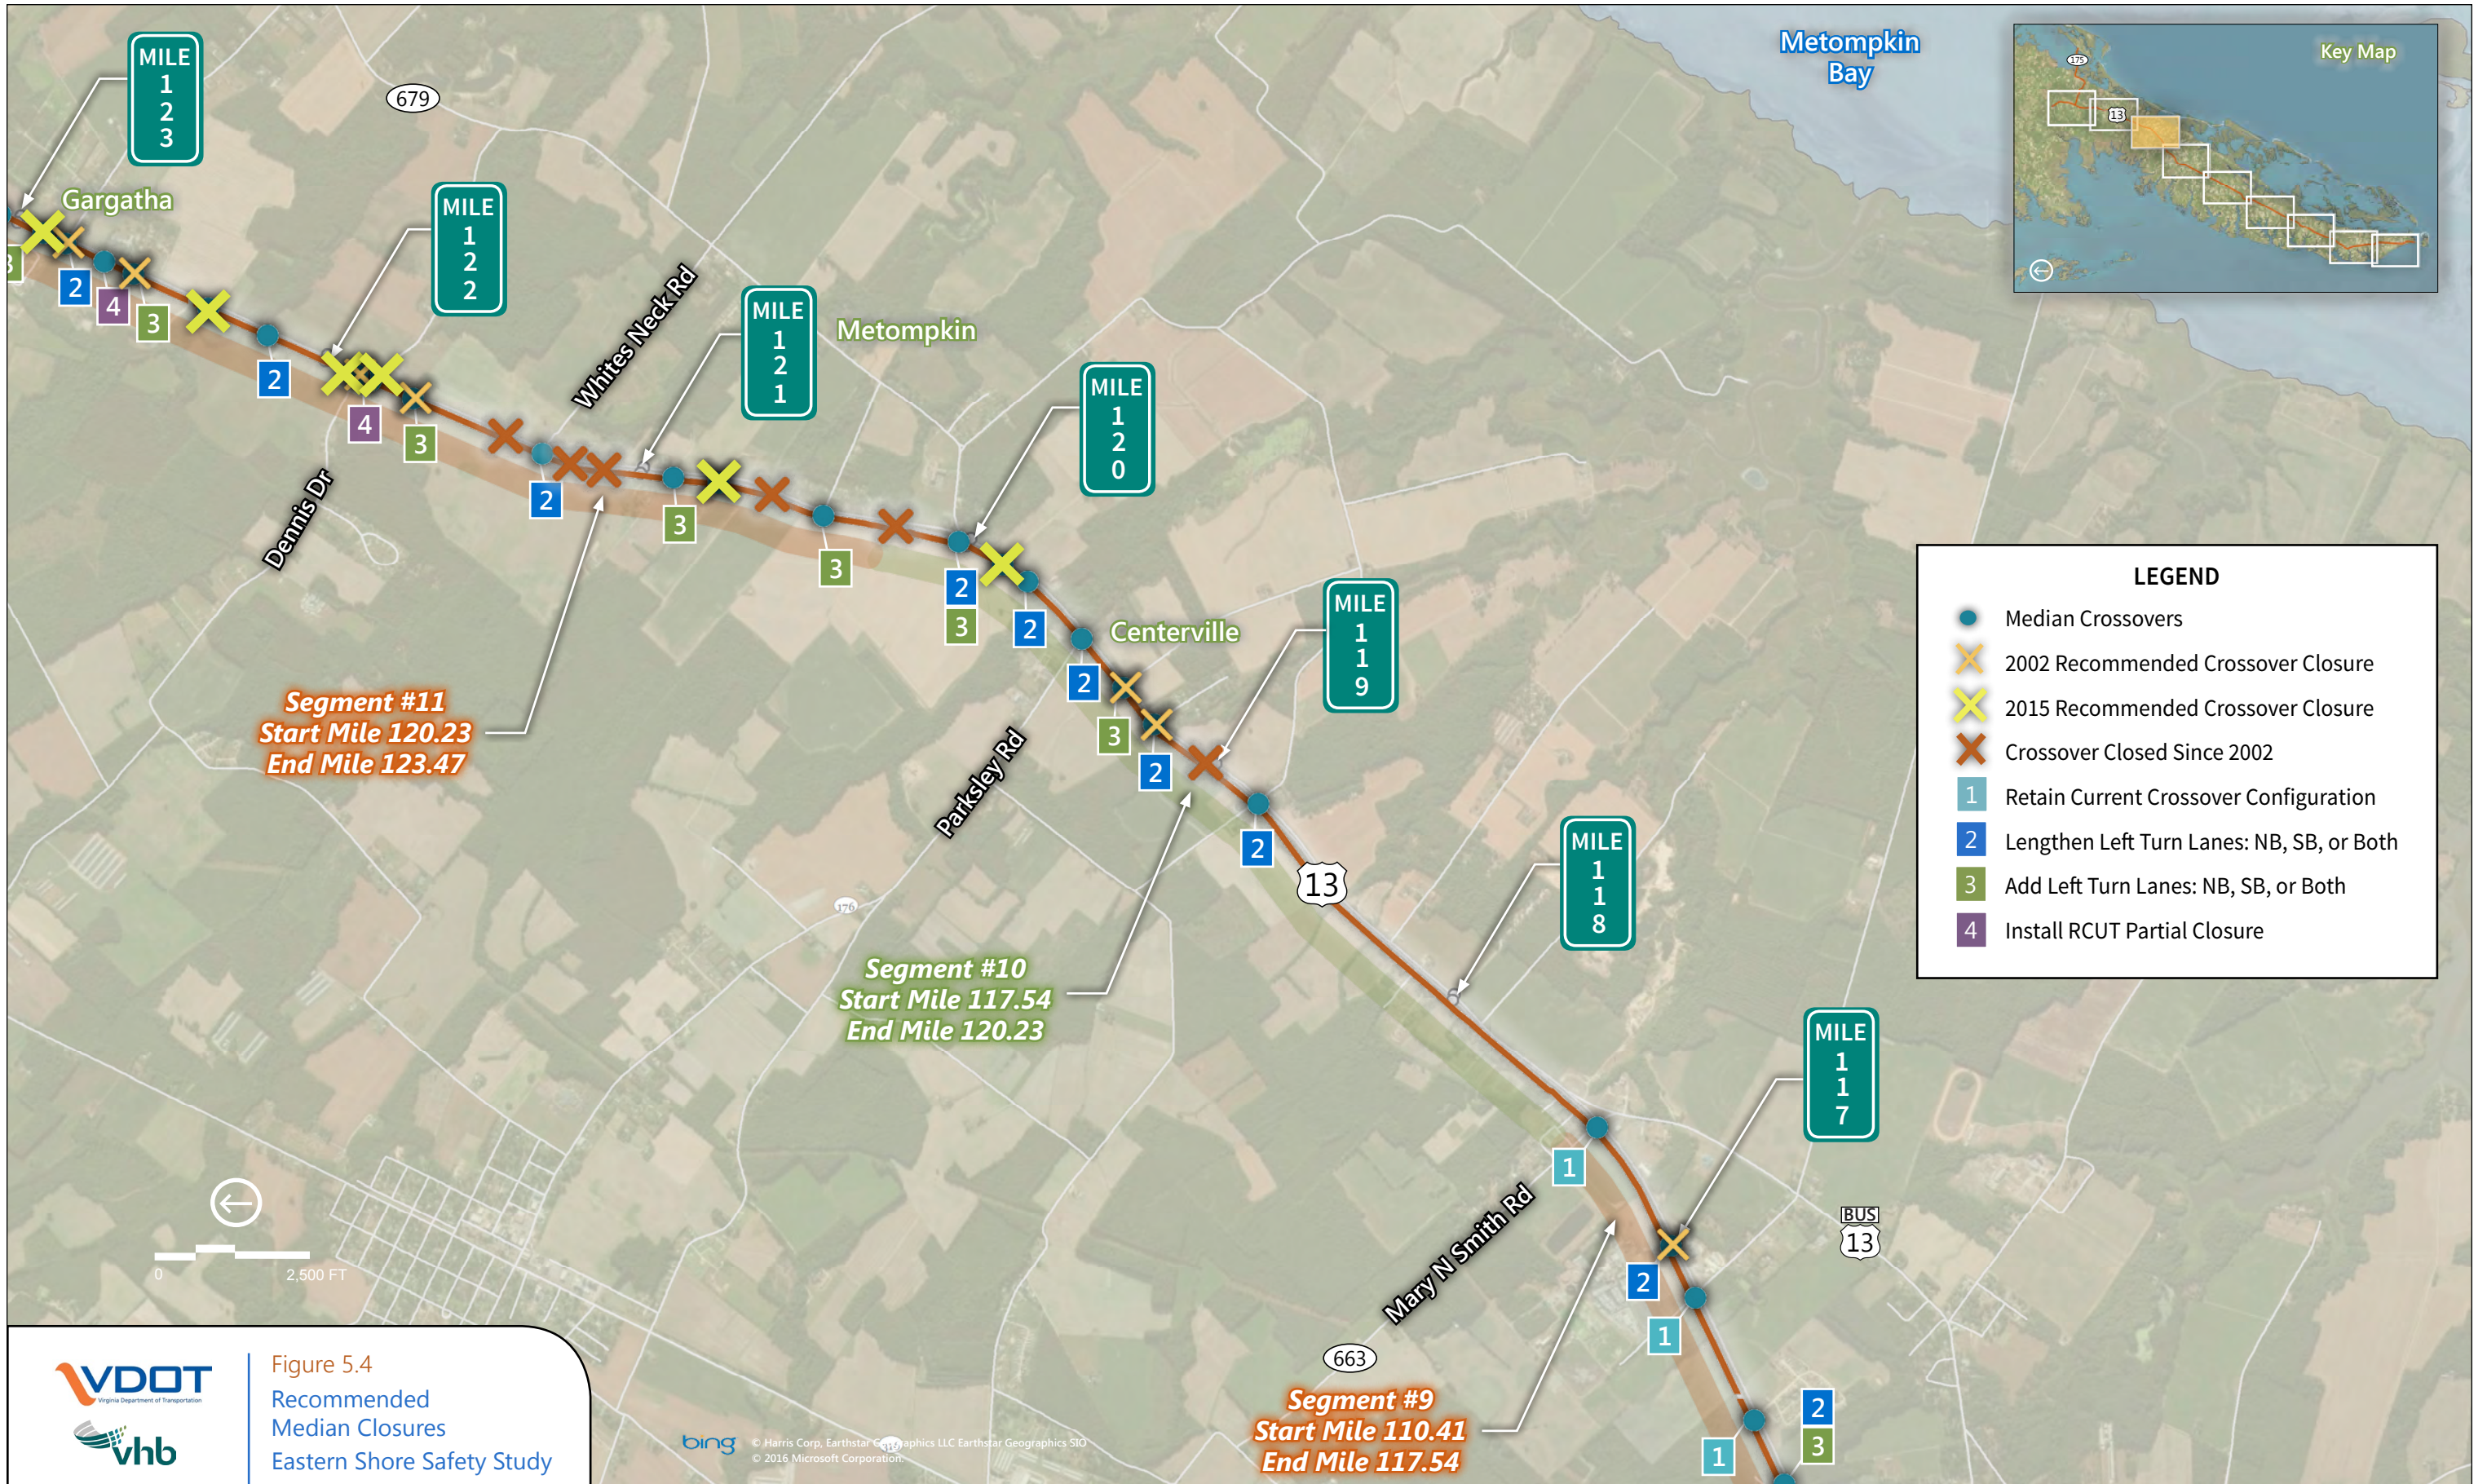
Figure 5.4
Recommended
Median Closures
Eastern Shore Safety Study

Figures 5.2 to 5.10 present the location of all crossovers and intersections, the crossovers recommended for closure in the 2002 Study, the crossovers closed since 2002, recommendations from VDOT during a 2014 evaluation, and the recommended closure or treatment based on this current study. Of the 85 remaining crossovers identified to be closed in the previous study, only 45 are still recommended to be closed. There are also 15 partial closures or RCUT median openings recommended. The detailed tabulated results of the evaluation can be found in Appendix D.

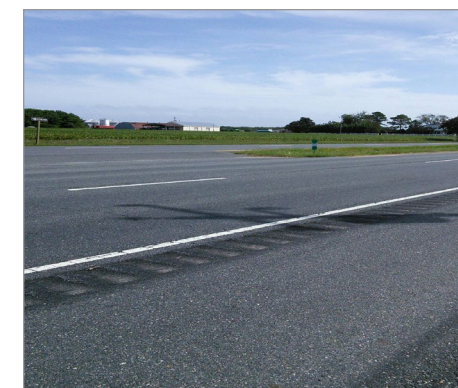
Facing east, a view of the median crossover on U.S. Route 13

The surrounding area is a mix of open fields and woods with some houses and field access. Outside shoulders are present for both north and southbound directions, and there are limited median shoulders present in either direction. Median and shoulder rumble strips are present in both north and southbound directions. There is no on-street parking or lighting. During the field review high truck traffic and vehicular speeds were observed.

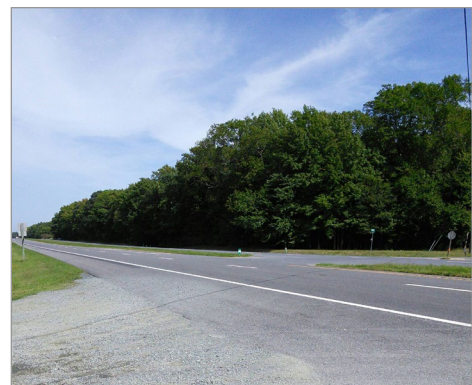
Looking north from Eyrehall Drive

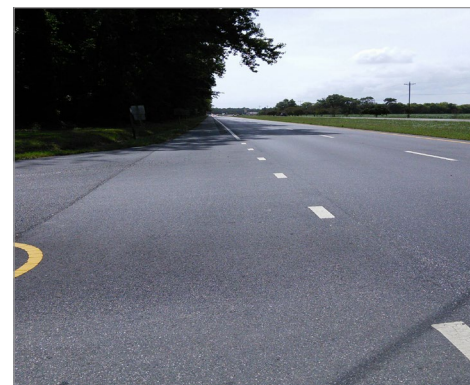
Looking south from Cobbs Station Road

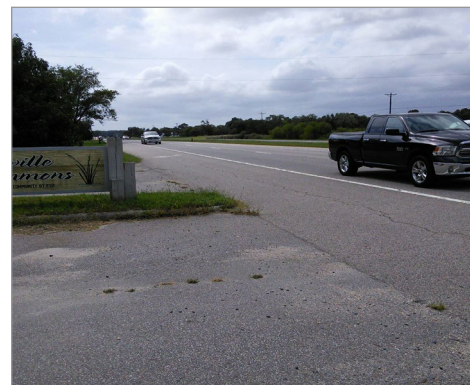
Looking south from Eastville Commons

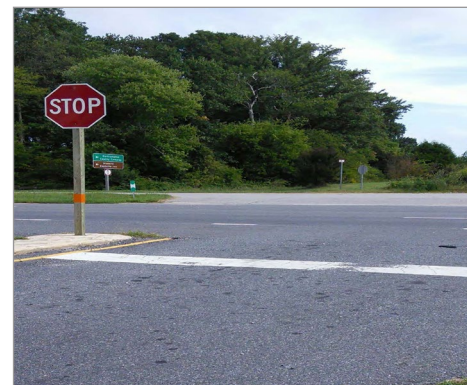
Looking east at intersection of U.S. Route 13 and Captain Howe Lane

- ◆ Grade change in median at paving joint causes an uneven transition for drivers and traps debris which could cause drivers to lose traction.
- ◆ Lack of right turn lanes in southbound direction limit southbound drivers' ability to slow down before turning onto Captain Howe Lane. Additionally, the northbound right turn lane is not adequately marked.
- ◆ Street signs are difficult to see from U.S. Route 13 due to the travel speeds; a single stop sign was placed on the median island on Captain Howe Lane and no stop sign on the right side of the intersection. These signs are not MUTCD compliant.

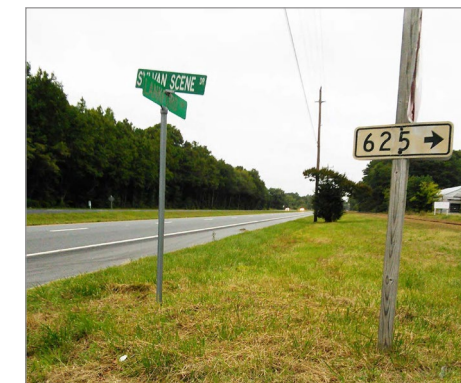
Looking north from westbound approach at Sylvan Scene Drive

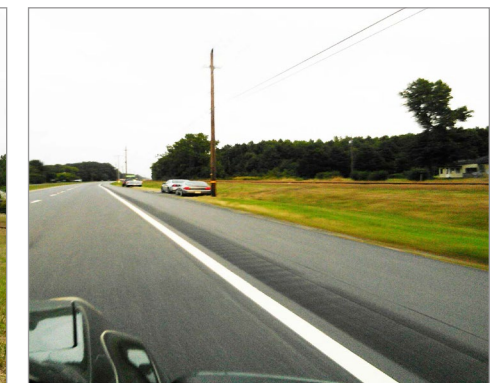
Vehicles parked on the eastern side of the northbound travel lane on U.S. Route 13

- ◆ Parked vehicles on shoulder. There is a lack of expectancy for drivers on U.S. Route 13 as vehicles were not observed parking along the roadway on other parts of the corridor. These vehicles serve as fixed objects within the clear zone. Furthermore, these vehicles are parked in the grass requiring them to enter U.S. Route 13 at relatively slow speeds compared to the vehicles already traveling at higher speeds on U.S. Route 13.
- ◆ Lack of positive guidance for drivers, particularly at night. Difficult for vehicles to recover if they drive off the road due to narrow median shoulders.
- ◆ Nighttime crashes.

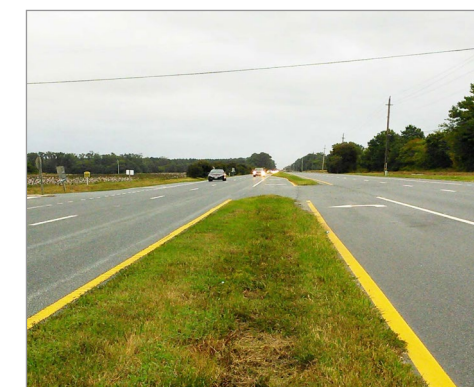
Looking northbound from the median at Bayford Road

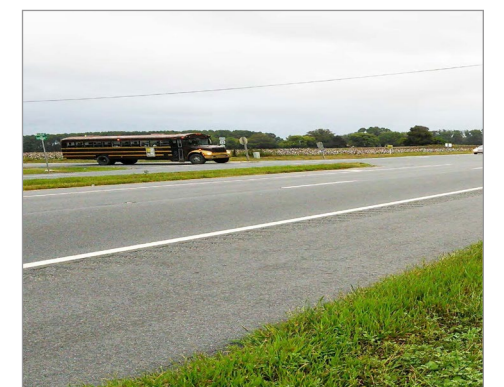
Bus entering onto U.S. Route 13 from Bayford Road

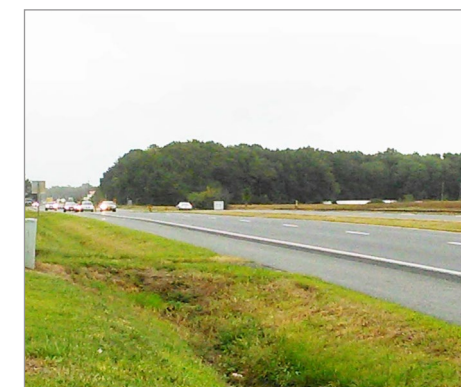
Looking north from the western side of U.S. Route 13

- ▶ Widen/add median shoulders to four feet and add rumble strips. If shoulders are not possible then incorporate rumble stripes in the southbound direction.
- ▶ Review ditches to see if the depth and slope can be reduced. If not, widen shoulder and add guardrail or pipe ditch to eliminate hazard within clear zone.

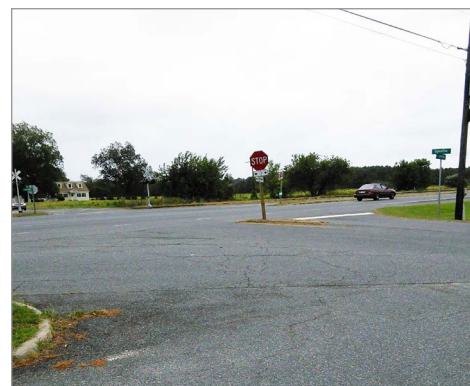
Looking south from Tammy and Johnny's restaurant

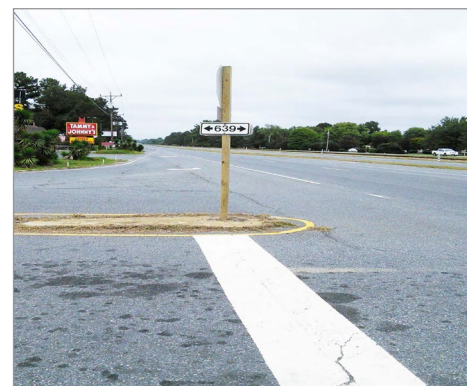
Looking north from southwest quadrant of intersection

- ▶ Insufficient space for drivers to slow down before turning onto intersecting streets or parking lot entrances.
- ◆ U-turn prohibition due to narrow median and speeds.
 - ▶ Signage is present but vehicles still conduct maneuver.
- ◆ Unclear signage
 - ▶ Some of the signs or sign posts are bent/damaged.
 - ▶ Street signs are difficult to see traveling at speed on U.S. Route 13.

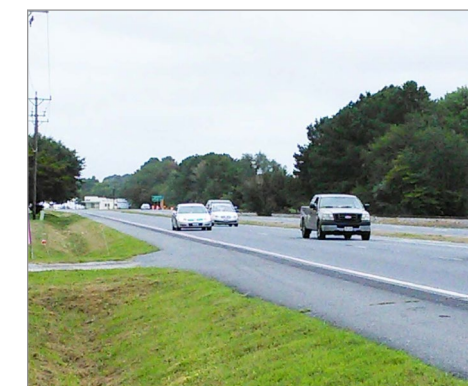
Looking north from the western side of U.S. Route 13

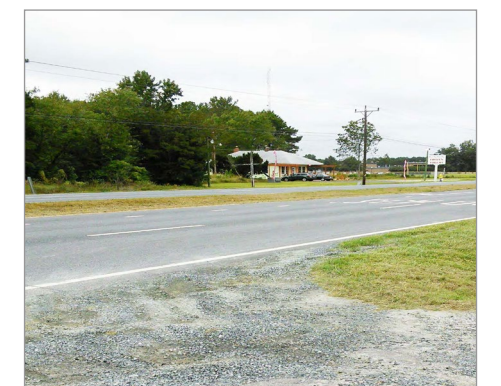
Gravel access road on eastern side of U.S. Route 13

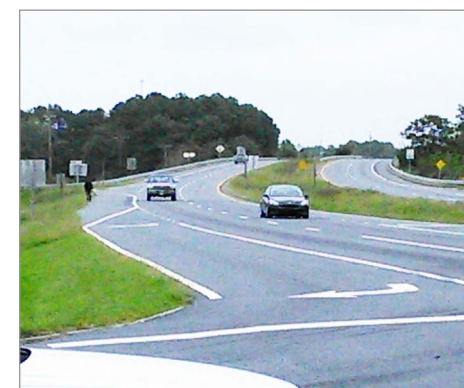
Looking north from the eastbound approach at Chesapeake Square Shopping Center

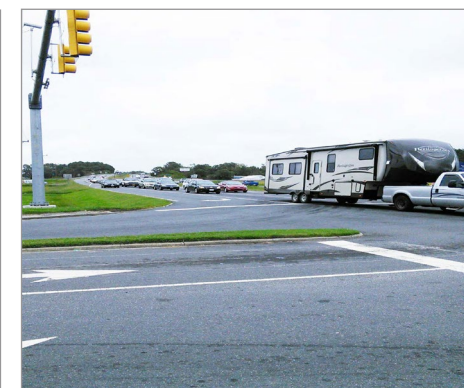
Field observations noted long queues on the southbound approach. The northwest corner of the section was worn away from southbound vehicles driving over the corner which could potentially be due to high vehicle speeds or inadequate turning radius for large trucks.

Vehicles queuing on the southbound approach of U.S. Route 13 at Chesapeake Square Shopping Center

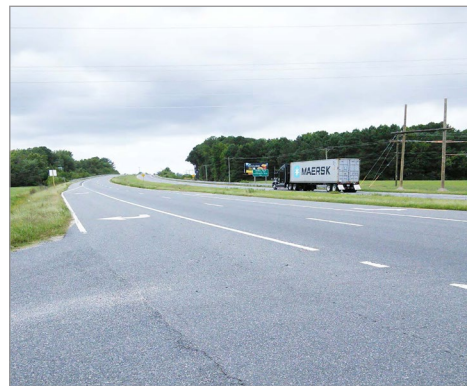
- ◆ No intersection warning.
- ◆ Lack of intersection expectancy due to lack of intersection warning along with horizontal curvature and trees reducing intersection sight distance in the southbound direction.
- ◆ Observed high travel speeds.
- ◆ Street and stop sign placement is not MUTCD compliant.

Looking south on U.S. Route 13 from the westbound approach at Taylor Road

- ▶ Install 12-inch street name signs to conform with MUTCD recommendations and revise placement to ensure they are visible from U.S. Route 13. Add stop signs on the right side of the street on Taylor Road, and add intersection warning signs on U.S. Route 13.

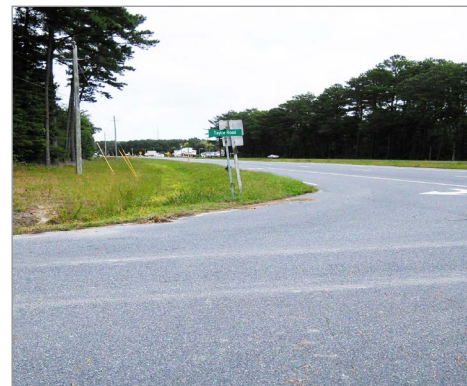
Looking north on U.S. Route 13 from the eastbound approach at Taylor Road

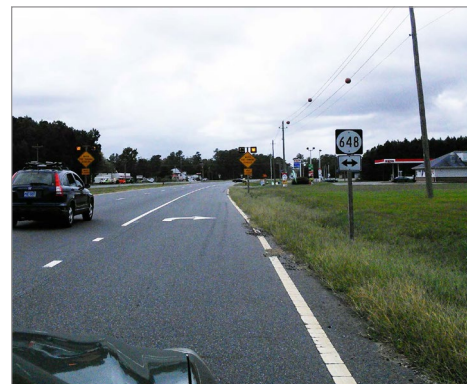
- ◆ Insufficient turn lane and taper lengths.
- ◆ Horizontal curvature reduces intersection sight distance for southbound vehicles.
- ◆ Observed high travel speeds.
- ◆ Lack of median crossover delineation.
- ◆ Access management of adjacent properties, particularly those properties on the southwestern and southeastern corners. These properties have multiple consecutive entrances on U.S. Route 13 and Daugherty Road. There are eight (8) driveway accesses south of the intersection: three (3) on U.S. Route 13 southbound and five (5) on U.S. Route 13 northbound, and one north of the intersection on the southbound approach.

Vehicle traveling southbound on U.S. Route 13 approaching Daugherty Road

- ▶ Install a Restricted Crossing U-Turn (RCUT) intersection by modifying median access so that vehicles can only turn right from Daugherty Road with an available subsequent u-turn opportunity. Access for emergency responders that currently use this intersection can use an alternative route to the north to avoid the u-turn. Response time should be confirmed as a part of advancement of this recommendation.
- ▶ Implement access management measures on the properties adjacent to the intersection to consolidate access points onto U.S. Route 13.
- ▶ Lengthen substandard turn lanes to provide 200 feet of storage and 200 feet of taper for an overall minimum length of 400 feet.

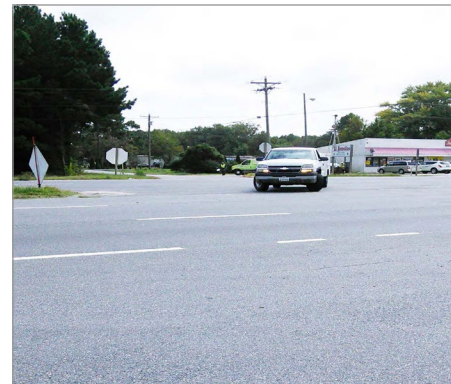
Vehicle turning right on U.S. Route 13 from westbound approach at Daugherty Road

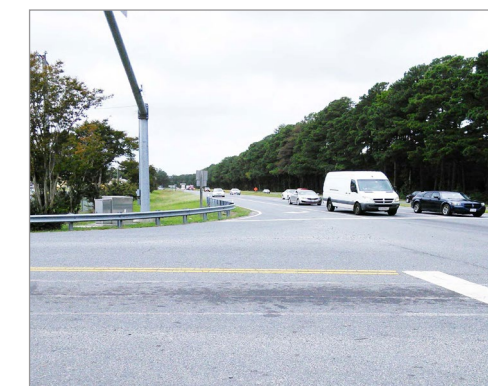
- ◆ Horizontal curve and wooded area prior to intersection on northbound approach limits intersection visibility and expectancy.
- ◆ Observed high travel speeds on U.S. Route 13.
- ◆ Lack of recovery area along median and positive guidance.

Looking south on U.S. Route 13 from the westbound approach on Courthouse Avenue

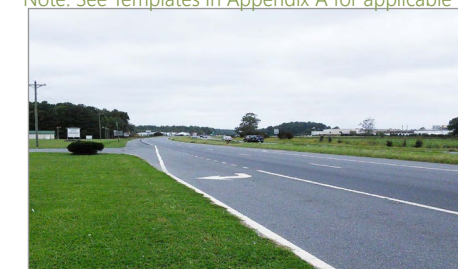
Northbound right turn lane onto Front Street from U.S. Route 13

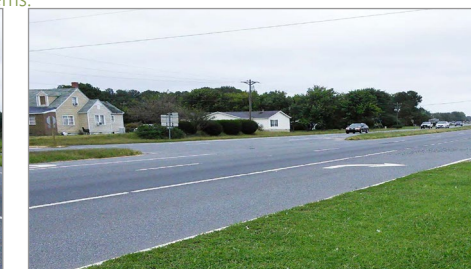
Looking north from the southeast corner of the intersection

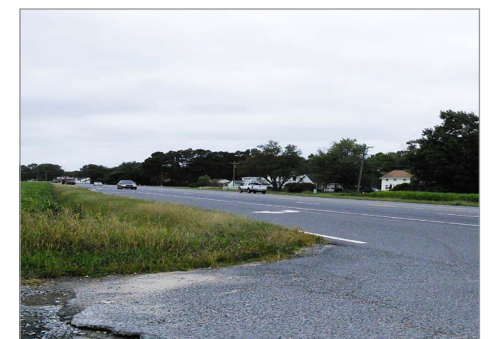
- ◆ Horizontal curvature.
- ◆ Nighttime crashes.
- ◆ Lack of recovery space along the median, particularly in the southbound direction.
- ◆ Stop sign installed too low on westbound approach on Johnson Road.
- ◆ Unmarked roadside hazards within clear zones.

Looking south on U.S. Route 13 from westbound approach on Johnson Road

- ▶ Provide additional positive guidance through post mounted delineators and wider 6-inch pavement markings.
- ▶ Incorporate safety edge to provide an additional method for vehicles to recover from roadway departure crashes.
- ▶ Install Johnson Road stop sign at appropriate height.
- ▶ Mark steep ditches and culverts with object markers.
- ▶ Review ditches to see if the depth and slope can be reduced. If not, widen shoulder and add guardrail or pipe ditch to eliminate hazard within clear zone.

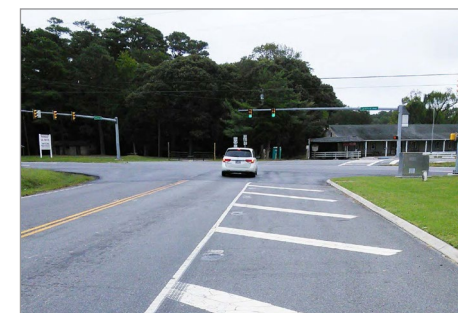
It was evident that trucks encroach on the southwest corner pedestrian space and run over the ramp when making a right turn from the eastbound approach. The field review team noted that trucks were barely making the turn and were very close to driving into the grassy median. The RSA team also witnessed southbound right turning trucks barely making the turn without encroaching into the eastbound through lane.

Eastbound approach on Parksley Road

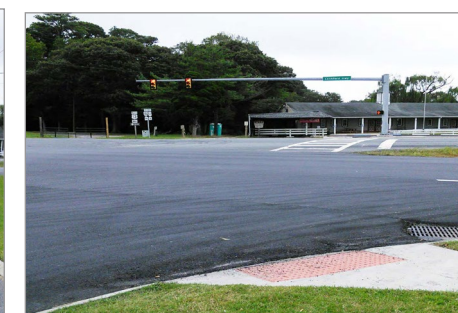
U.S. Route 13/Parksley Road intersection from southwest corner

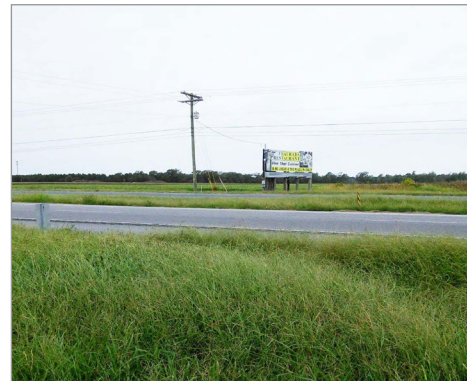
Tall grass grows along eastern side and center median of U.S. Route 13

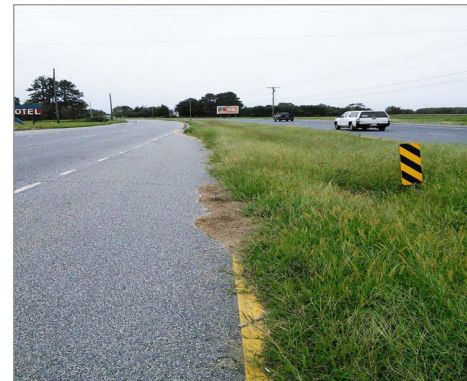
Looking south from the median on U.S. Route 13

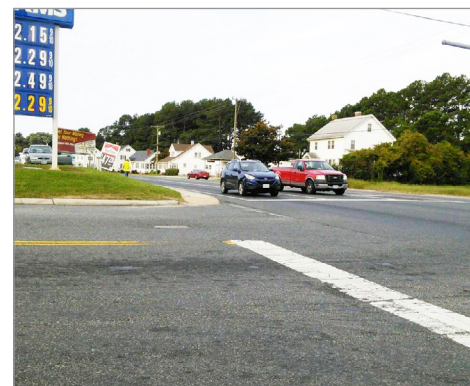
Vehicles traveling north on U.S. Route 13

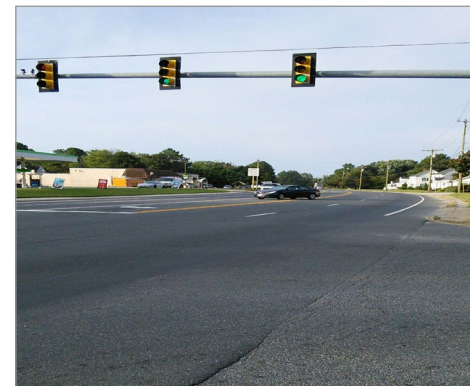
Traffic signals for vehicles traveling southbound on U.S. Route 13

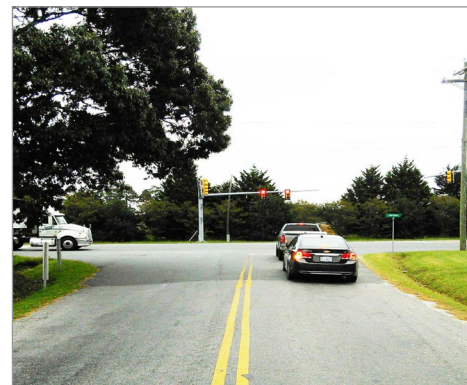
Vehicles stopped at the eastbound approach on Groton Town Road

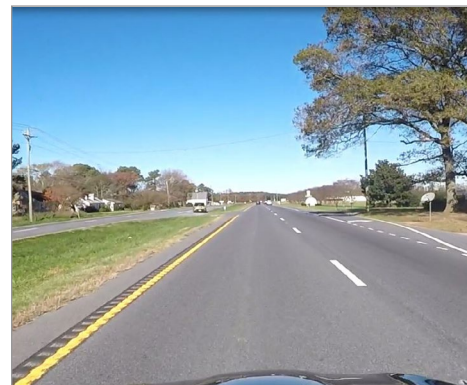
Vehicle traveling northbound on U.S. Route 13 approaching Thorton Road

- ◆ Short northbound right turn lane at Thornton Road intersection. Trees obscure the intersection in northbound direction, and the intersection is located immediately after on-street market parking.
- ◆ Lack of expectancy at both Hallwood and Thornton Road intersections.
- ◆ Ability of drivers from side streets to judge acceptable gaps.
- ◆ Hallwood Road and U.S. Route 13 intersection is skewed limiting the northbound sight distance.
- ◆ At Hallwood Road the stop sign is posted in the median island. There is no right-side posted stop sign as recommended in the MUTCD.
- ◆ Wide open access to parking lot at the southwestern corner of the Hallwood Road intersection.

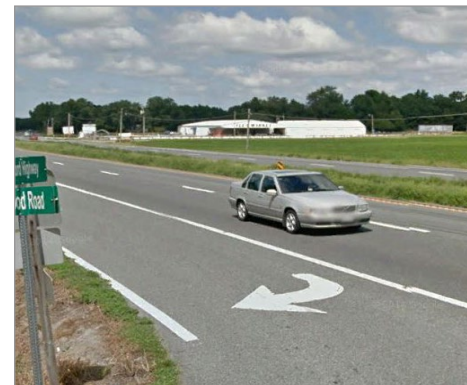
Vehicle traveling southbound on U.S. Route 13 approaching Holland Road

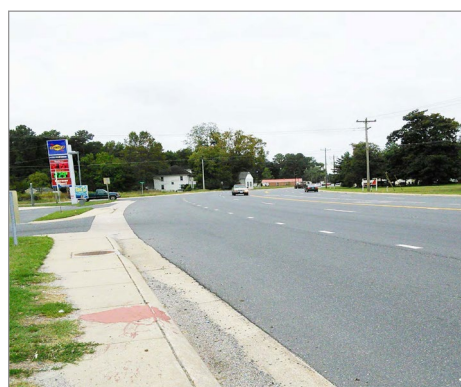
Looking south on U.S. Route 13

Throughout this roughly 3,800-foot corridor segment of U.S. Route 13, there is gutter pan located on both sides of the roadway. During a night field review, the RSA team noted the lack of positive roadside guidance for drivers unlike other parts of the corridor where edge line and raised pavement markers were present.

Narrow sidewalks are present throughout this portion of the corridor. Beginning at New Temperanceville Road and extending approximately 1,500 feet south of Temperanceville Road, the sidewalk is present along both sides of the road. The sidewalk is present along the eastern side of U.S. Route 13 from New Temperanceville Road to approximately 1,200 feet to the north of New Temperanceville Road. During the field review no pedestrians were viewed and a local resident noted that there is only the occasional pedestrian.

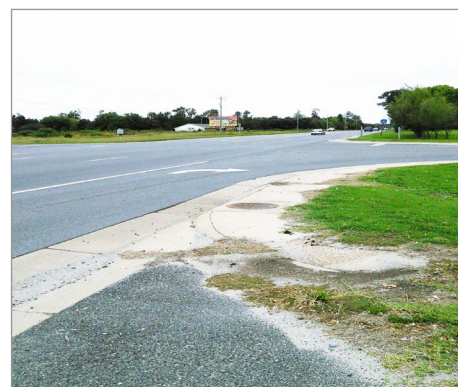
Looking north on U.S. Route 13 at New Temperanceville Road

- ◆ Lack of adequate gaps for vehicles attempting to turn onto U.S. Route 13 or drivers turning left off of U.S. Route 13 and on to a side street/driveway.
- ◆ Horizontal curve and high speeds reduce driver's ability to maintain control.
- ◆ Horizontal curve also limits intersection sight distance.
- ◆ Lack of positive roadside guidance.
- ◆ Pedestrian facilities with narrow sidewalk in poor condition. Ramps did not appear to meet ADA standards and no pedestrian crossing measures were present.
- ◆ Debris in gutter pan, within intersections/driveway entrances, and on sidewalk.
- ◆ Numerous conflict points due to number of lanes on U.S. Route 13 along with the proximity of intersections and driveway entrances.
- ◆ Eastbound approach at New Temperanceville Road intersection has a limited sight distance to the north due to horizontal curve.

- ▶ Trim/remove vegetation on the northeast corner of the New Temperanceville intersection to improve sight distance to the north.
- ▶ Install 12-inch street name signs at both intersections to conform to MUTCD recommendation.

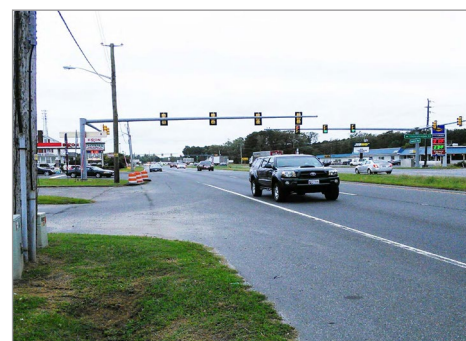
Vehicles traveling northbound on U.S. Route 13

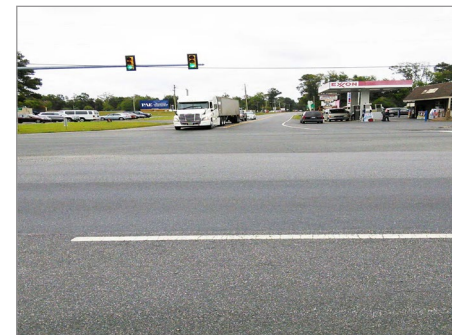
Vehicles stopped in the westbound approach at U.S. Route 13 and Chincoteague Road

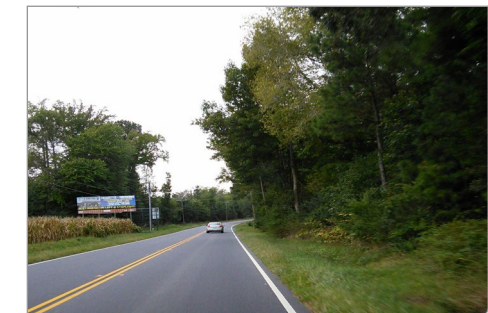
Traveling westbound on Route 175

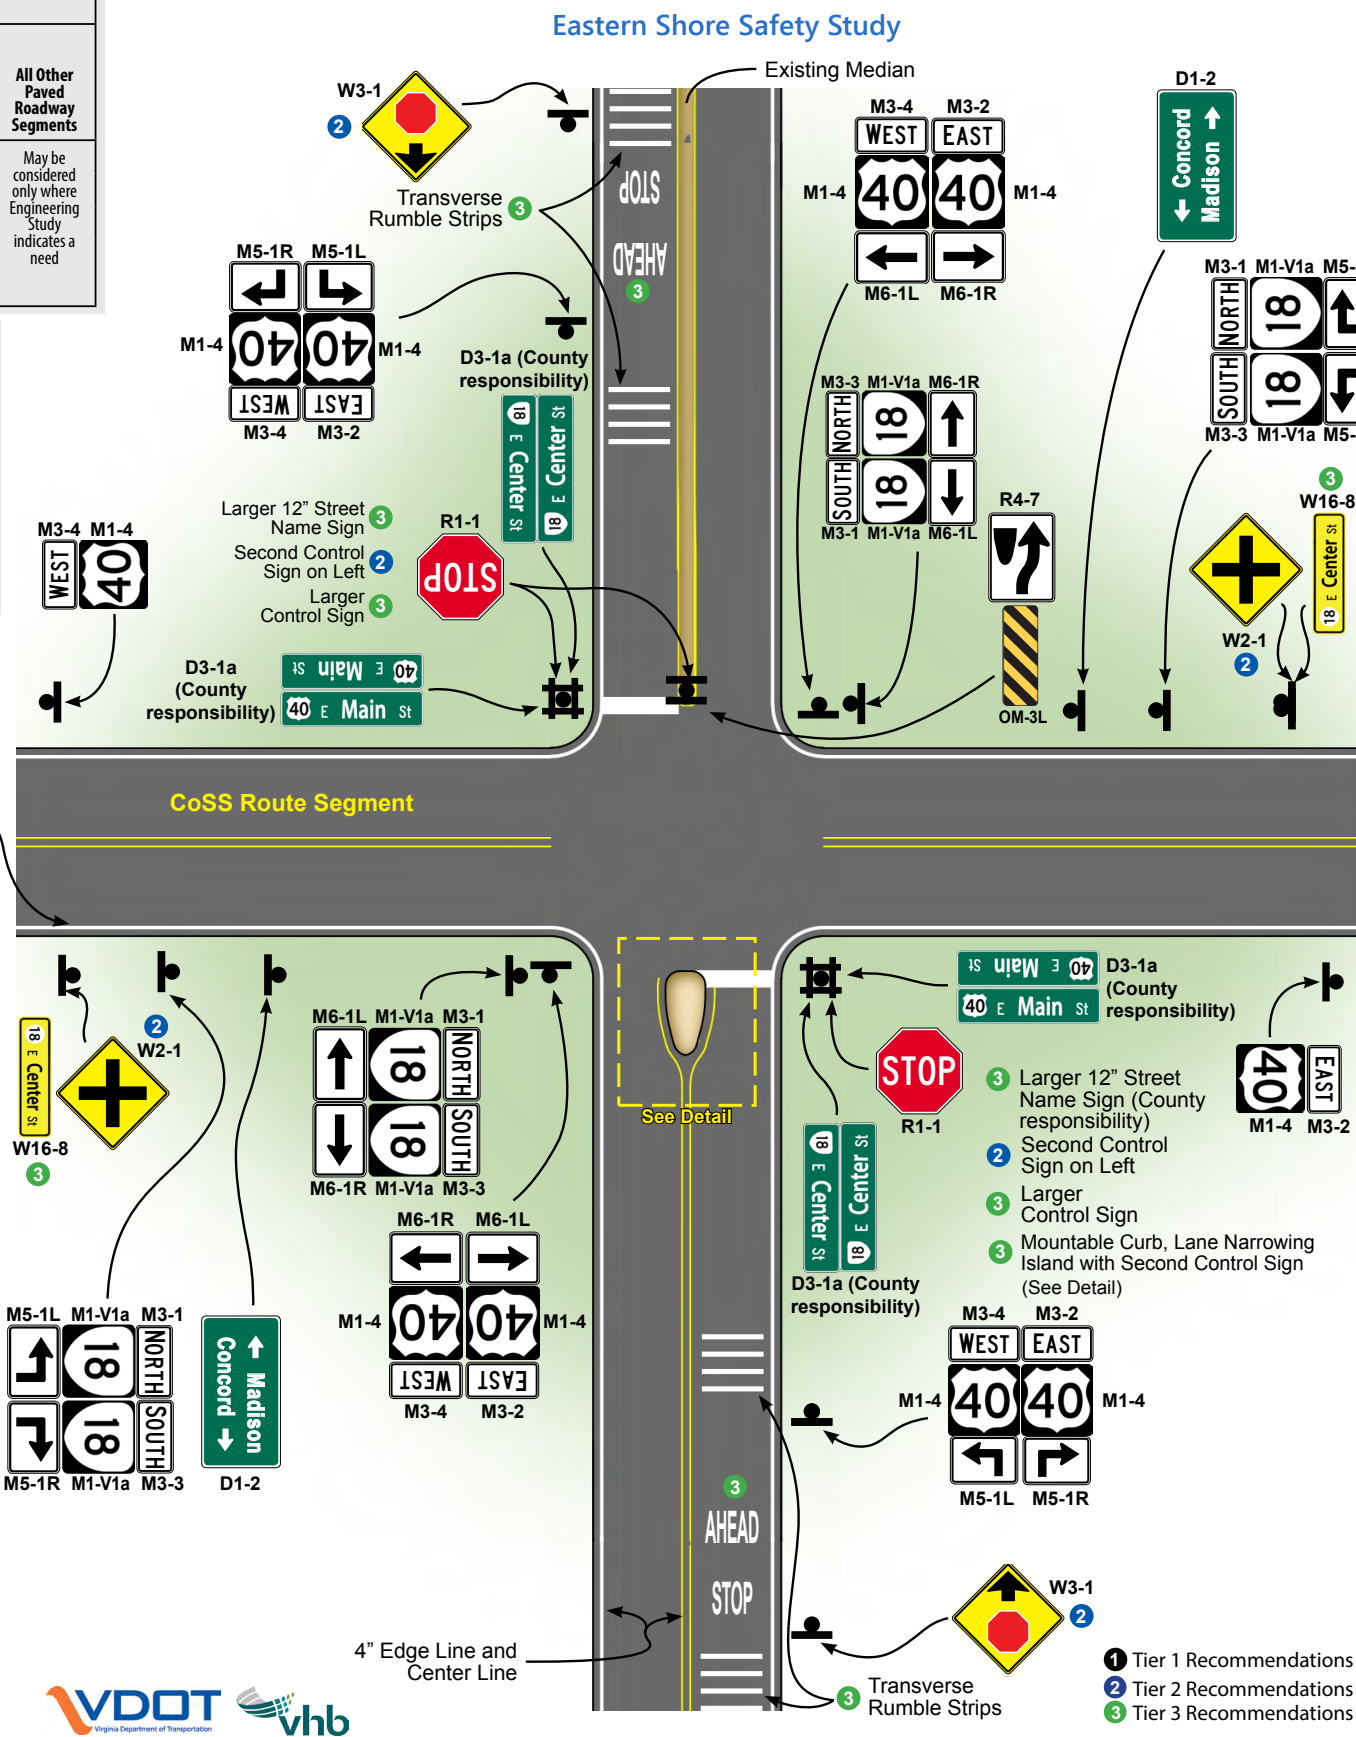
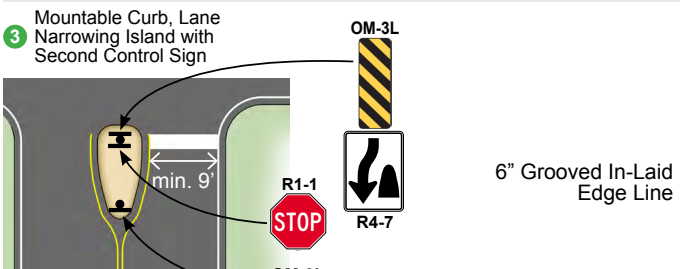
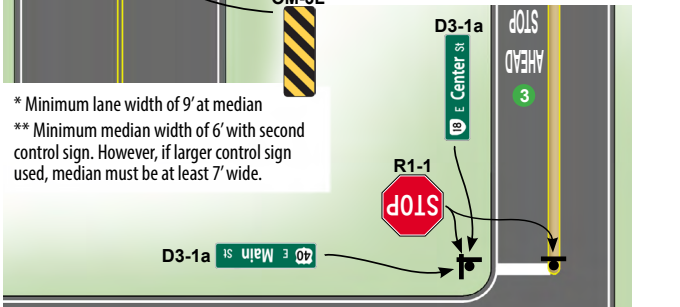
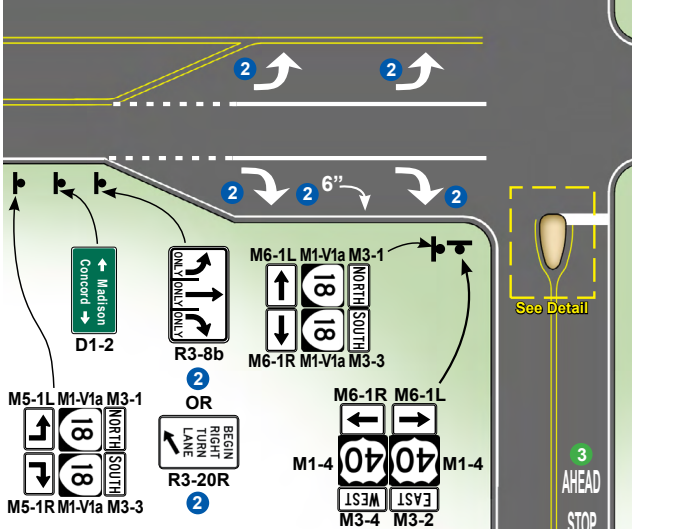
Template 1 - Unsignalized Intersection - 4-leg (2-way stop controlled), Undivided (3 Tiers)

- Signage**
- 1 Upgraded signs with current MUTCD standards (font, size, retroreflectivity, placement, message, etc.)
 - 1 Fluorescent yellow sheeting on change of Direction Warning signs

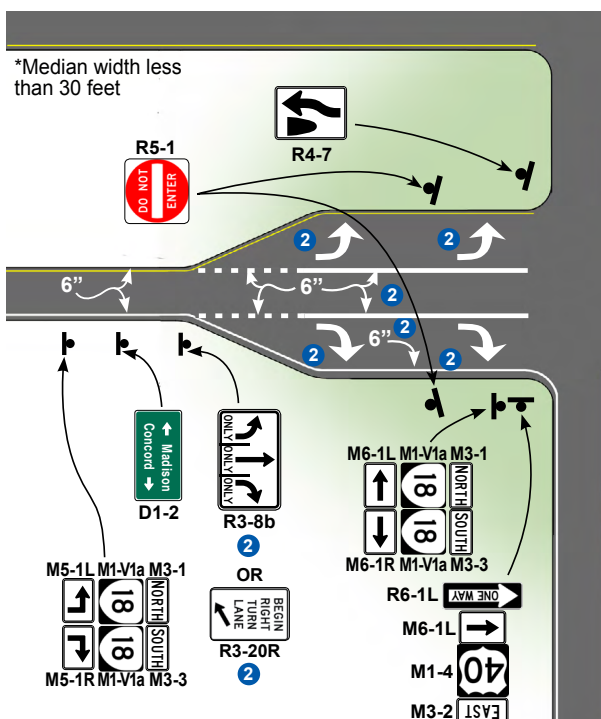
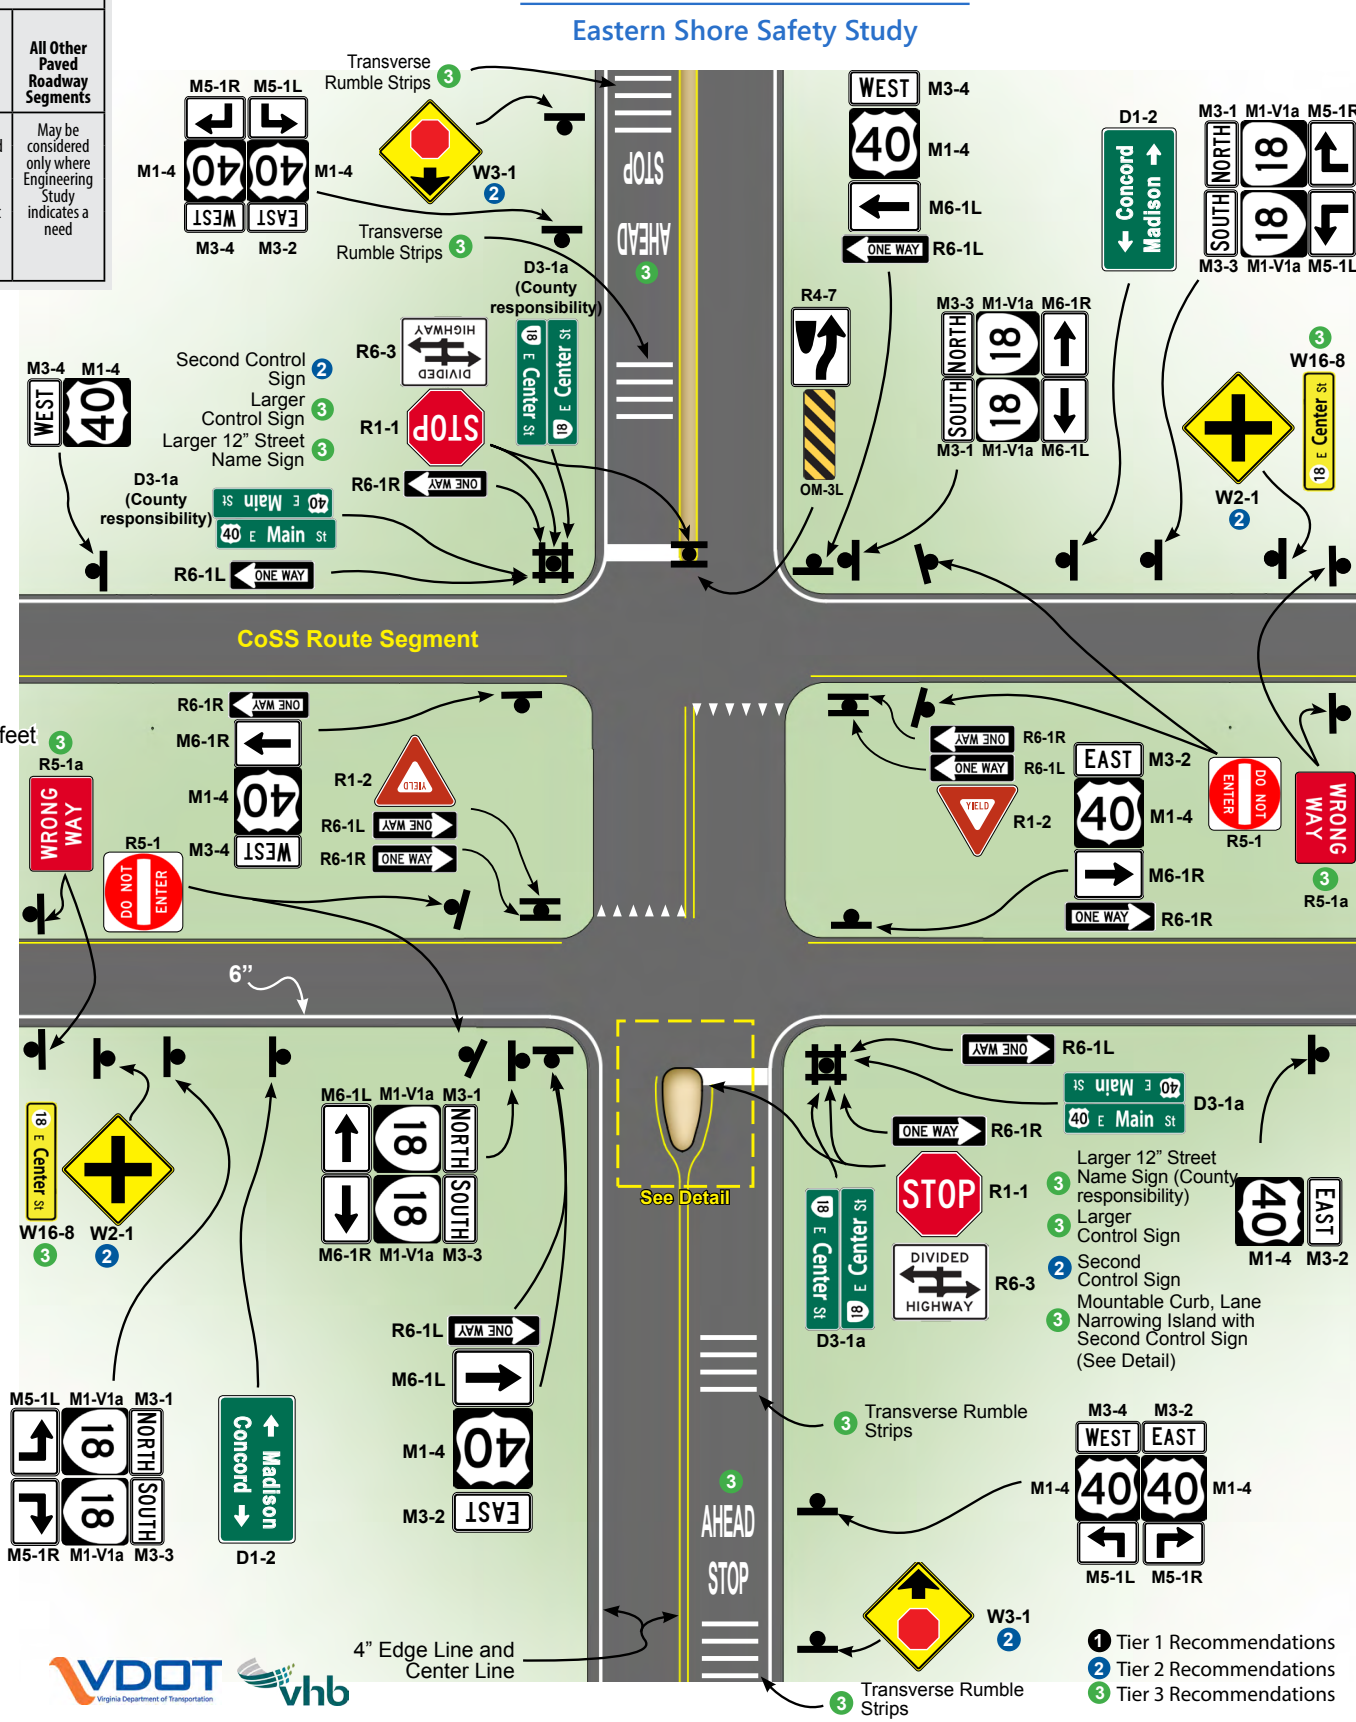
Template 2 - Unsignalized Intersection - 4-leg (2-way stop controlled), Median Separated (3 Tiers)

- 1 Upgraded signs with current MUTCD standards (font, size, retroreflectivity, placement, message, etc.)
 - 1 Fluorescent yellow sheeting on change of Direction Warning signs

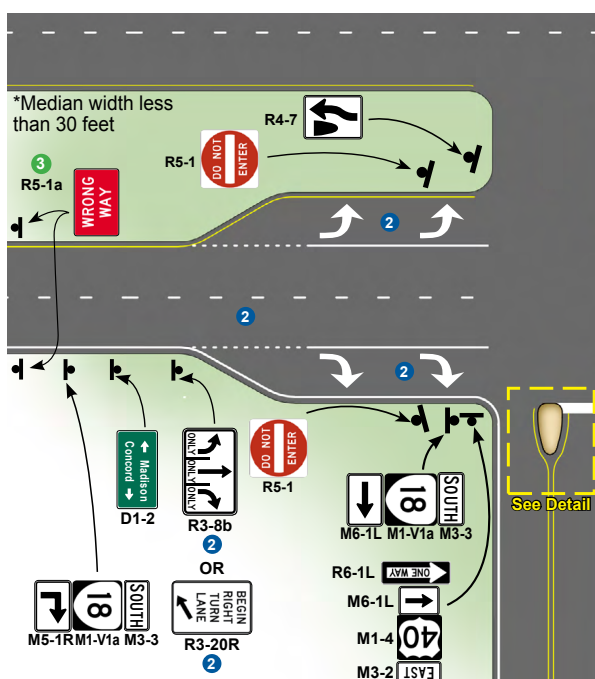
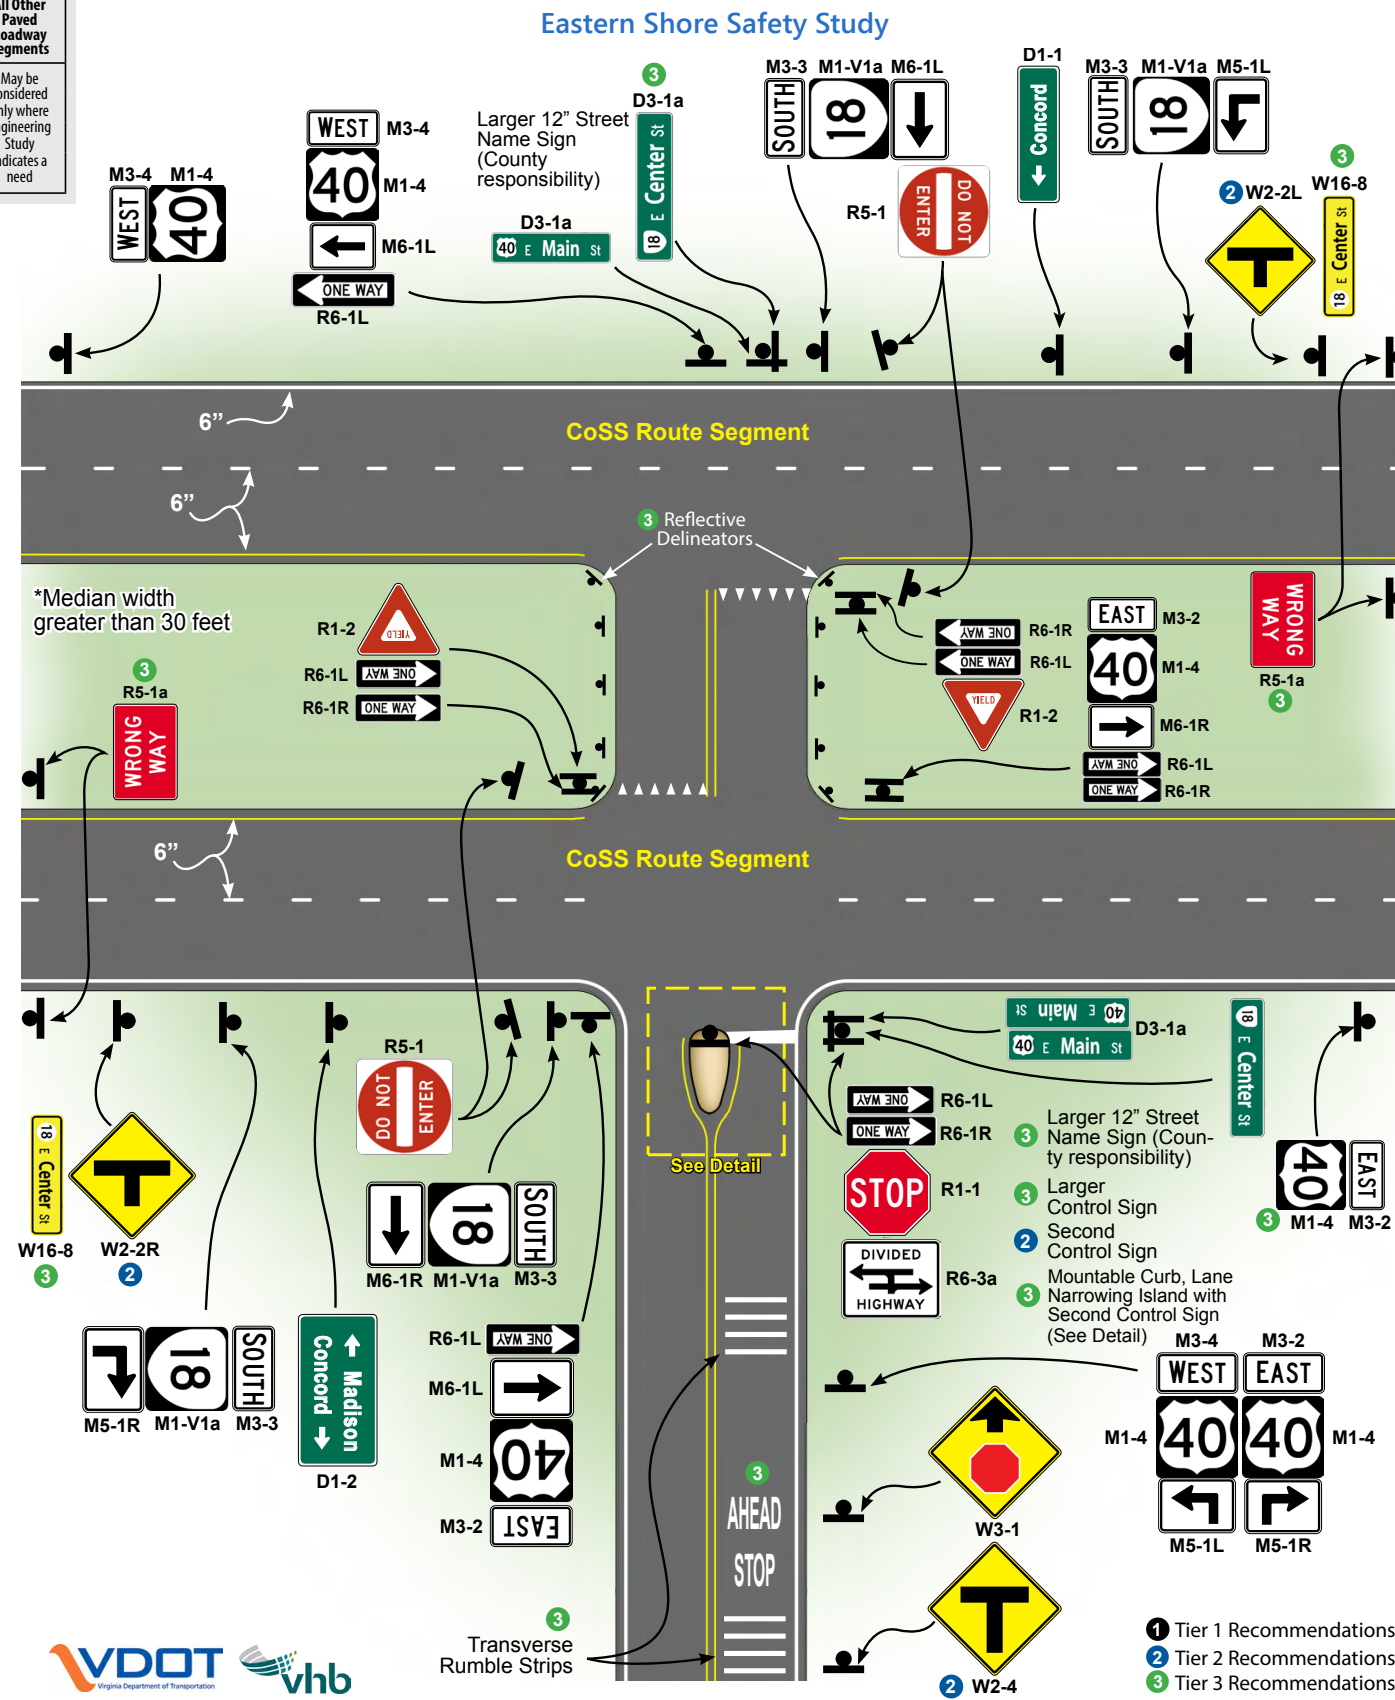
Template 4 - Unsignalized Intersection - 3-leg (1-way stop controlled), Median Separated (with crossover) (3 Tiers)

Mountable Curb, Lane Narrowing Island with Second Control Sign
