Eastern Shore

Safety Study

April 2016

Virginia Department of Transportation (VDOT)

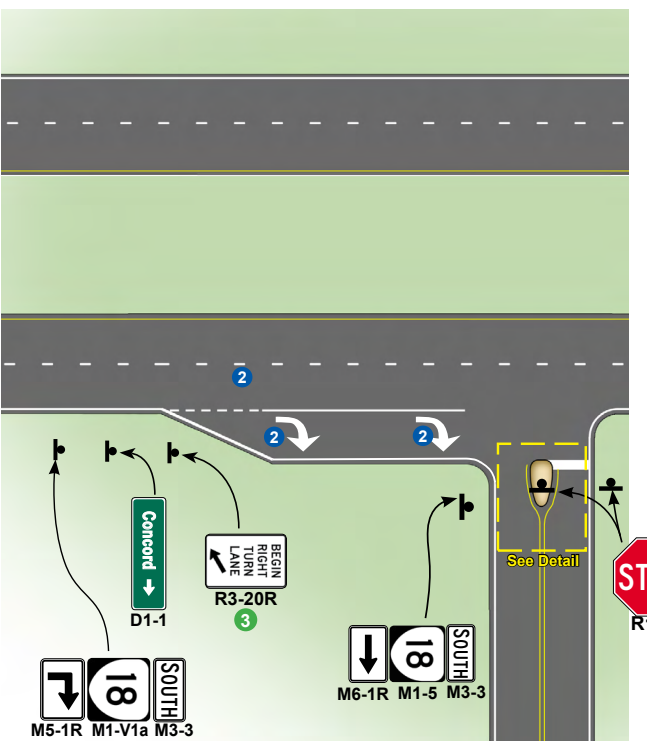
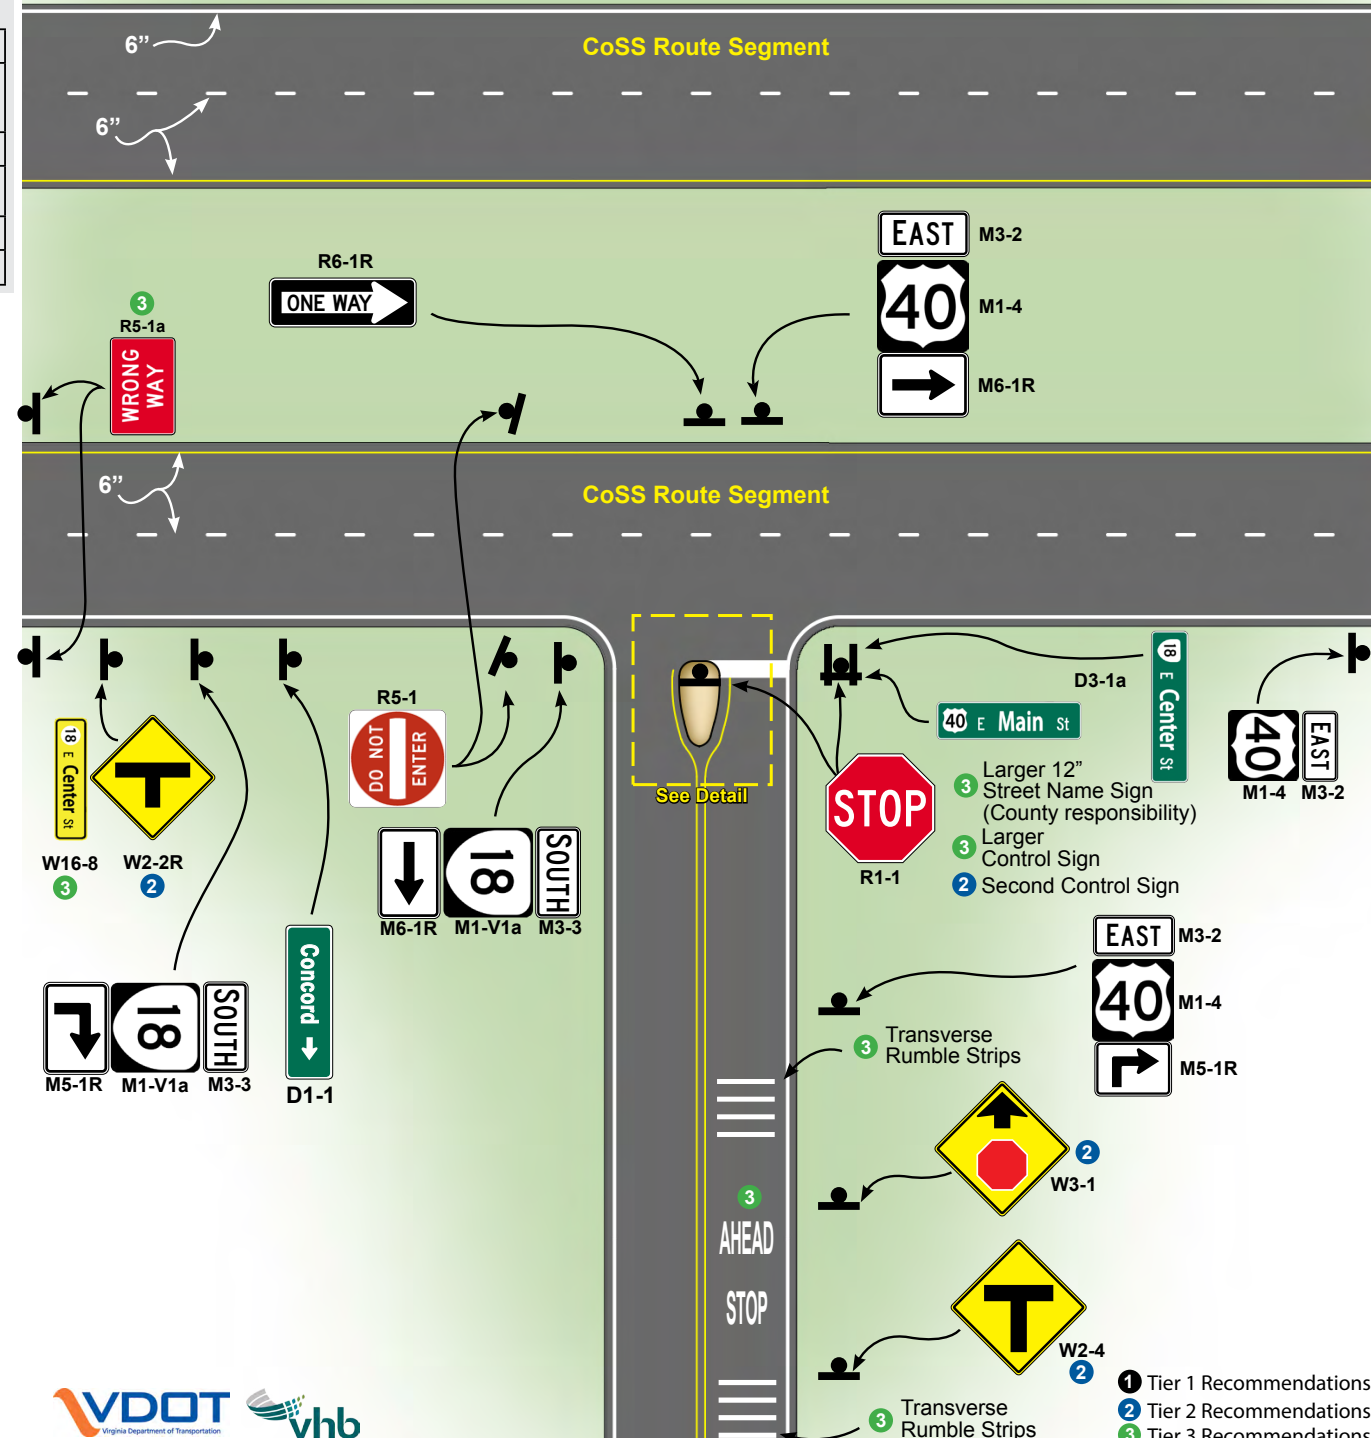
Template 5 - Unsignalized Intersection - 3-leg (1-way stop controlled), Median Separated (no crossover) (3 Tiers)
Eastern Shore Safety Study

Mountable Curb, Lane Narrowing Island with Second Control Sign

- Signage**
- 1 Upgraded signs with current MUTCD standards (font, size, retroreflectivity, placement, message, etc.)
 - 1 Fluorescent yellow sheeting on change of Direction Warning signs

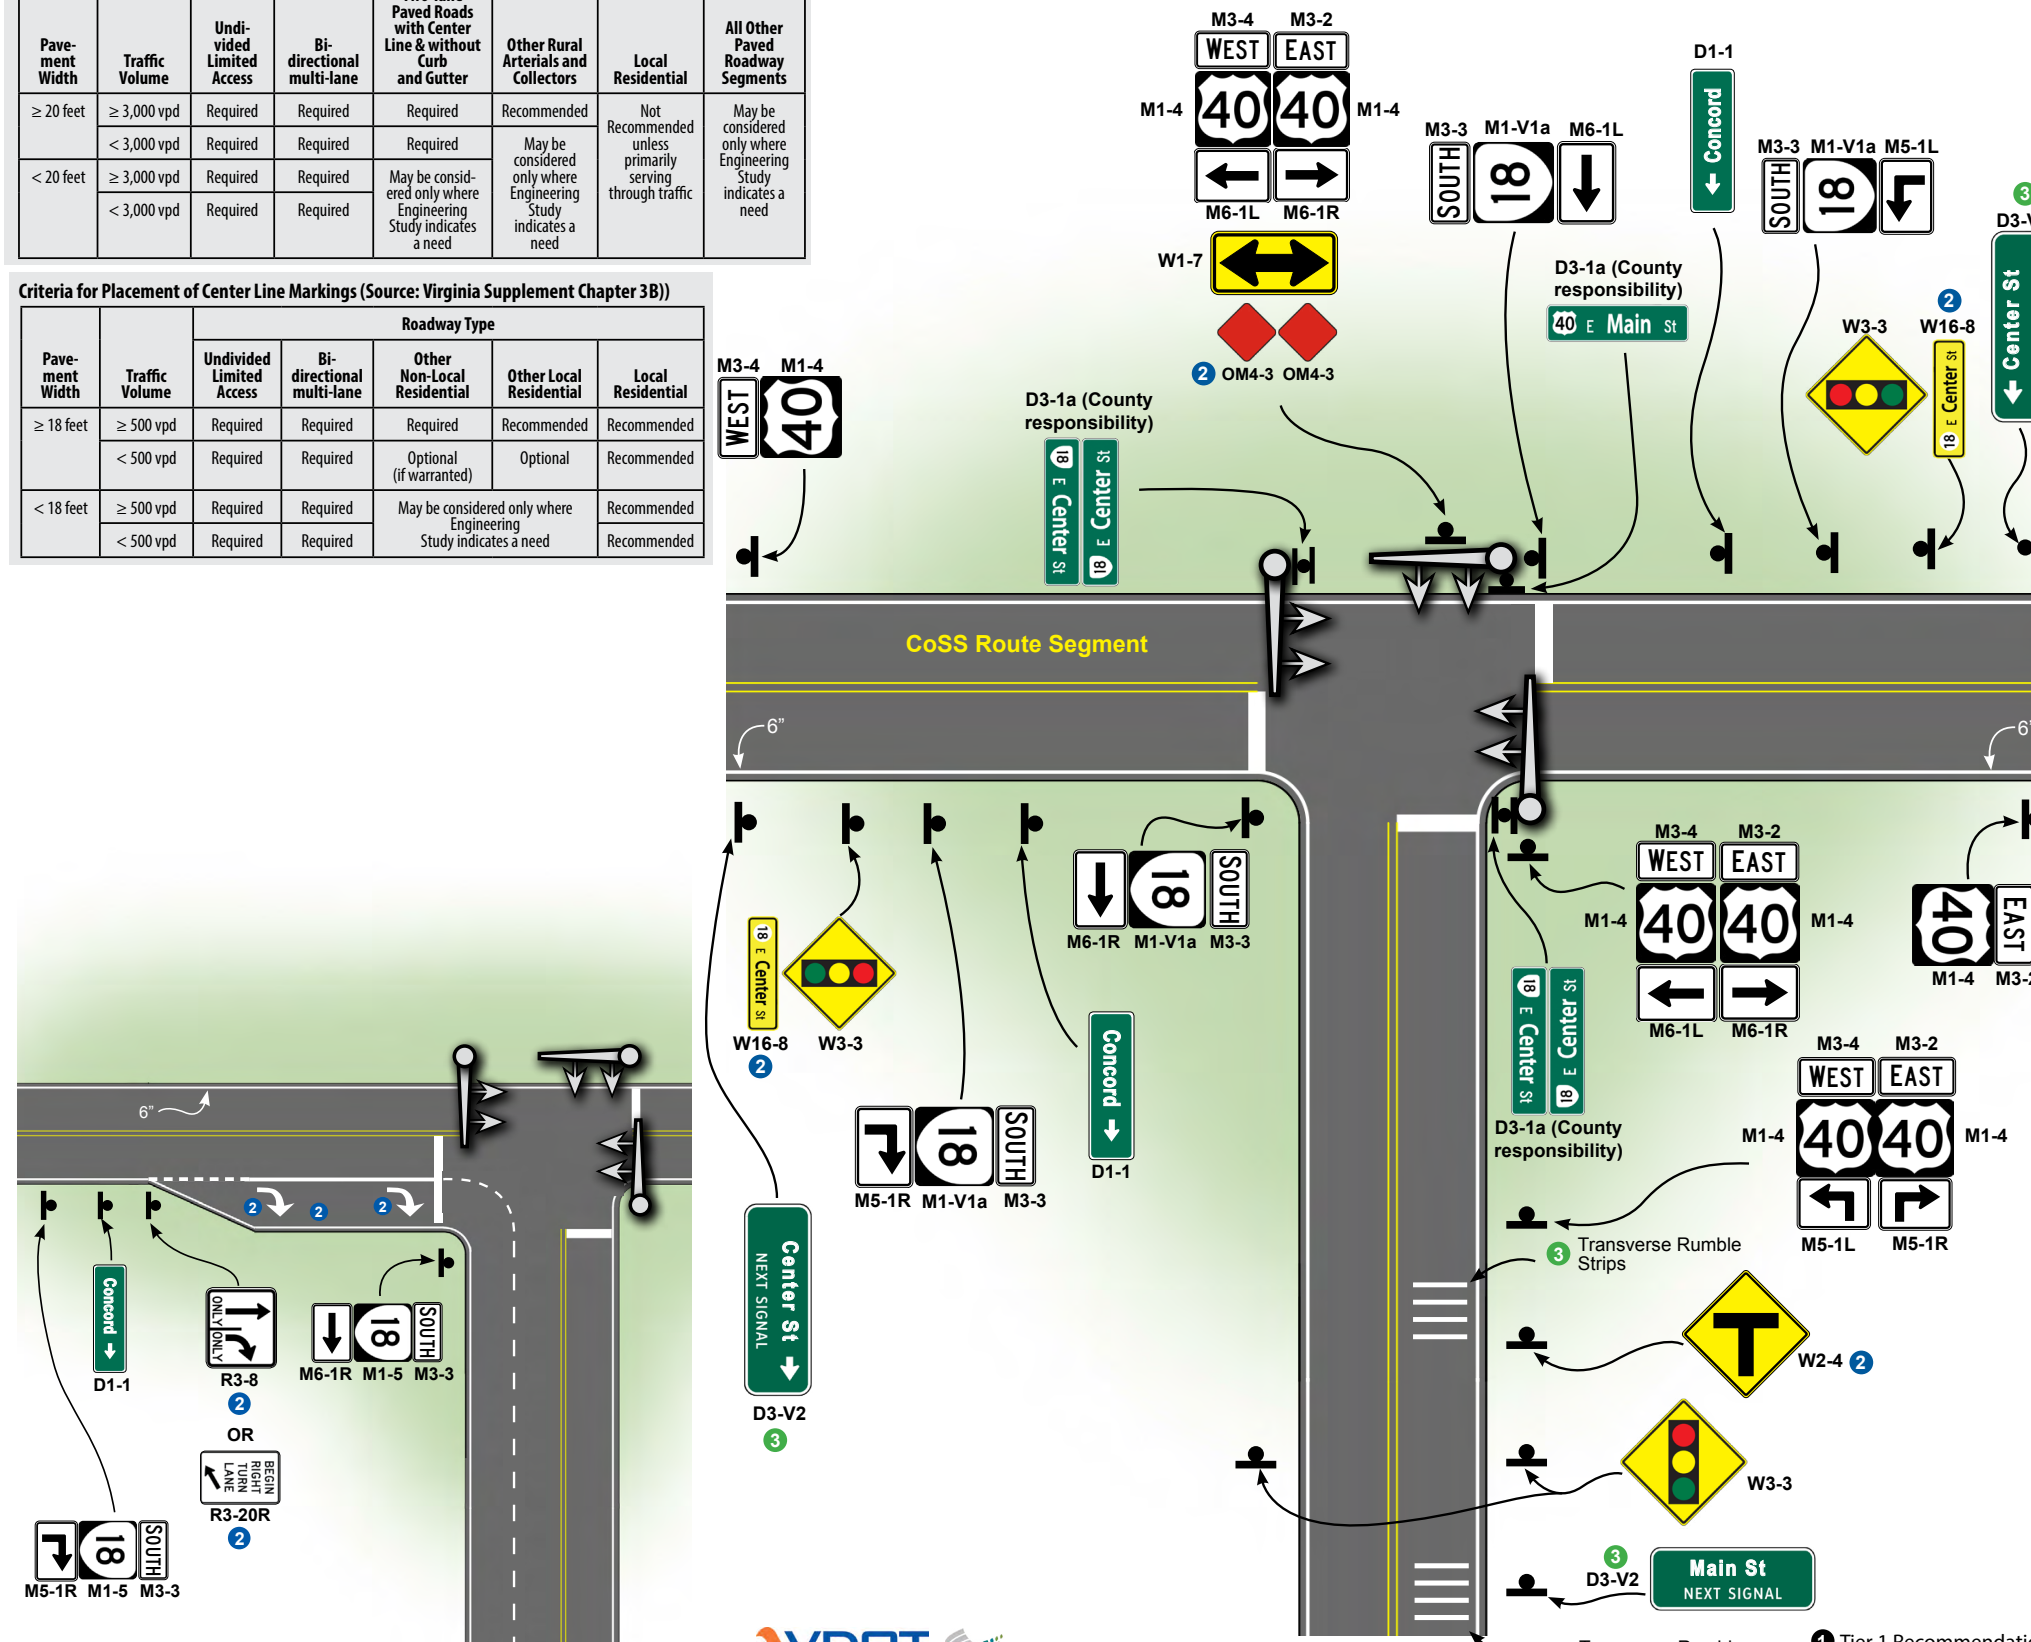
Template 7 - Signalized Intersection - 3-leg (3 Tiers)

- 1 Tier 1 Recommendations
- 2 Tier 2 Recommendations
- 3 Tier 3 Recommendations

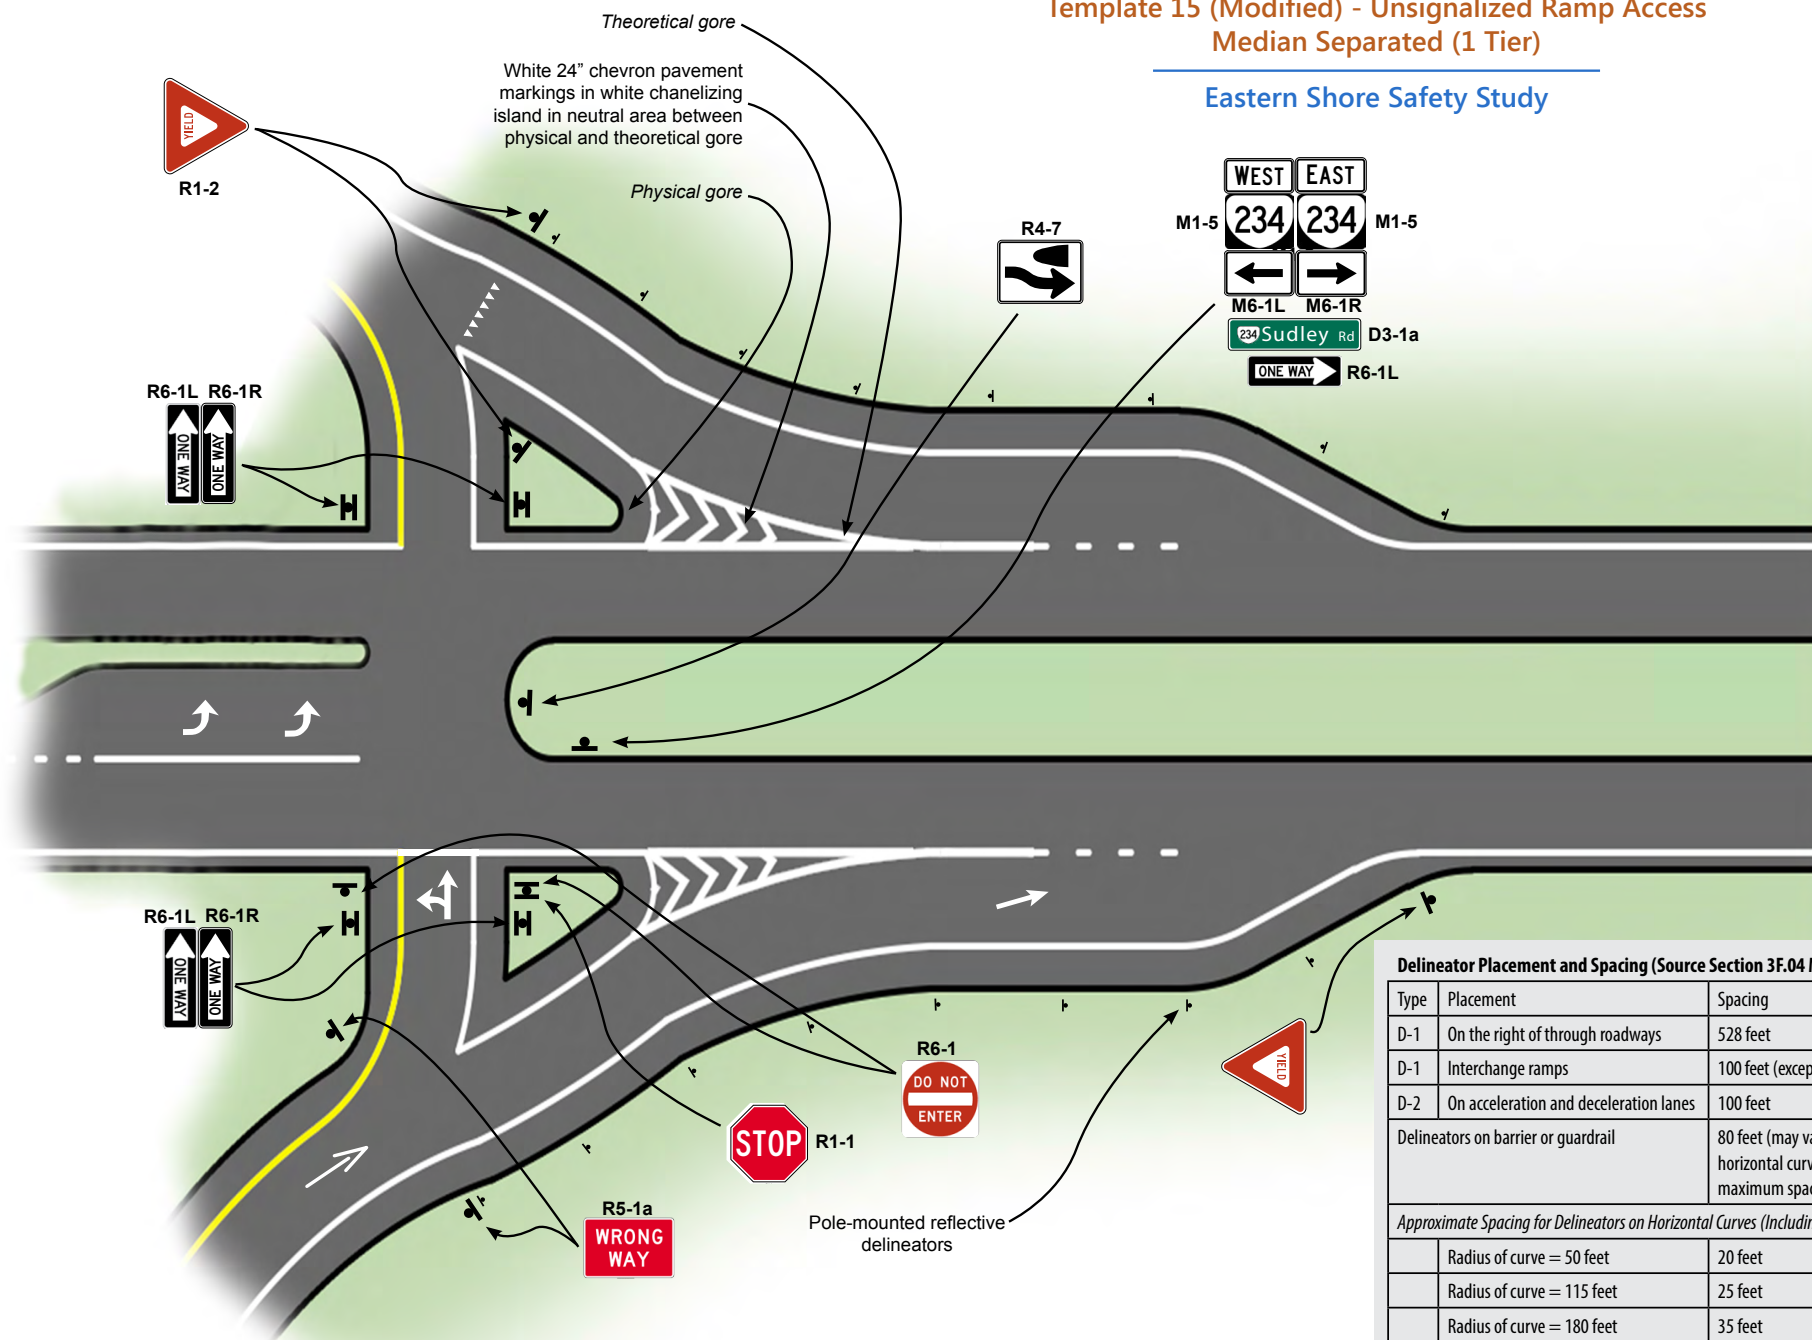
Template 15 (Modified) - Unsignalized Ramp Access
Median Separated (1 Tier)

Delineator Placement and Spacing (Source Section 3F.04 MUTCD VA Supplement)

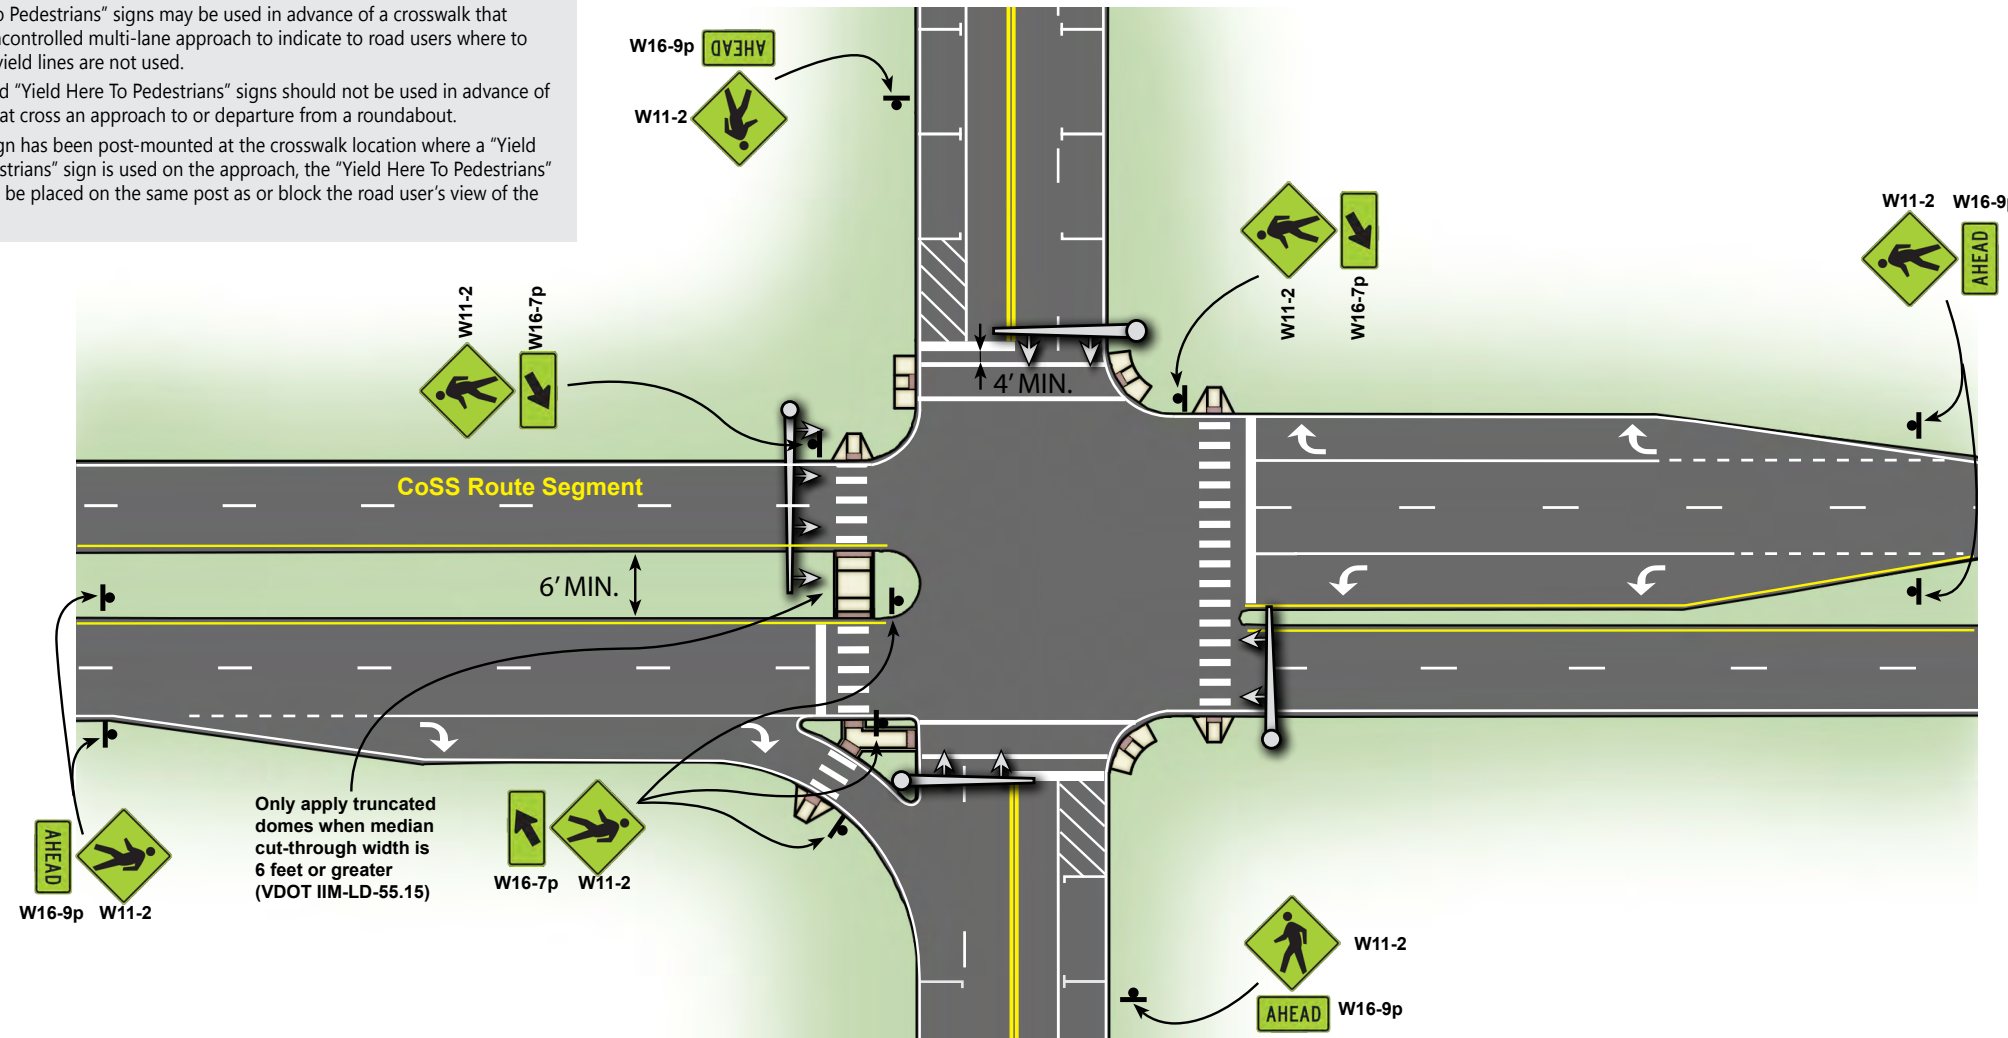
Template 16 - Pedestrian Measures

Only apply truncated domes when median cut-through width is 6 feet or greater (VDOT IIM-LD-55.15)

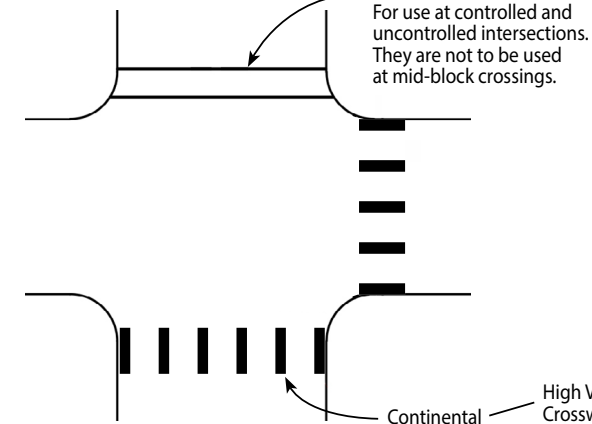
CROSSWALK MARKINGS

See Section 3B.18 of the MUTCD VA Supplement and VDOT TE Guidelines for the installation of marked crosswalks for application and design Guidance.

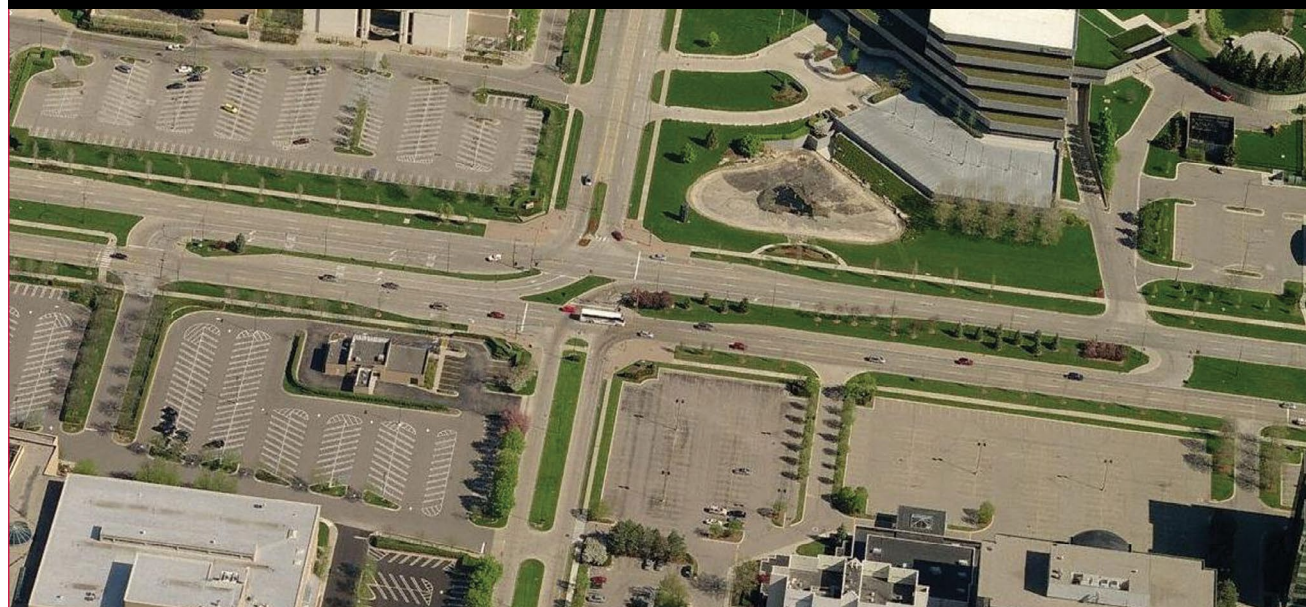
Figure 1. RCUT intersection in Troy, MI.

The corresponding report, *Alternative Intersections/Interchanges: Informational Report (AIIR)* (FHWA-HRT-09-060), covers four intersection designs and two interchange designs. These designs offer substantial advantages over conventional at-grade intersections and grade-separated diamond interchanges. The *AIIR* provides information on each alternative treatment and covers salient geometric design features, operational and safety issues, access management, costs, construction sequencing, and applicability. This TechBrief summarizes information on one alternative intersection design—the restricted crossing U-turn (RCUT) intersection (see figure 1).

RCUT intersections have been constructed in several States following the introduction of the concept in the early 1980s.⁽¹⁾ An RCUT at a location in Michigan is shown in figure 1. Other installations include three unsignalized RCUT intersections on U.S. Route 301 on Maryland's Eastern Shore and two on U.S. Route 15 in Emmitsburg, MD. One of the Emmitsburg, MD, installations is shown in figure 3. RCUT intersections have also been recently installed at several locations in North Carolina, including a 2.5-mi stretch of U.S. Route 23/74 in Haywood County, where three RCUT intersections were installed. Five RCUTs were also installed on Route 1 in Lee and Moore Counties, and three were installed on a signalized corridor of U.S. Route 17 in Brunswick County.

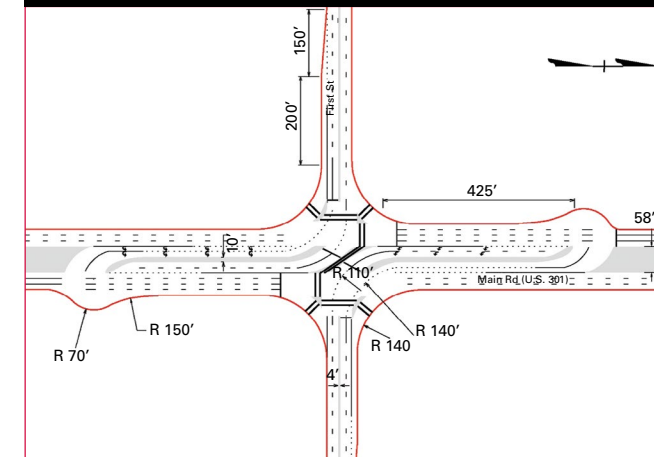
Figure 2. Typical RCUT plan view with crossovers on mainline approaches.

The RCUT, also referred to as the superstreet intersection or J-turn intersection, is characterized by the prohibition of left-turn and through movements from side street approaches as permitted in conventional designs. Instead, the RCUT intersection accommodates these movements by requiring drivers to turn right onto the main road and then make a U-turn maneuver at a one-way median opening 400 to 1,000 ft after the intersection. Left turns from the main road approaches are executed in a manner similar to left turns at conventional intersections and are unchanged in this design (see figure 2). Left-turn movements from the major road could also be removed at primarily rural unsignalized RCUT designs.

- The RCUT intersection has either no median openings at the intersection or has only one-way median openings for the exclusive use of left-turning traffic from the main road.
- Desirable minimum median widths between 40 and 60 ft are typically needed to accommodate large trucks so that they do not encroach on curbs or shoulders. RCUT intersections

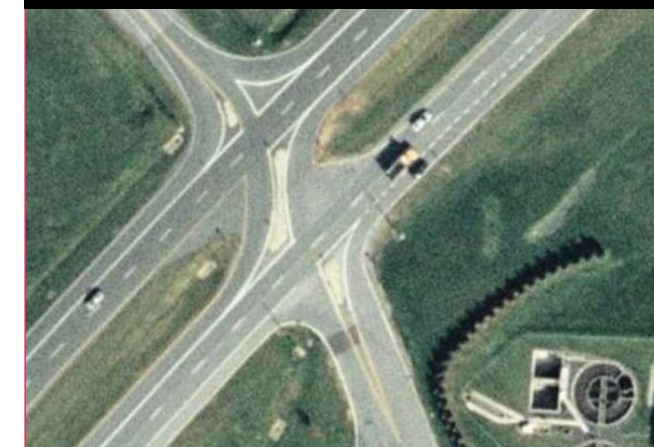
Figure 4. Movement in a loon at a crossover that features two U-turn lanes.

with narrower medians need bulb-outs or loons at U-turn crossovers (see figure 4).

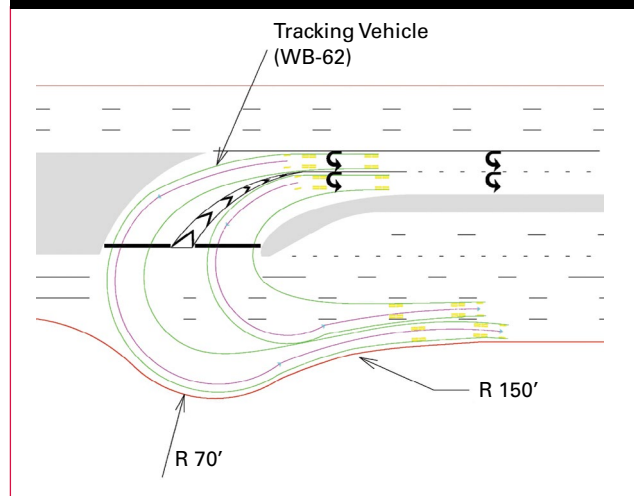
- The spacing from the main intersection to the U-turn crossover varies in practice. The American Association of State Highway and Transportation Officials recommends spacing of 400 to 600 ft based on signal timing.⁽²⁾ The Michigan Department of Transportation recommends 660 ft ±100 ft, and the North Carolina Department Transportation standard minimum spacing between main intersections and crossovers is 800 ft.
- Driveways should not be allowed near the main intersection or on the opposite side of

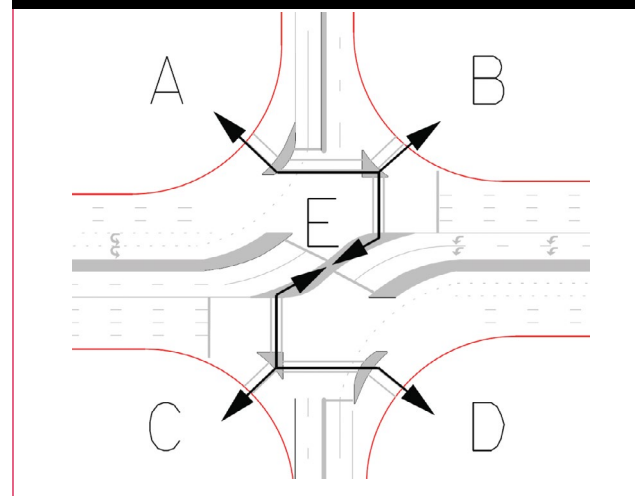
Figure 5. Pedestrian movements in an RCUT intersection.

- Pedestrian crossings of the major road at the RCUT intersection are usually accommodated on one diagonal path from one corner to the opposite corner (see figure 5).
